## Original Research Paper

# Thermal segregation of asphalt material in road repair

This paper presents results from a field study of asphaltic pavement patching operations performed by three different contractors working in a total of ten sites. It forms part of an ongoing research programme towards improving the performance of pothole repairs. Thermal imaging technology was used to record temperatures of the patching material throughout the entire exercise, from the stage of material collection, through transportation to repair site, patch forming, and compaction. Practical complications occurring during patch repairs were also identified. It was found that depending on the weather conditions, duration of the travel and poor insulation of the transported hot asphalt mix, its temperature can drop as high as 116.6 °C over the period that the reinstatement team travel to the site and prepare the patch. This impacting is on the durability and performance of the executed repairs. Cold spots on the asphalt mat and temperature differentials between the new hot-fill asphalt mix and existing pavement were also identified as poorly compacted areas that were prone to premature failure. Fo

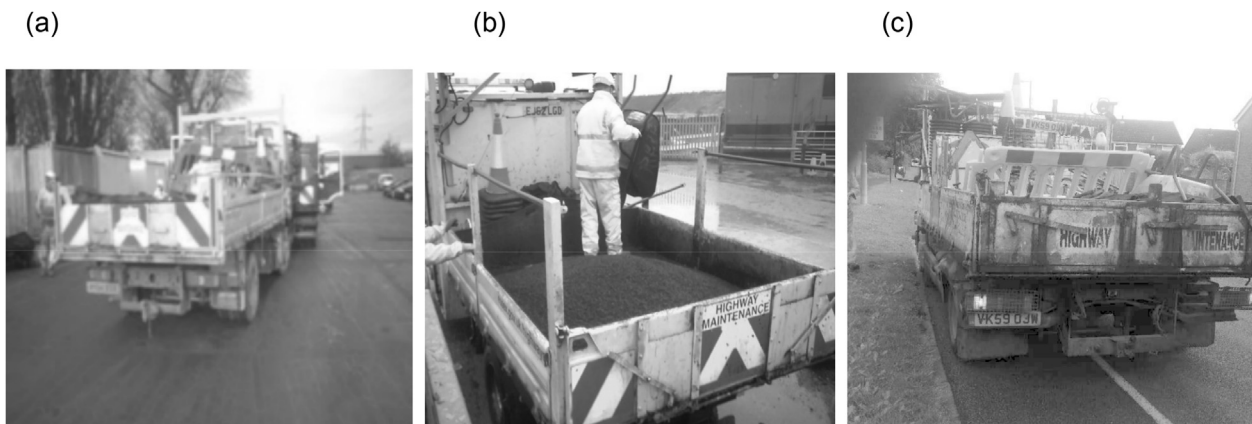
Further, all three contractors used a type of end dump truck to transport the asphalt material from the production facilities to the locations of the repair sites (Fig. 1). After the material was loaded into the truck it was covered by an insulating sheet. They all used the same uncontrolled process of transportation. The described data are presented in Table 1.

Fig. 1 – Mode of HMA transportation. (a) Contractor A. (b) Contractor B. (c) Contractor C.

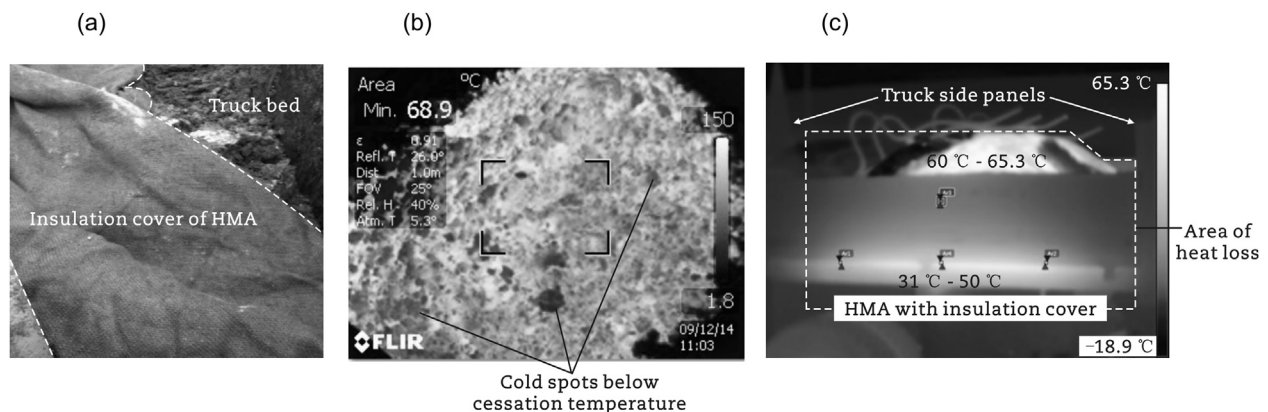
During transportation, the HMA was covered only with a thin insulation sheet (Fig. 2(a)). Two thermal images were taken immediately after the HMA was loaded onto the truck. At this point, thermal segregation had begun to develop, this shown as black areas on Fig. 2(b). The temperatures of the asphalt mat at this stage varied between 69 °C and 150 °C, indicating cold spots throughout the asphalt mat. Further, heat loss occurred through the panels of the truck and the cover sheet (Fig. 2(c)). The dark areas on the periphery of both thermal images are the surroundings to the HMA containment and not the material itself.

**Fig. 2 – Asphalt collection at the production plant for repair sites 1–5. (a) Insulation cover of HMA. (b) Asphalt mat temperatures after collection. (c) Insulation cover temperatures.**

production facility. Improper insulation of the hot-fill material and long travel time, in combination with low ambient temperatures, impacted on the asphalt mix temperature causing significant temperature losses through the panels of the truck and the cover sheet (Fig. 2). Table 2 and Fig. 3 present the overall transportation time and temperature drop versus time respectively of the asphalt from the production plant to each repair site.

There was an initial drop at temperature of 6.5 °C after 50 min of transportation between the asphalt plant and the first repair site. An overall drop of 60 °C occurred between the initial temperature of 150 °C and the delivery temperature on the last repair site, after 7 h and 25 min. A dramatic temperature difference of 33 °C occurred between repair sites 3 and 4 with the asphalt mat reaching 95 °C. This was a reduction of approximately 37% from the initial temperature of 150 °C. Asphalt temperature decreased by 40% between the asphalt plant and the last repair site.

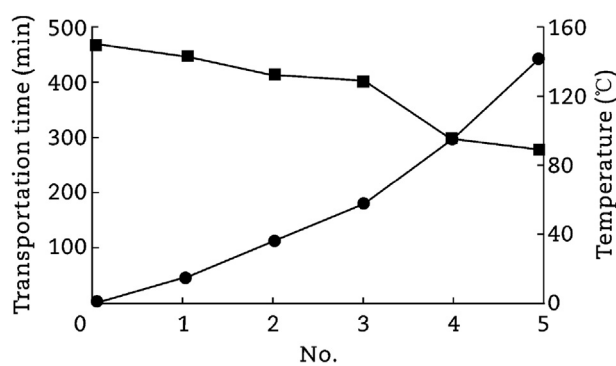
Fig. 3 – Asphalt temperature variation and transportation time between asphalt production facility and each repair site.

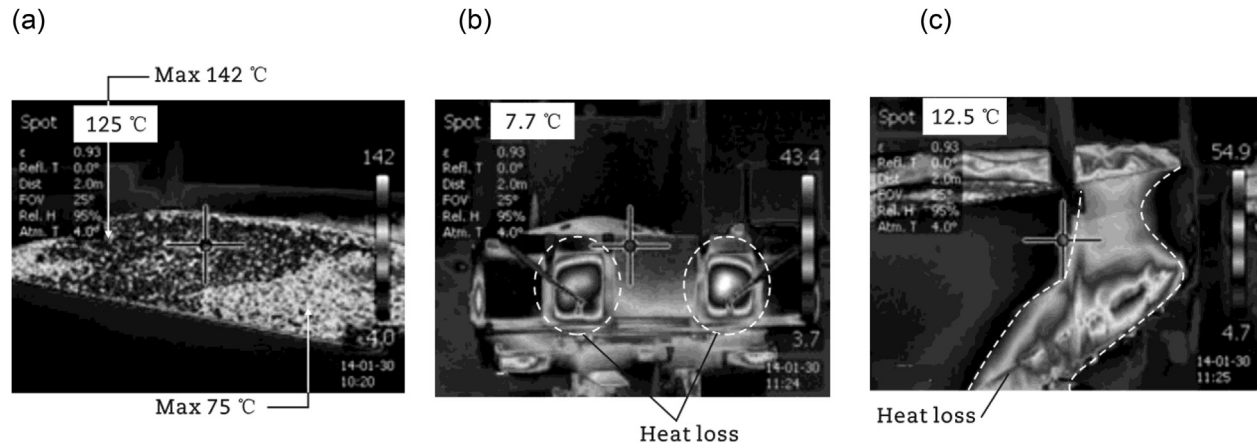
Contractor B was monitored during their patch repair activity on repair site 6, between the production facility and this. The transportation process of Contractor B is similar to that of Contractor A. A tail gate dump track type was used to transport the HMA. When the asphalt was loaded onto the track it was covered by an insulation sheet. The prevailing ambient temperature was approximately 4 °C. Three thermal images of the asphalt were taken immediately after loading the HMA onto the truck, these are all shown in Fig. 4.

The crew travelled approximately 2 h to reach the repair site. This caused a temperature drop of 42 °C compared to the initial maximum temperature of 142 °C.

Fig. 4 – Asphalt collection at the production plant for repair site 6. (a) Temperature variation of HMA after collection. (b) Heat loss from the back of the truck. (c) Heat loss alongside the vehicle.

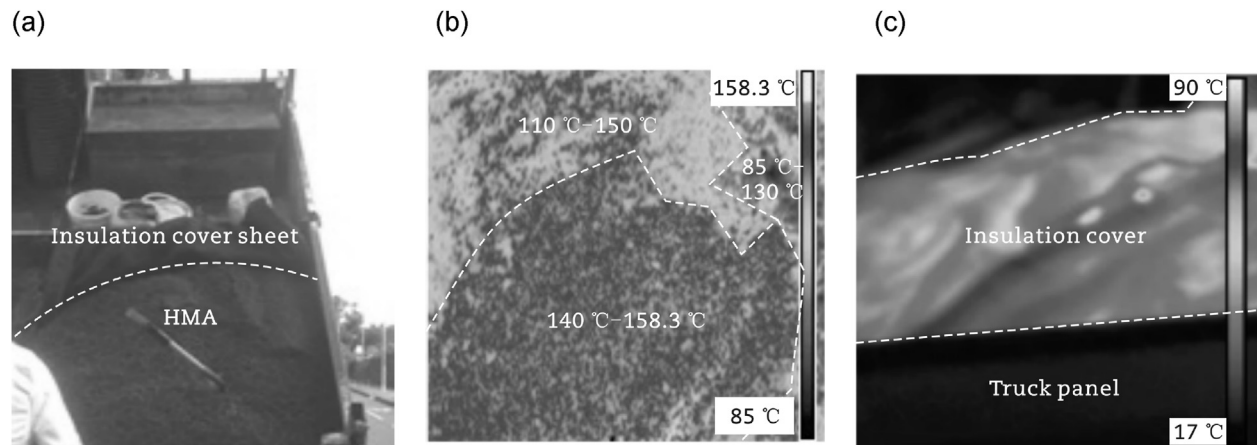
The maximum temperature of asphalt, when gathered from the production plant at day 1, was approximately 158.3 °C (Fig. 5(b)). Thermal segregation had started to develop as observed with Contractors A and B. Heat loss from the truck panels and insulation cover was also observed, shown in Fig. 5(c). At day 2, the maximum temperature measured on the mat of the HMA was 138.5 °C with cold spots also seen throughout the asphalt mat as per all the repairs previously discussed Fig. 6(b). Further, Table 3 and Fig. 7 demonstrate transportation time and temperatures of the mix upon arrival at repair sites.

As the results show, during the transportation of the HMA at day 1 there was an overall dramatic decrease of asphalt mixture temperature of 116.6 °C. This heat loss is attributed to the travelling time and uncontrolled insulation of the hot material. At day 2, the overall maximum temperature drop was much less, reaching a difference between asphalt plant and last repair site of 16.5 °C.

Fig. 5 – Asphalt collection at the production plant during the first day of repairs for sites 7–8. (a) Transportation truck with HMA. (b) Asphalt mat temperatures after collection. (c) Insulation cover temperatures.

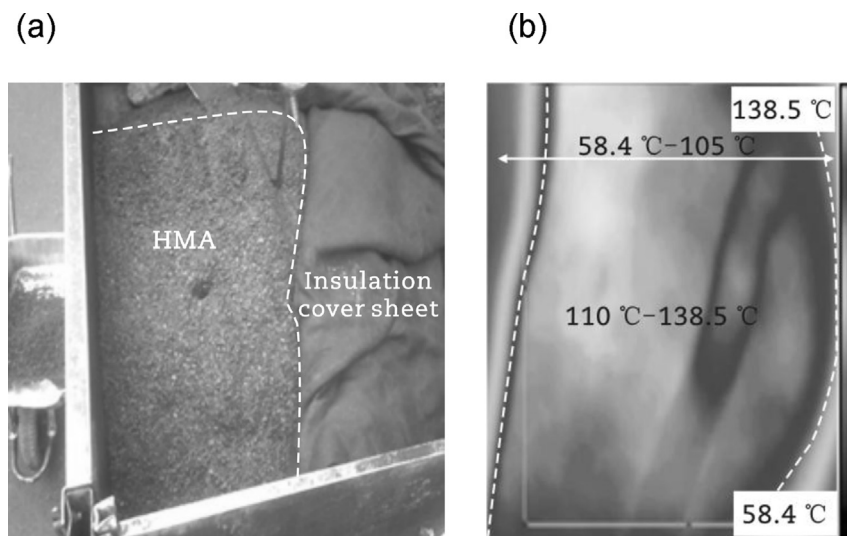
Fig. 6 – Asphalt collection at the production plant during the second day of repairs for sites 9–10. (a) Transportation truck with HMA and insulation cover. (b) Asphalt mat temperatures after collection.

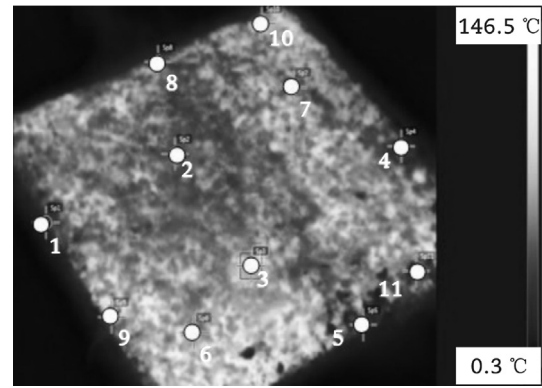
For Contractor A, Figs. 8 and 9 were taken after compaction of the HMA at repair site 1. Fig. 8 presents eleven points taken randomly on the mat. The maximum temperature of the compacted hot fill mix surface was 146.5 °C. The point temperature measurements show cold spots throughout the whole surface of the repair (Fig. 8 and Table 4) that had reached and decreased below cessation temperature indicating the areas that are most likely to prematurely fail. These were also expected to have affected the effectiveness of the compaction.

**Fig. 8 – Temperature variation of patch repair on paving site 1 after compaction—thermal image 1.**

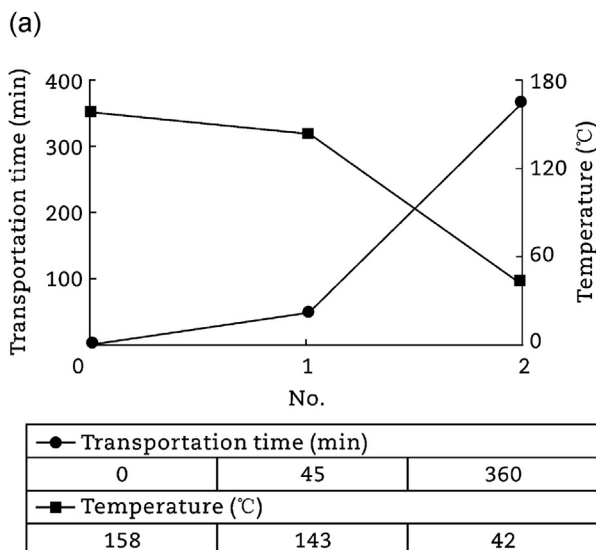
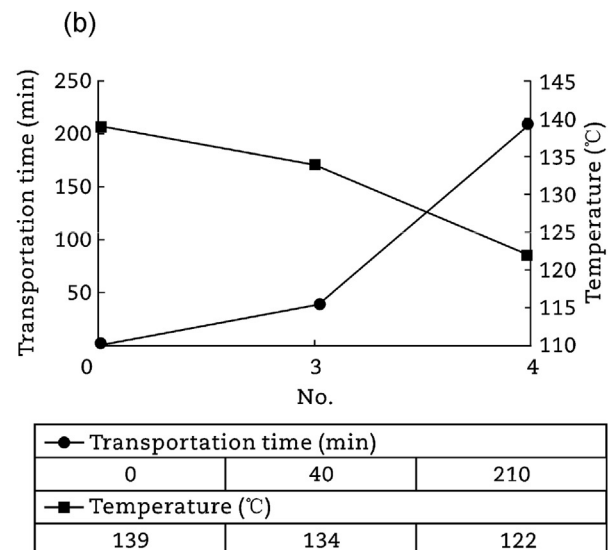
**Fig. 7 – Temperature variation and transportation time of HMA between asphalt production facilities and each repair site. (a) Day 1 repair sites 7–8. (b) Day 2 repair sites 9–10.**

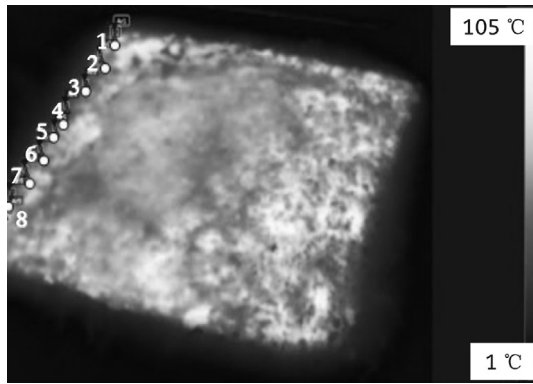
Fig. 9 shows temperature variations between the host pavement and the new hot-fill material. Eight points were chosen from the edge of the patch repair. All showed temperatures are below the cessation temperature (Table 5), indicating low strength interface bonding, prone to water ingress and premature failure under traffic loading.

Fig. 9 – Temperature variation of patch repair on paving site 1 after compaction—thermal image 2.

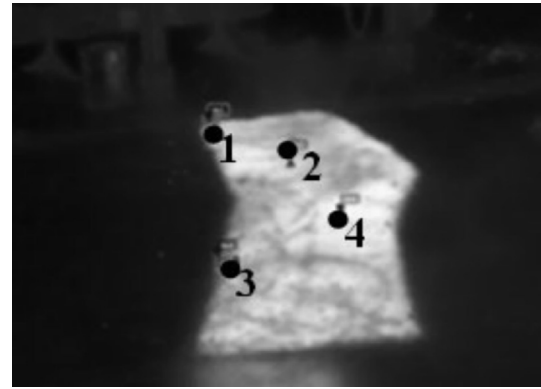
Fig. 10 represents temperature measurements at repair site 2. Four random points were selected to understand the variation in temperature. For each point, seven measurements were collected at different times. Points 1 and 3 were taken on the edges of the mat, and points 2 and 4 were in the middle area of the mat. The measurements

showed that different locations of the mat exhibit different repair quality. This means that the points with low temperature are expected to have been poorly compacted creating areas of future premature failure. The points located on the edges (points 1 and 3) had lower temperatures than those located in the middle of the mat (points 2 and 4). The temperature reduced, after 21 min reaching a temperature difference of 56.4 °C for point 1 from the first thermal image shot, 30.6 °C for point 2, 53.3 °C for point 3, and 32.9 °C for point 4 (Table 6). This means that the average percentage of temperature reduction on the edges was approximately 50% and it was approximately 29% in the middle. Consequently, the edges of the repair appear to have a temperature difference of approximately 28% from the middle of the mat, indicating low interface bonding between the host pavement and the hot-fill material which may lead to premature failure of the repair at its edges.

Fig. 10 – Thermal image of patch repair immediately after compaction on paving site 2.

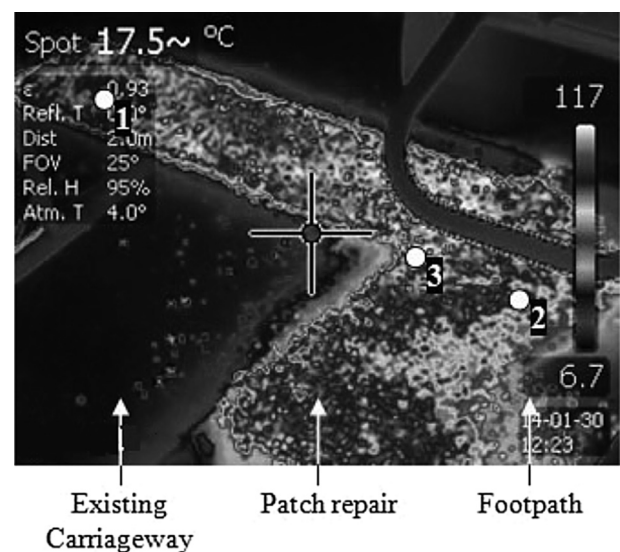
Contractor B was followed during the pothole repair at a single site. Fig. 11 presents the compacted new HMA pothole mix. The

image gives an indication of the overall temperature variation of the mix immediately after compaction. Three points (Points 1, 2 and 3) were studied in more detail. Point 1 was situated away from the kerb line and drainage area. Point 2 was located near the kerb line and within the drainage area and, finally, Point 3 was located at the edge between the new and old reinstatement. Further, due to the position of the repair water was flowing through the patch constantly. Eight temperature recordings were collected for each point all these displayed in Table 7. All points had an initial temperature of approximately 100 °C. This is a 42 °C drop from the initial temperature of 142 °C when the HMA was loaded onto the truck.

The results indicate that, in a period of 5 min, the temperature for points 1, 2 and 3 dropped to approximately 33%, 65%, and 71%, respectively. The highest drop is for points 2 and 3 which are located at the edges of the repair. Similar results were observed for the repair examples of Contractor A,

Fig. 11 – Thermal image of patch repair immediately after compaction on repair site 6.

indicating a similar weak point of the executed repairs. Usually, the areas of the repair with a temperature less than the cessation temperature tend to have lower density and cause failure of the patch repair.

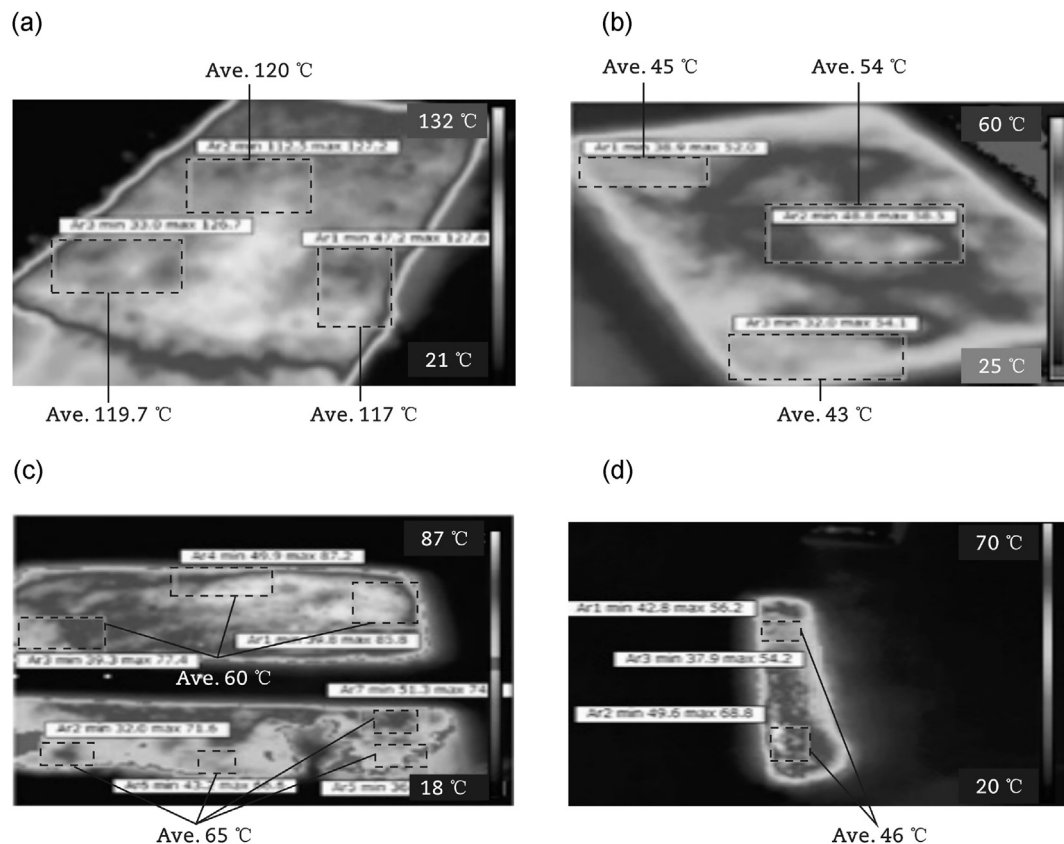
In contrast with the other two contractors, temperatures during these repairs were measured on areas and not on specific points. Fig. 12 demonstrates four thermal images for each repair site with temperature variations immediately after compaction. All four repairs had cold spots throughout

the repair area with the lowest temperatures being located at the interface between the host pavements and the new hot-fill material.

**Fig. 12 – Thermal images of patch repairs immediately after compaction. (a) Repair site 7. (b) Repair site 8. (c) Repair site 9. (d) Repair site 10.**

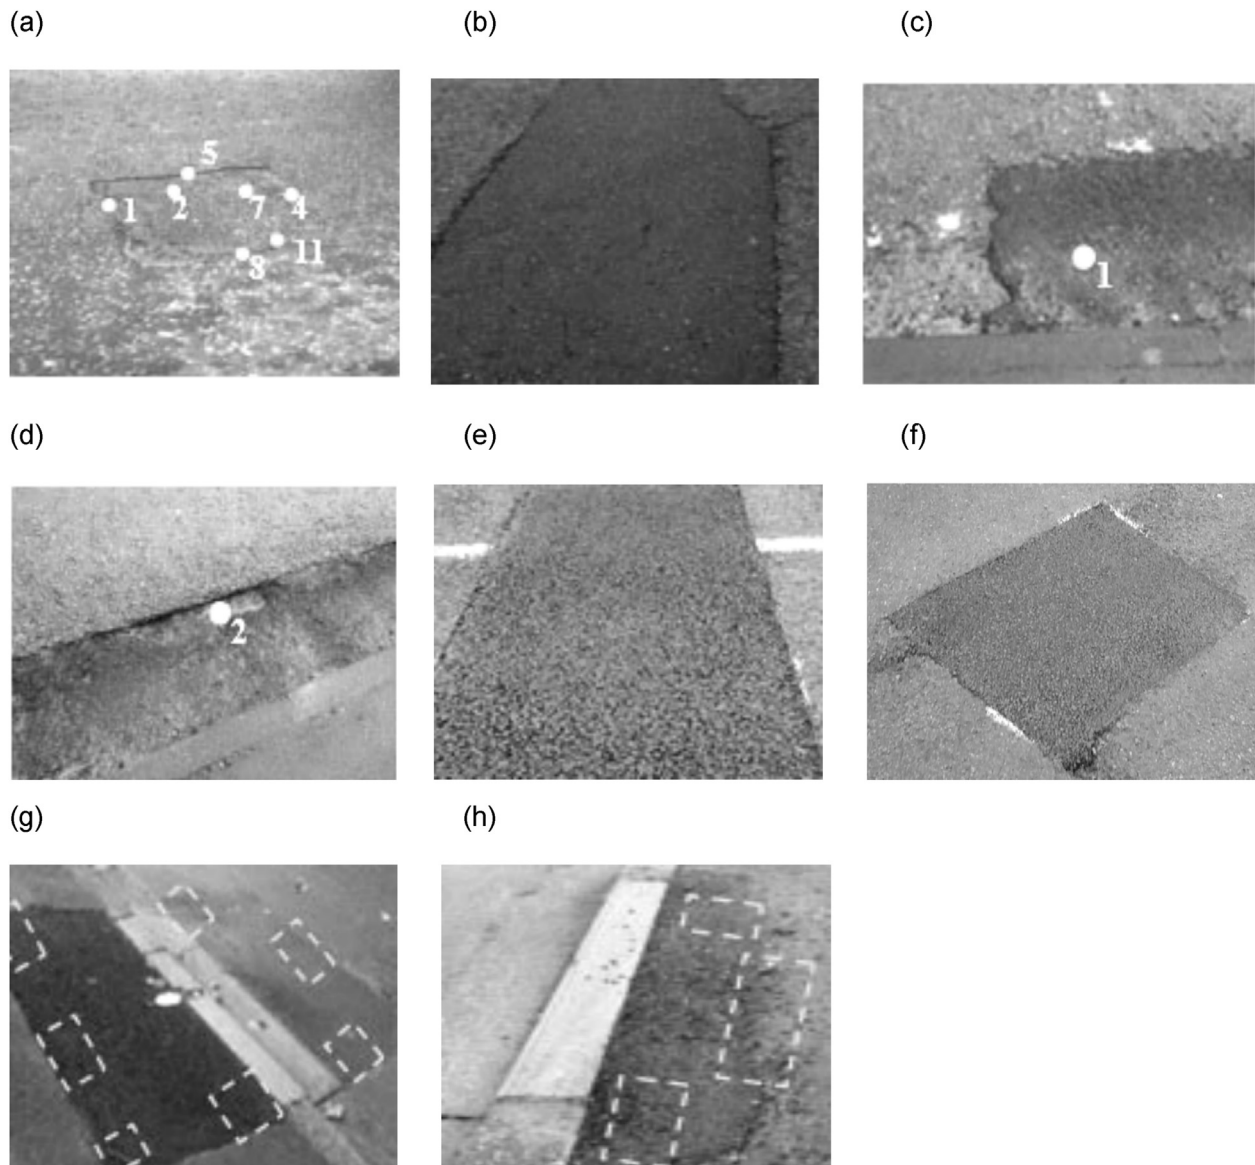
All the repaired sites were revisited three months after completion of the repair work. Fig. 13 presents the condition of most of the repairs. The main points of failure were observed along the edges of the reinstatement. Repair site 1 showed also evidence of settlement. Whereas, on repair

sites 6 and 7–10 the patch material had started to fall away. Images (a), (c), (d), (g), and (h) of Fig. 13 demonstrate examples of the points and places where excessive low temperatures were observed after the compaction of the hot-fill material.

Fig. 13 – Patch repair sites after three months of completion. (a) Repair site 1. (b) Repair site 2. (c) and (d) Repair site 6. (e) Repair site 7. (f) Repair site 8. (g) Repair site 9. (h) Repair site 10.

To offset the described effects, it would be necessary to plan a days repair work, taking into account the cooling characteristics of the transported repair asphalt relative to ambient temperature, distance and probably travelling time between sites, host pavement temperatures at each site relative to arrival time and anticipated repair time at each site. Without these considerations, there is a risk of repair temperatures below cessation temperature. It would be advantageous to heat the pothole excavation but this must be in a controlled manner.
