# The water weakening effect on the progressive slope failure under excavation and rainfall conditions

Xiang Yu<sup>1,2</sup> · Tao Zhao<sup>2</sup> · Bin Gong<sup>2</sup> · Chun'an Tang<sup>1</sup>

## Abstract

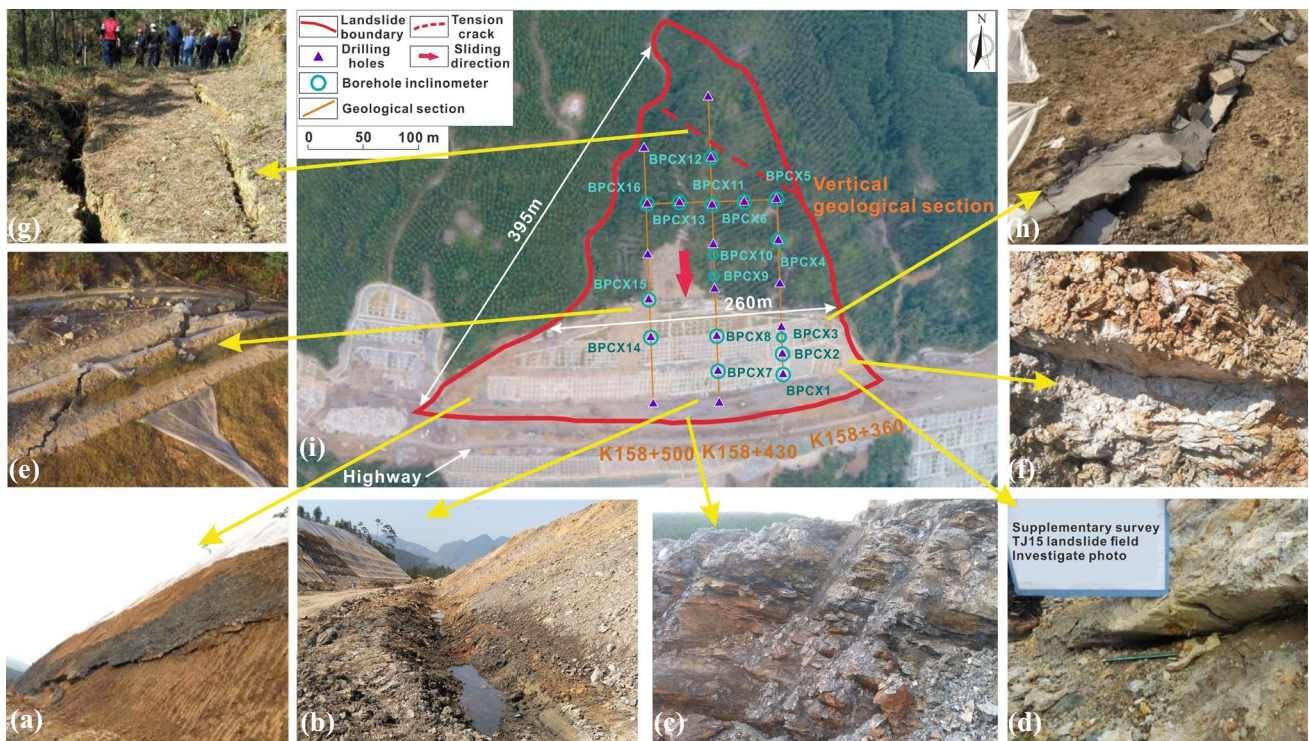
Fig.2 The landslide characteristics: (a), (d), (f) shear outlets, (b) underground water springs, (c) landslide drumlin, (e), (h) cracks, (g) through cracks, and (i) remote sensing image of landslide area

also set on the slope shoulder to intercept surface runoff. Unfortunately, the slope slid and significant deformed just 30 days after construction was completed. The front toe extruded and uplifted to form a landslide drumlin, as shown in Fig. 2(c). Shear outlets were found at the lower first level slope, as depicted in Fig. 2(a), (d), and (f). At the middle, soil masses from the first and second level

slid, causing the first-level platform to stagger by 0.6 m. Cracks were also observed at the intercepting ditch of the slope shoulder and the second platform, as seen in Fig. 2(e) and (h), suggesting that the supporting structure wasn't effective. A large number of through cracks with a width of 50-100 cm were also observed 135–240 m behind

the slope shoulder, as shown in Fig. 2(g). The large-scale landslide from the top to the foot of the slope has formed.

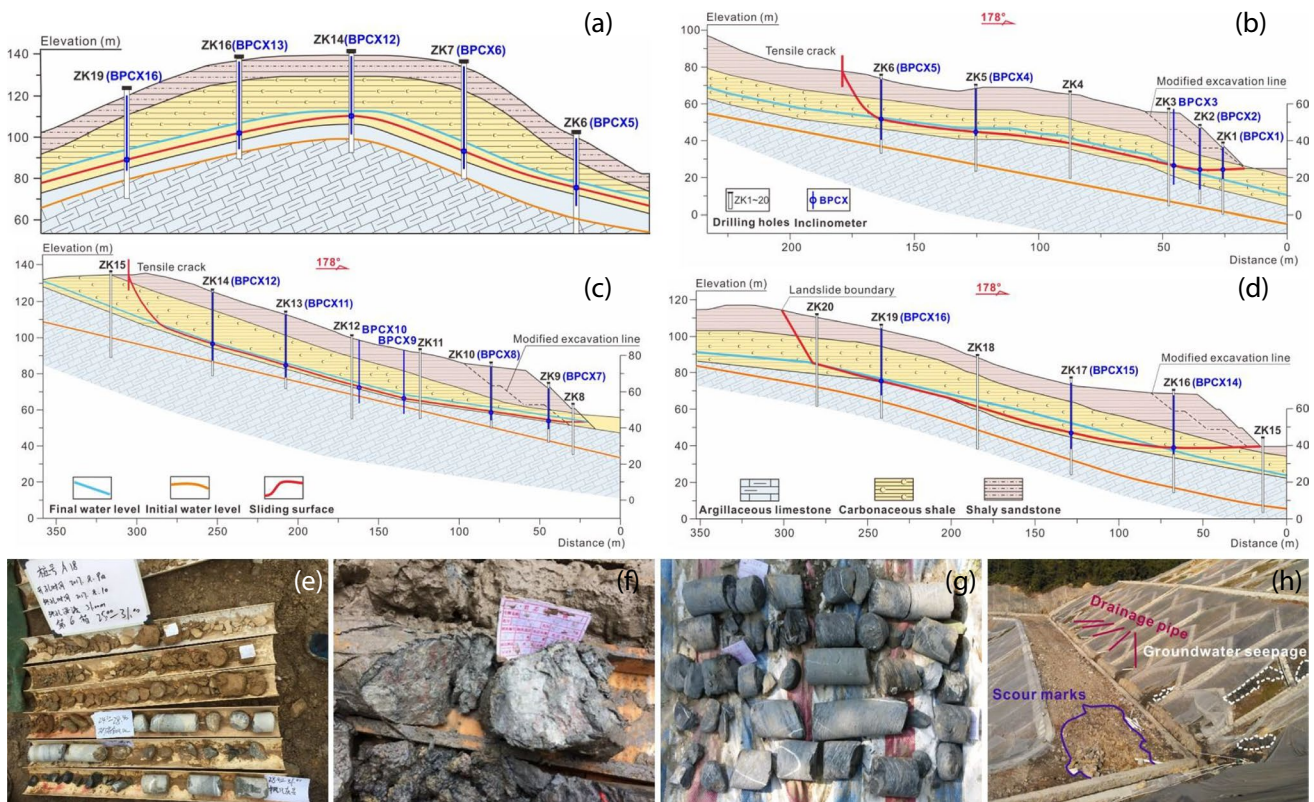
The drilling results show that the strata are gently inclined from north to south and basically parallel to the terrain from east to west. The slope is covered by argillaceous sandstone, carbonaceous shale, and argillaceous limestone from top to bottom. The sandstone cores are broken and soft, showing no apparent signs of immersion, as depicted in Fig. 3(e).

The shale cores are earthy and wet, displaying obvious slip marks, as illustrated in Fig. 3(f). The limestone cores are incomplete and hard, without sliding mark on the surface, as shown in Fig. 3(g). Groundwater levels were observed 32 times, including 16 times both for initial water and stable water level, all of which were located in the lower carbonaceous shale. Groundwater was found to be gushing out at the front of K158 + 430 section, with a daily inflow of 0.72 tons. The location is close to the water springs, indicating that the groundwater level has hardly changed after local failure, as shown in Figs. 2 (b) and 3 (h). Combined with the preliminary investigation report, it can be speculated that the initial groundwater level is located at the upper argillaceous limestone and rises to the lower carbonaceous shale after being recharged by rainfall in May, 2016.

**Fig. 3** Field investigation: (a) the geological cross section, (b), (c), (d) K158 + 360, 430, and 500 sections (e), (f), (g) cores of argillaceous sandstone, carbonaceous shale and argillaceous limestone, and (h) groundwater seepage at lower first-level slope

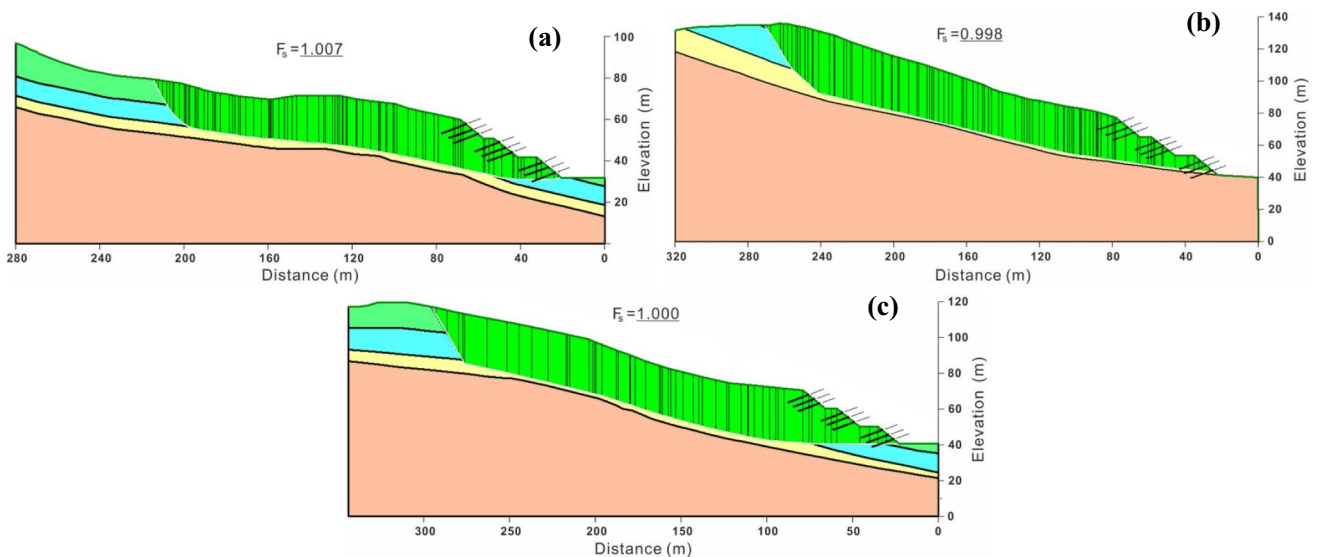
The inverted parameters are presented in Table 2. When the cohesive force and internal friction angle of the weakened carbonaceous shale are 15 kPa and  $15^\circ$ , the critical factor of safety for the K158 + 360, 430 and 500 section are

**Fig.4** Final sliding surfaces of parameter inversion: (a) K158+360 section, (b) K158+430 section, and (c) K158+500 section

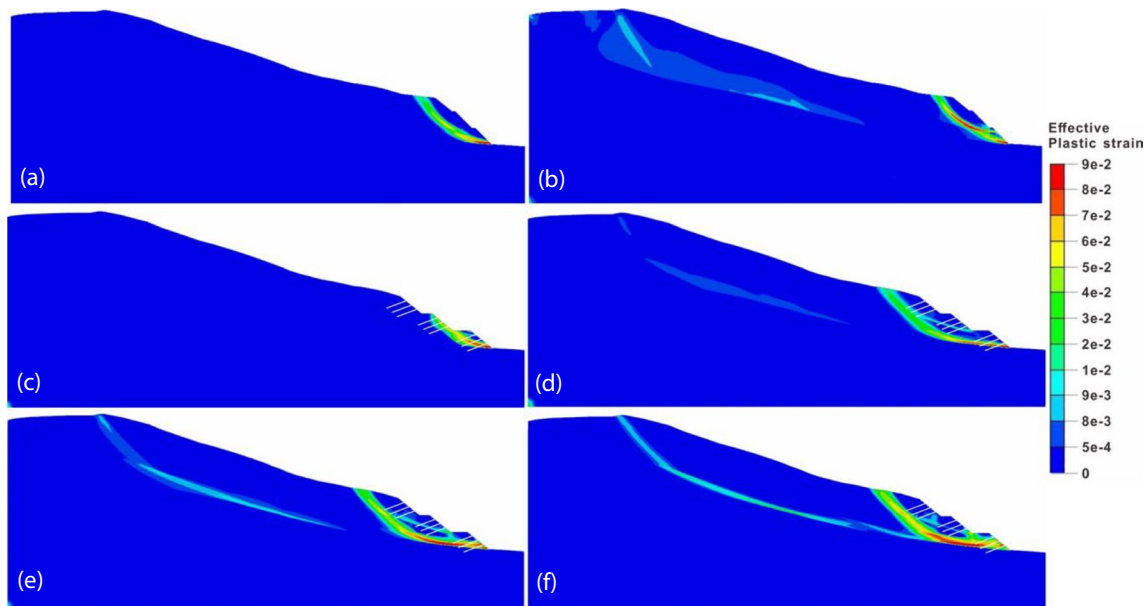
Considering the large number of time steps involved in the analysis of hydration, representative simulation results for the 10th (initial), 20th (middle), and 30th days (late) are displayed alongside the results of two excavation and rainfall conditions. Figure 5 presents the effective plastic strain

evolution. Over the course of construction, the scope of slope failure shifted from shallow to deep, while the failure type transitioned from local collapse to overall bedding sliding. Following initial excavation, a plastic zone developed along the excavated slope, with its maximum value located at the slope toe. During the rainfall stage, the plastic strain extended from the toe to the upper excavated slope, indicating a traction landslide pattern. Additionally, a new plastic zone formed in the middle of the slope, extending towards the slope top and originating from the saturated shale.

After modifying the excavation and implementing slope support, the plastic strain at the middle and rear of the slope disappeared, while a shallow plastic zone appeared from the slope toe to the second-level slope. However, carbonaceous shale hydration caused the slope to deform and slide once again. By the 10th day of hydration, the shallow plastic zone had transformed into a deep-seated sliding surface that circumvented the support structure and cut along the hydration layer. Simultaneously, the plastic zone from the hydration layer in the middle extended towards the slope top. On the 20th day of hydration, both the front and rear plastic zones expanded; the front plastic strain increased significantly, and the rear plastic zone began extending downward along the weakened shale, with a tendency to connect to the front sliding surface. By the 30th day of hydration, the front and rear plastic zones had fully connected, forming a large landslide mass that spanned the slope from top to toe.

**Fig.5** Evolution process of slope plastic strain under different analysis condition: (a) initial excavation (b) rainfall (c) modified excavation and support (d), (e) and (f) represent 10, 20 and 30 days of hydration

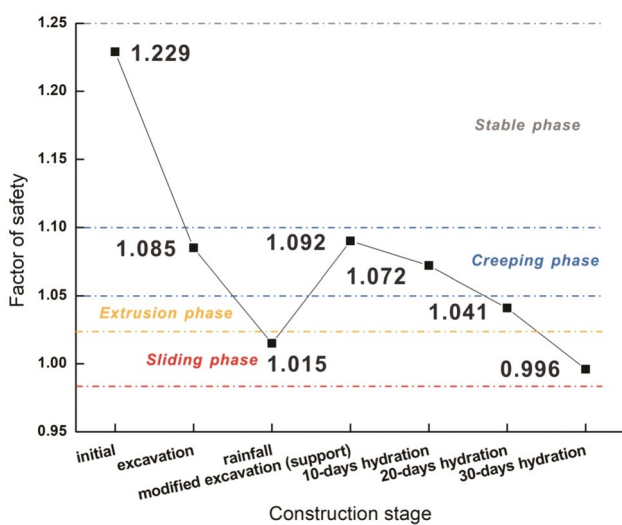
Figure 6 displays the variation of the slope factor of safety during each modeling stage. During the construction stage, slope stability initially decreased rapidly, followed

by a brief increase and subsequent decrease. After 30 days of hydration, the slope factor of safety reached 0.996, and was close to the slope factor of safety 0.998 obtained from parameter back analysis. This indicates good consistency between numerical simulation and inversion. According to Wang et al. (2017), who summarized the relationship between deformation and factors of safety, the cutting slopes can be categorized into the creeping stage ( $1.05 < \text{FoS} < 1.1$ ), the extrusion stage ( $1.02 < \text{FoS} < 1.05$ ), the sliding stage ( $0.98 < \text{FoS} < 1.02$ ), and the sudden slip stage ( $0.95 < \text{FoS} < 0.98$ ), the following section presents an analysis of the slope failure characteristics based on the four stages.

Fig.6 Factor of safety at each stage of the slope

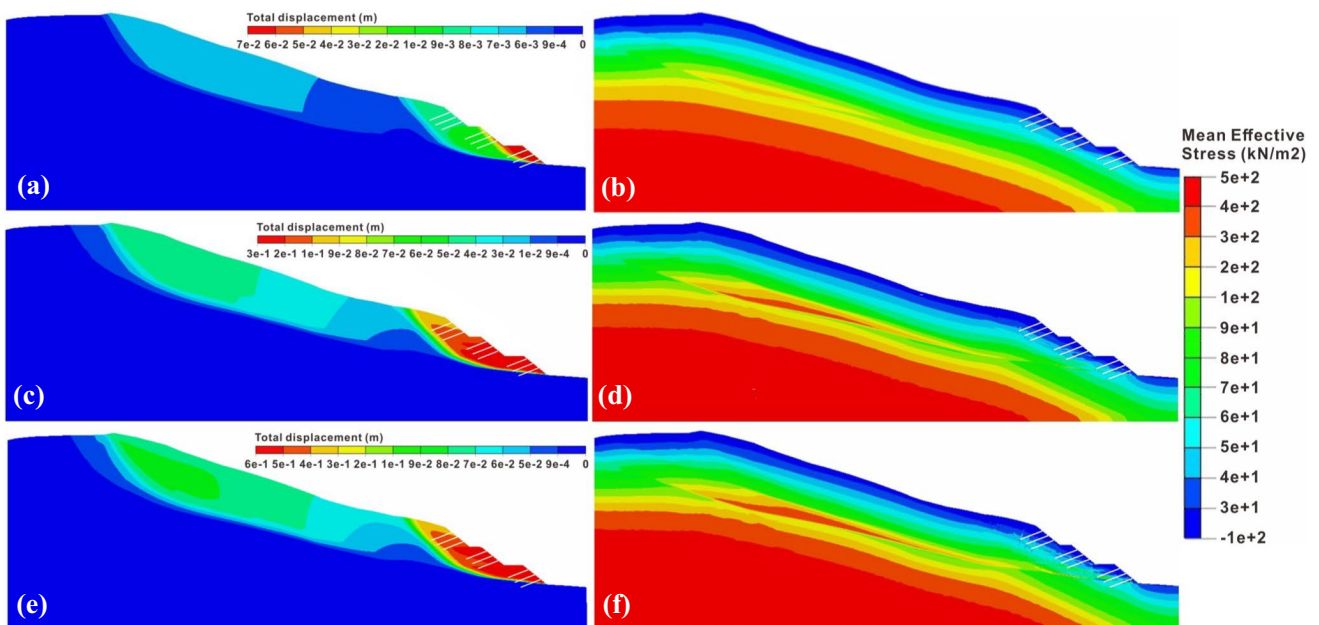
factor of safety of 1.072, only 1.9% lower than the previous. However, stress and deformation characteristics were significantly changed. Positive effective stress concentrated in the middle to rear of the hydration layer while surface values oscillated from positive to negative, as depicted in Fig. 8(b), indicating compression and tension occurring in deep and shallow layers. The plastic zone of the excavated slope shifted from shallow to deep, with the sliding surface bypassing the anchor rod and cutting along the exposed position of the lower shale, as shown in Fig. 5(d). This rendered the support structure ineffective and caused deformation of the first-level slope. Furthermore, due to weakened shale parameters, the middle and rear soil mass exhibited displacement exceeding 6 mm, as shown in Fig. 8(a).

At the end of the hydration, the slope exhibited instability. The factor of safety sharply dropped to 0.996, reaching sliding failure stage. The cohesion and internal friction angle reduced to the lowest, which were only 48.4% (15 kPa) and 65.2% (15°) of initial values, disrupting torque balance of weathered layer. Both compressive stress and plastic strain zone connected to front excavated slope, as shown in Figs. 8(f) and 5(f). A large bedding landslide from slope toe to top had completely formed. The first-to-second-level slope displacement exceeded half a meter, consistent with the 0.6 m stagger deformation observed in the second-level platform.

**Fig. 8** Stress and deformation characteristics under hydration: (a), (c), (e) Total displacement on the 10th, 20th, and 30th day of hydration, (b), (d), (f) Mean effective stress on the 10th, 20th, and 30th day of hydration

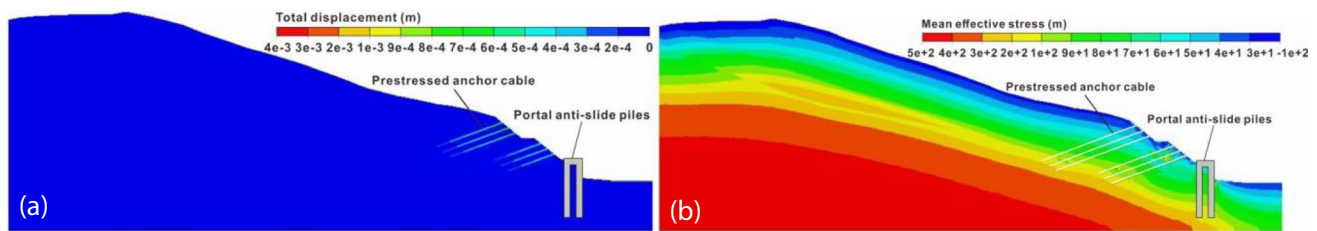
**Fig. 10** Stress and deformation of slope with proposed reinforcement under 30 days hydration: (a) total displacement, and (b) mean effective stress

Given the gentle inclination and longitudinal length (320 m) of the slope stratum, the thrust generated by the bedding landslide is significant. To address this issue, the author proposes adopting a scheme of prestressed anchor cable and double row portal anti-slide pile to support the front excavated slope. The pile is poured with C30 concrete, with a length of 27 m and embedded in the bedrock of 11.6 m. The cross-sectional size is 2 m × 2 m, with a 6 m spacing and a middle connecting beam width of 2 m. The prestressed anchor cable is made of 7 steel strands with a diameter of 15.2 mm, with a single tensile strength of 1860 Mpa. The prestressed force is 700 kN, and the spacing between the anchor cables is 4 m × 4 m. The anchoring section length is 10 m, mostly embedded in landslide bed.

By simulating the slope proposed support scheme under hydration, the slope factor of safety after 30 days of hydration is 1.38, meeting China's Code for Design of Highway Subgrades' requirements for a factor of safety greater than 1.25. The compressive stress band of the hydration layer appears only at the rear, and the maximum deformation observed is 0.27 mm, indicating the support structure effective control deformation, as shown in Fig. 10(a) and (b).
