Failure Analysis of a Steel Motorcycle Kickstand

Zainul Huda · Koh Wen Shi · Robert Bulpett

Submitted: 1 July 2008 / in revised form: 28 April 2009 / Published online: 12 May 2009
© ASM International 2009

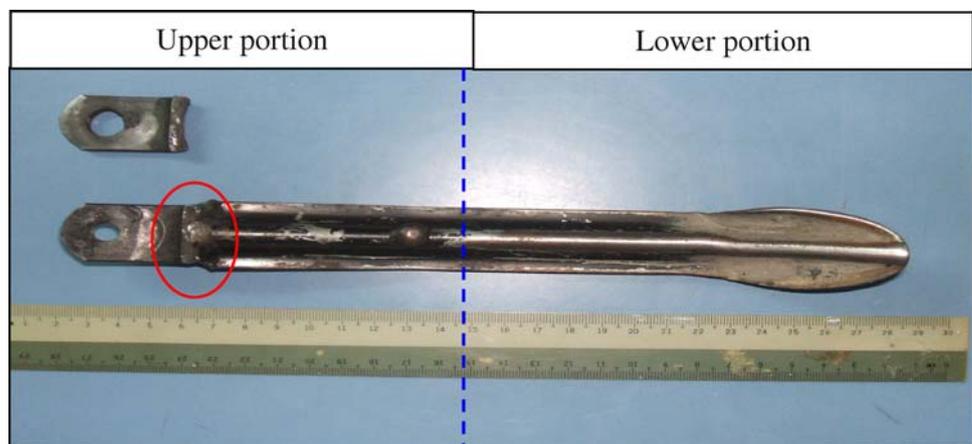
Fig. 2 General view showing the position of fracture (area under *red circle* indicates the fracture location)

The motorcycle kickstand had broken in the upper portion, as shown in Fig. 2. The fracture occurred at a location approximately 4 cm from the top-point of the kickstand. The top portion contains a fastener-hole so that the kickstand is firmly attached to the motorcycle frame. The kickstand material surface was protected by black paint; however, in some areas the coating had deteriorated. This is presumably due to exposure to the moist and warm atmosphere.

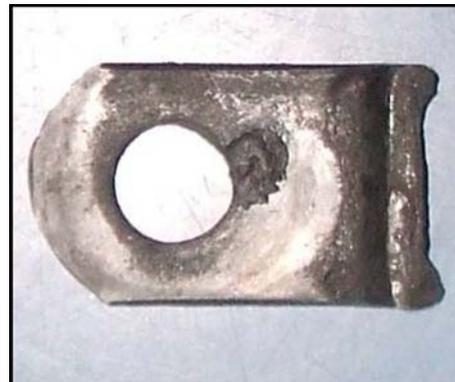
Unfortunately the fracture surfaces had not been protected immediately after failure and light corrosion, dirt and contaminants were present on the surfaces as shown in the higher magnification images of each half of the fracture (see Fig. 3 and 4). There is also some evidence of wear damage to the area around the bolt hole.

Fig. 3 Enlarged view of fracture surface showing solid dirt and contaminant on the surface

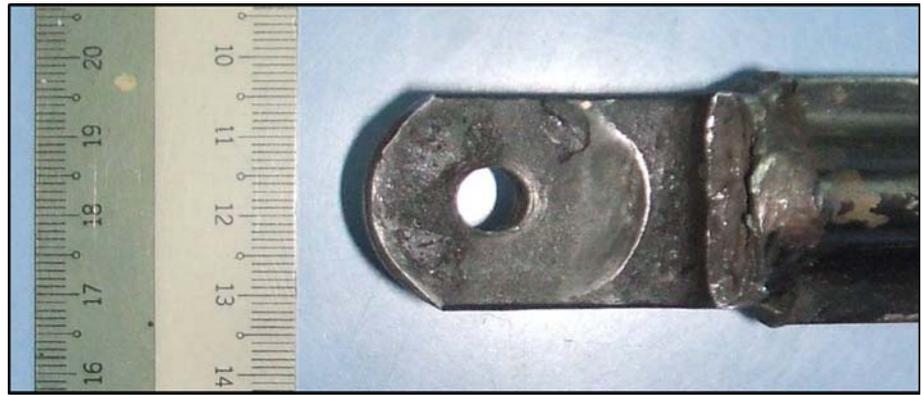
Fig. 4 Enlarged view of fracture surface

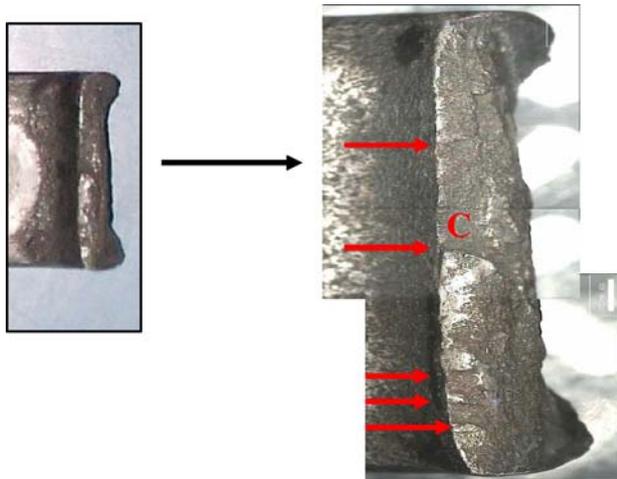
Fig. 5 Fracture surface of kickstand photographed with an optical microscope (40×). It shows several crack initiation points (red arrows). C = significant crack point

The fracture appeared to have initiated at several sites, as shown in Fig. 5. The most significant crack initiation point is indicated as point C. The major and minor crack points were propagating from the inward side to outward side. This would produce a final break at the outer side of the kickstand. This is consistent with the observation that the remaining lug had not been bent during the course of the failure as shown in Fig. 6.

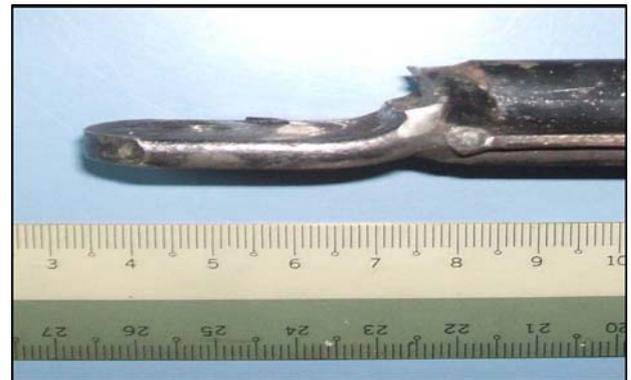
Fig. 6 Side view of the fractured kickstand

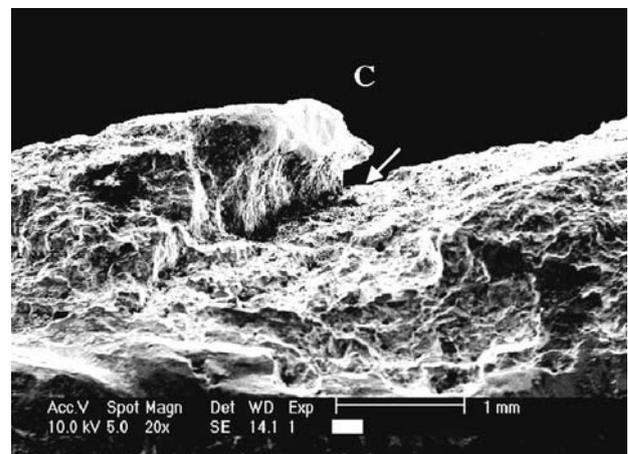
Fig. 7 SEM fractograph showing ductile tearing

shown in Fig. 7. The fracture then propagated by ductile tearing through the thickness of the section. Ductile tearing is a common fracture mechanism in steels [5–7].

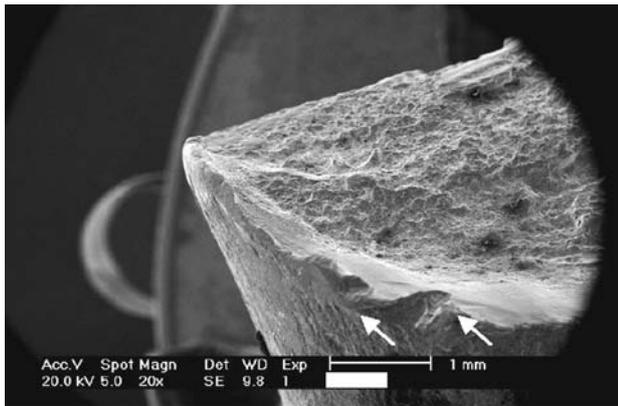
The outer surface of this fragment shows some evidence of post-fracture damage with smoothing of the fracture surface and indentations, as shown in Fig. 8.

Fig. 8 Damage to edge of fracture and outer surface (indicated by arrows)

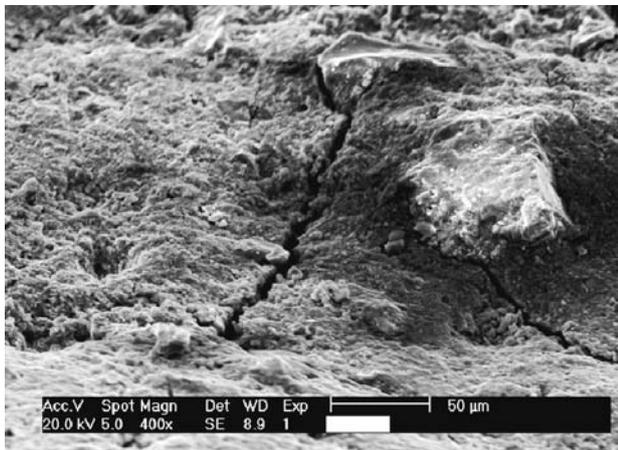
Analysis of the brown corrosion product (see Fig. 9) by energy dispersive X-ray spectroscopy (EDS) showed this to be iron oxide with calcium and potassium from contact with soil and a low level of chlorine. It should be noted that

Fig. 9 Cracking in the oxide layer in the failed kickstand

even small amounts of chlorine will accelerate corrosion in this type of steel.

The use of steel with higher strength and improved corrosion resistance would considerably extend the life of the kickstand. Appropriate heat treatment of medium carbon steel should provide adequate strength whilst corrosion protection can be provided by application of a suitably protective paint finish and lubrication of the moving parts.

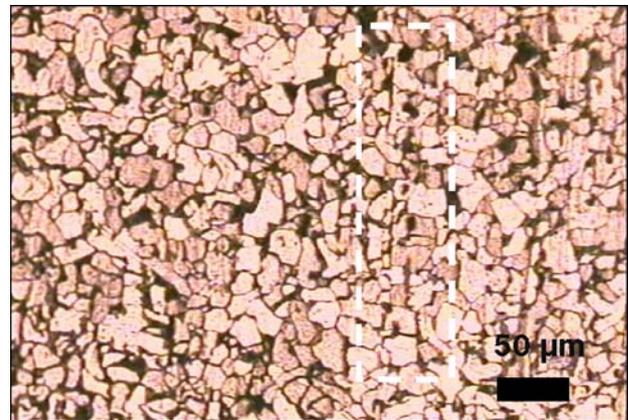
A longitudinal section through the fracture surface was prepared using standard techniques of grinding, polishing, and etching with a dilute solution of nitric acid in methanol. As we move away from the fracture surface, the microstructure has an equiaxed structure of ferrite grains interspersed with small areas of dark etching pearlite (see Fig. 10).

An interpretation of the microstructure (see Fig. 10) indicates that the material used for kickstand is low-to-medium (plain) carbon steel. This fact can be verified by observing the amounts of ferrite and pearlite present in the microstructure; the carbon content could be estimated in the range of 0.3–0.4%.

Fig. 10 Microstructure of the steel kickstand
