Experimental study on the fire behaviour of reinforced concrete slabs under combined uni-axial in-plane and out-of-plane loads

Yong Wang ^{a,b}, Guanglin Yuan ^a, Zhaohui Huang ^{c,*}, Junli Lyv ^d, Zhi-Qi Li ^a, Teng-yan Wang ^a

Abstract

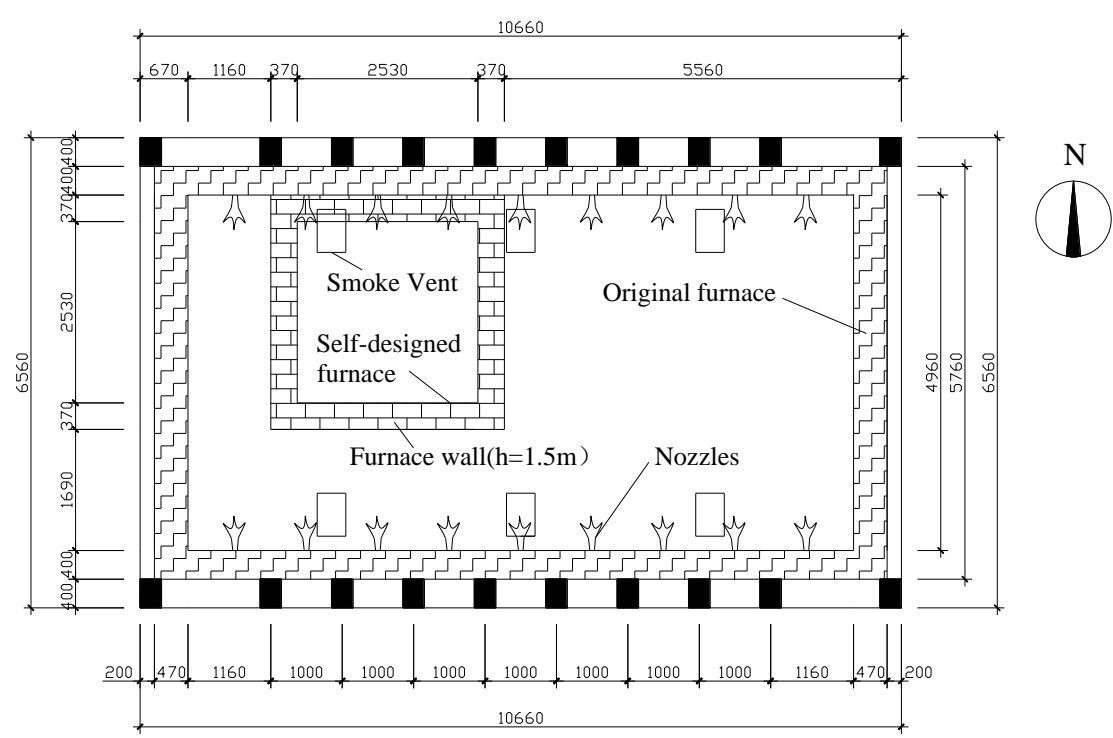
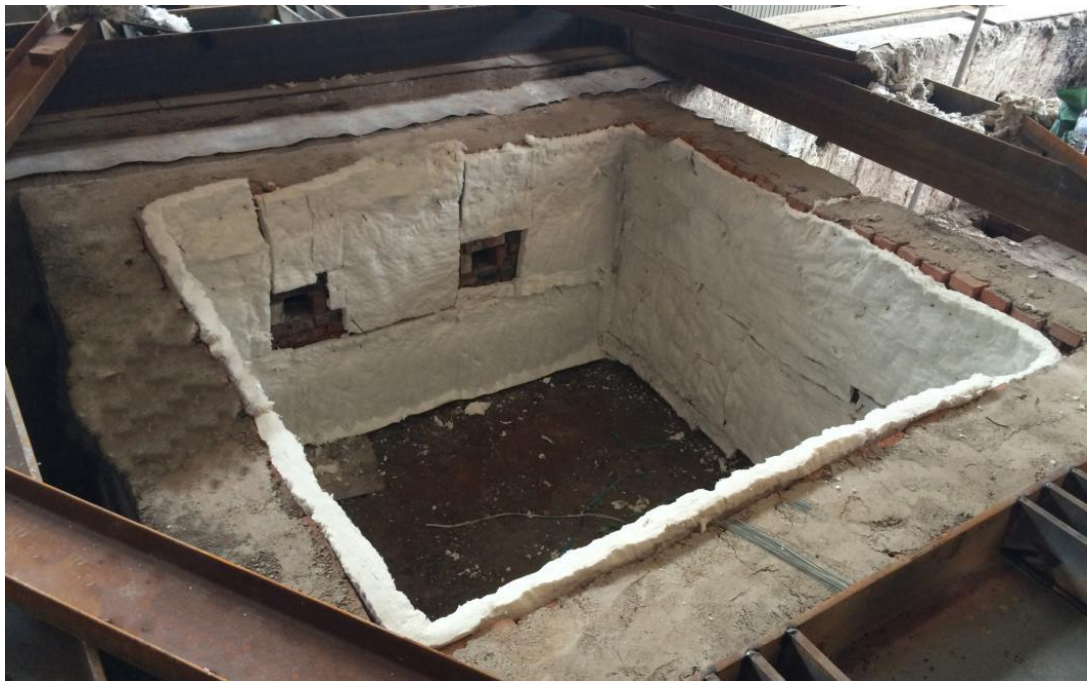
(a) Plan view of the furnace

(b) External view of the self-designed furnace

Fig. 1 Self-design furnace (all dimensions in mm).

As shown in Fig. 1, a furnace was specially designed and constructed to heat the four concrete slabs based on the original large furnace. The furnace walls were constructed from bricks (370 mm thick) and mineral wool (50 mm thick). The furnace was operated by two oil-fired burner nozzles located in the north furnace wall, and each nozzle was controlled independently. The dimensions of the furnace are 3270mm×3270mm×1500mm.

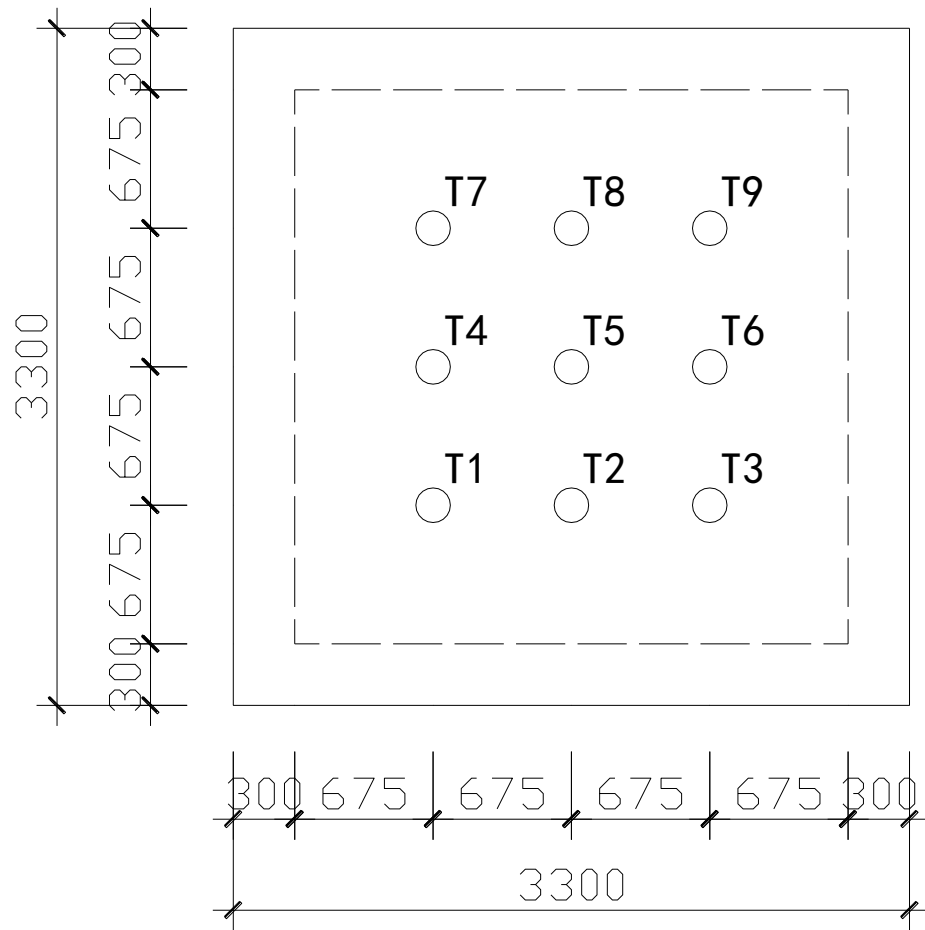
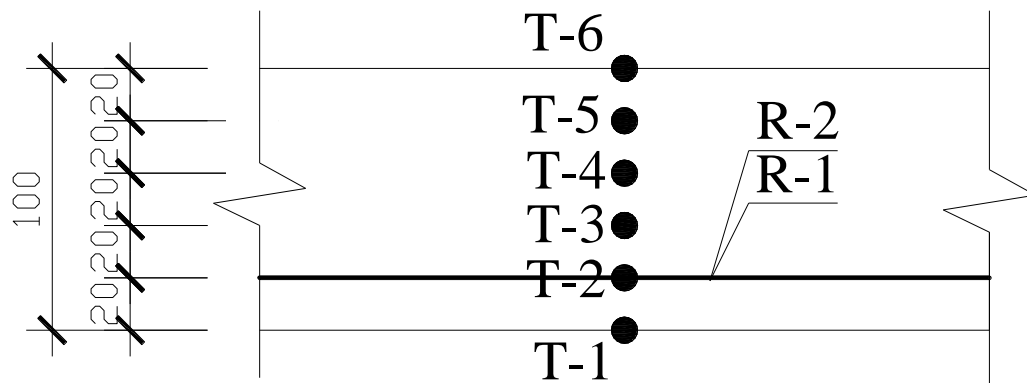
(a) Typical layout of thermocouples in the concrete slab

(b) Thermocouples across the full-depth of each slab

Fig. 2 The details of thermocouples' distribution within the slab (all dimensions in mm).

The furnace temperatures were measured by two thermocouples (F-1 and F-2) during each fire test. In addition, for each slab, nine groups of thermocouple trees (T1 to T9) were used to measure the temperatures within the slab, as shown in Fig. 2(a). Each thermocouple tree consisted of 6 thermocouples (see Fig. 2(b) Points T-1 to T-6) distributed vertically to measure

the concrete temperatures along the thickness of the slab. For measuring the temperatures of reinforcing steel, two thermocouples (Points R-1 and R-2) were placed at the mid-height of the steel bars, as shown in Fig. 2(b).

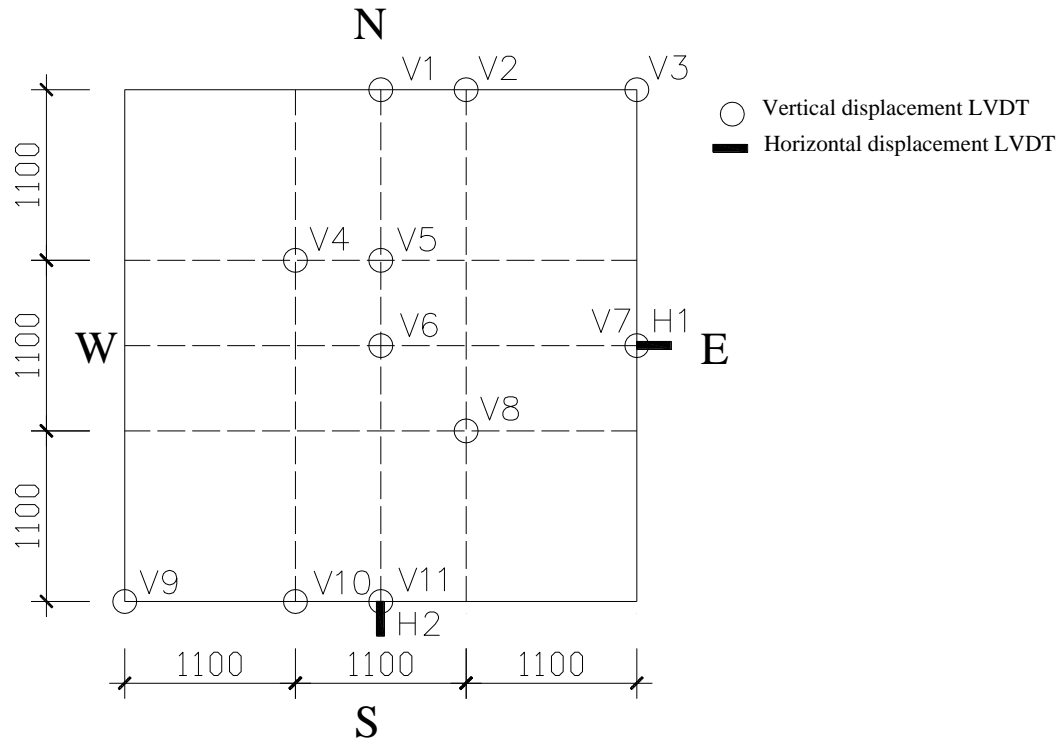
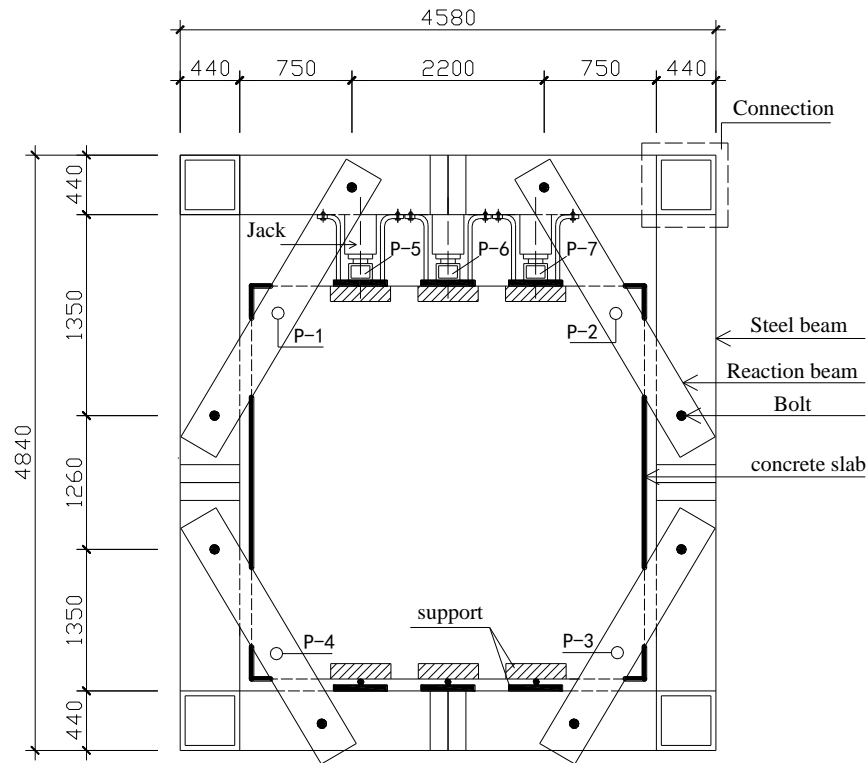
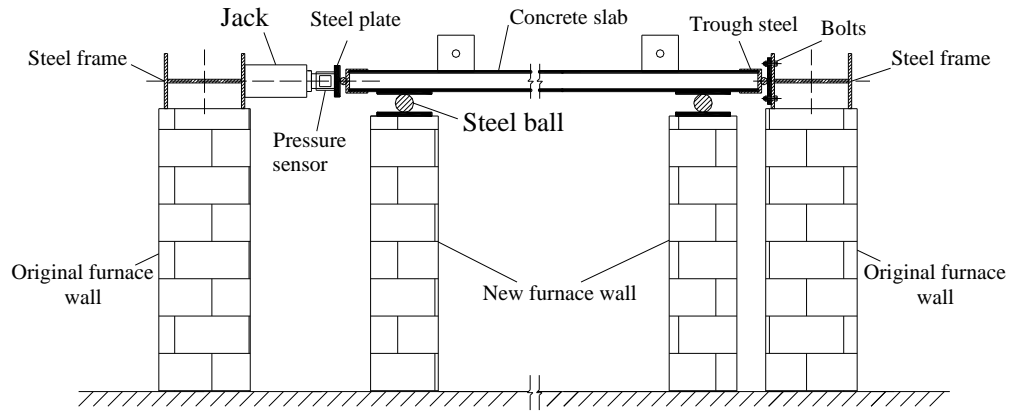
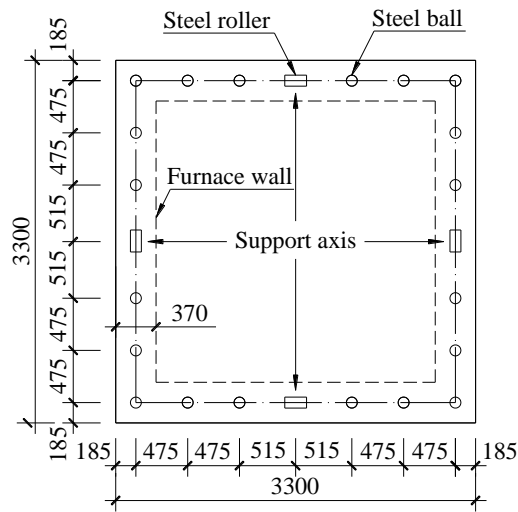
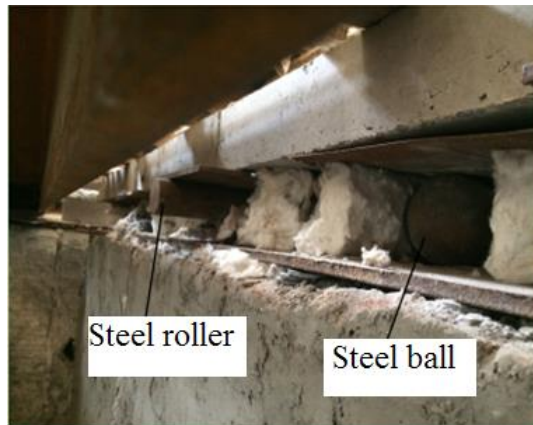
(b) Cross-section view of uni-axial in-plane loading frame

(c) Configuration of vertical edge supports

(d) Configuration of steel balls and steel rollers

Fig. 4 The details of horizontal uni-axial in-plane loading and vertical support systems (all dimensions in mm).

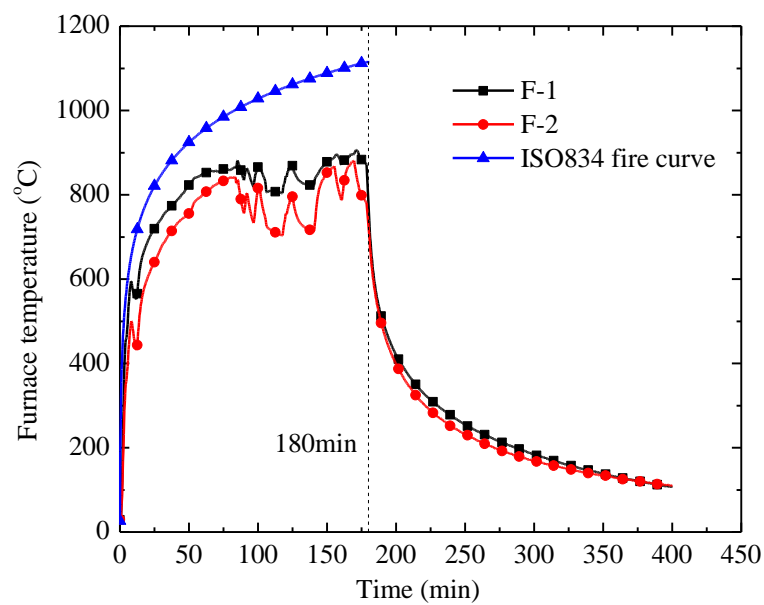
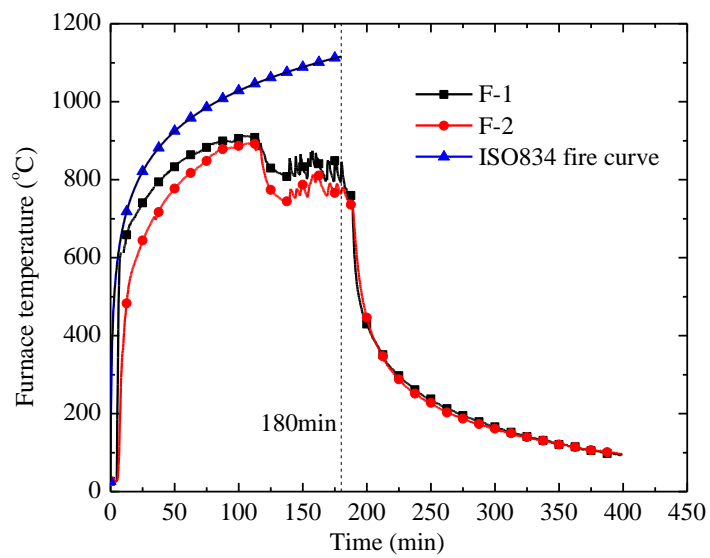
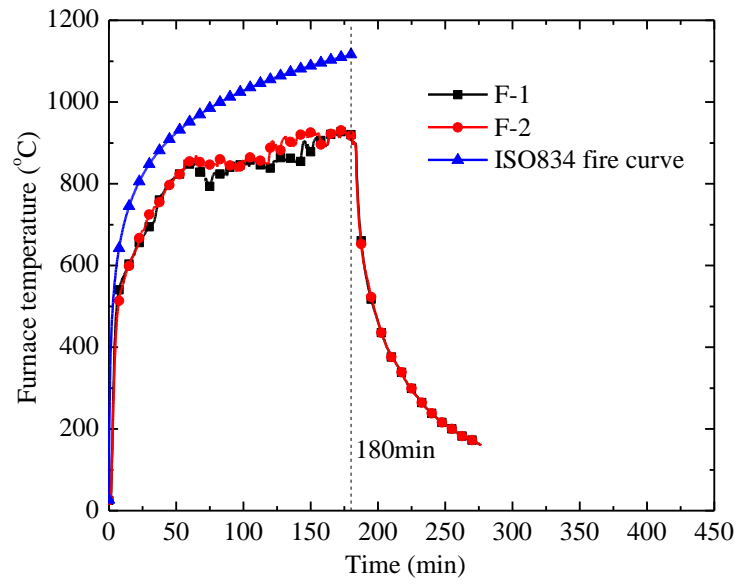
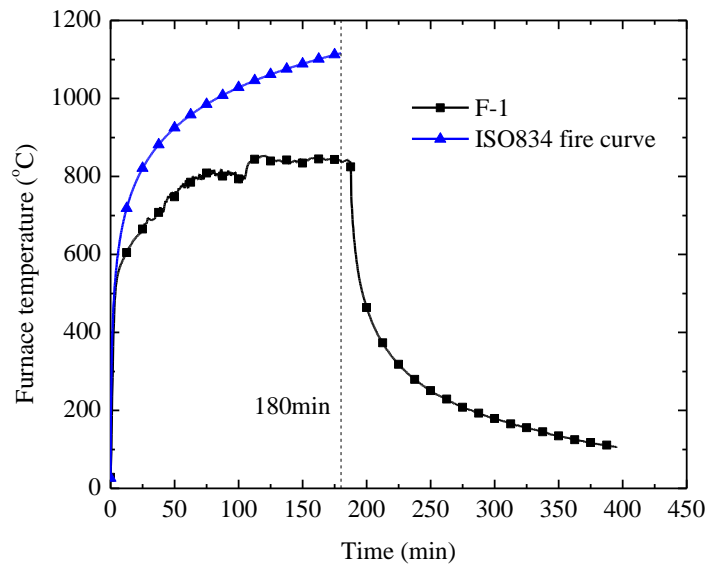
Fig. 5 Furnace temperature-time curves of: (a) Slab S1, (b) Slab S2, (c) Slab S3 and (d) Slab S4.

The measured furnace temperatures against time during both the heating and cooling phases for the four tests are shown in Figs. 5(a)-5(d). The furnace was shut off at 180 min after ignition in each test. It is noted that the data at Point F-2 in the Slab S4 test were not recorded due to the hardware problems. It is clear that, for the Slabs S1 to S3, the furnace temperatures measured by the two thermocouples F-1 and F-2 were similar. During the heating stage, the maximum furnace temperatures for the Slabs S1 to S4 were 906 °C, 913 °C, 930 °C and 853 °C, respectively. In addition, the average furnace temperatures of the four slabs at the test time of 180 min were 827 °C, 800 °C, 918 °C and 837 °C, respectively. It can be seen that the furnace temperatures of the four tests were well below the ISO Fire curve. However, the four slabs had similar average furnace temperature-time curves, indicating that the fire behaviour of the four slabs can be compared with each other. After 180 min, the furnace temperature decreased rapidly, and three tests (Slabs S1, S2 and S4) finished at 400 min after furnace ignition. Due to the malfunction of the collecting instrument, the fire test of the Slab S3 finished at 275 min. Tables 1 and 2 show the average furnace temperature-time history for each test during the heating and cooling stages.

From the Figs. 5(a)-5(d) it can be seen that during the initial stage of each test, the furnace temperature-time curve followed the specified ISO834 fire curve very closely. As the tests continued, the furnace temperatures showed significant deviation from the temperatures of the ISO standard fire, particularly in Slabs S2. This was due to insufficient air ventilation into the furnace and water escaped from the slab which caused incomplete combustion and resulted in a lot of black smoke pouring out of the furnace. However, this difference does not affect the comparison of the present tests and other results which were generated by similar furnace temperature-time trends [3-6, 17].

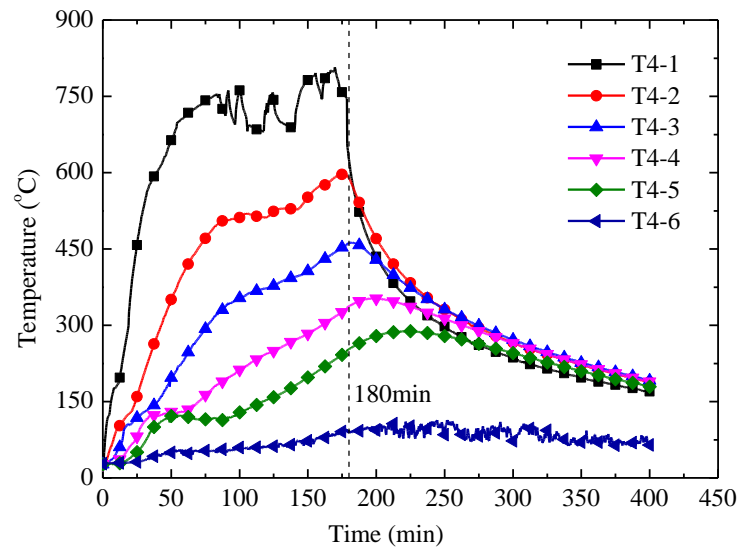
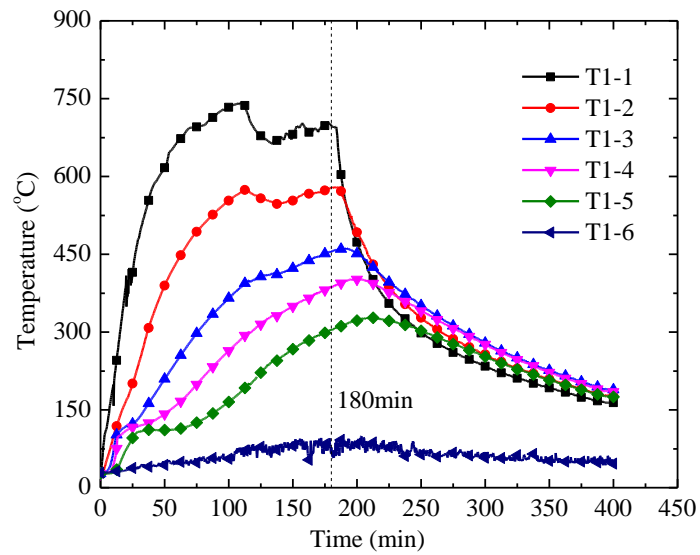
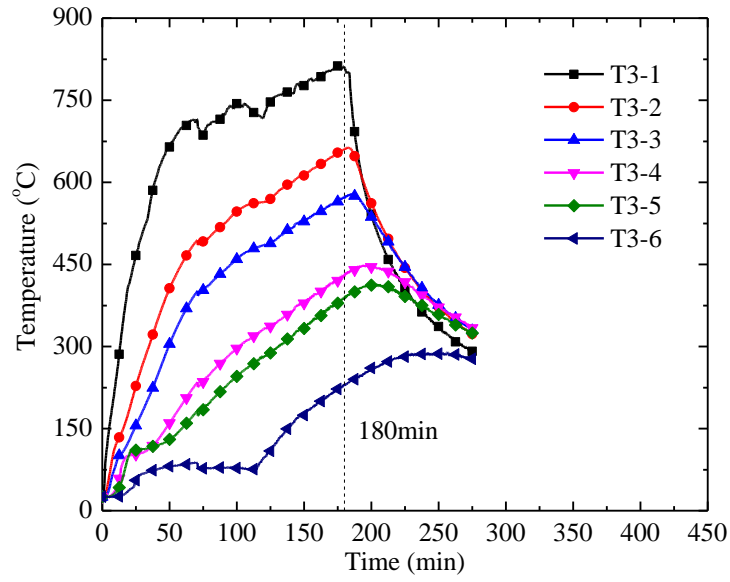
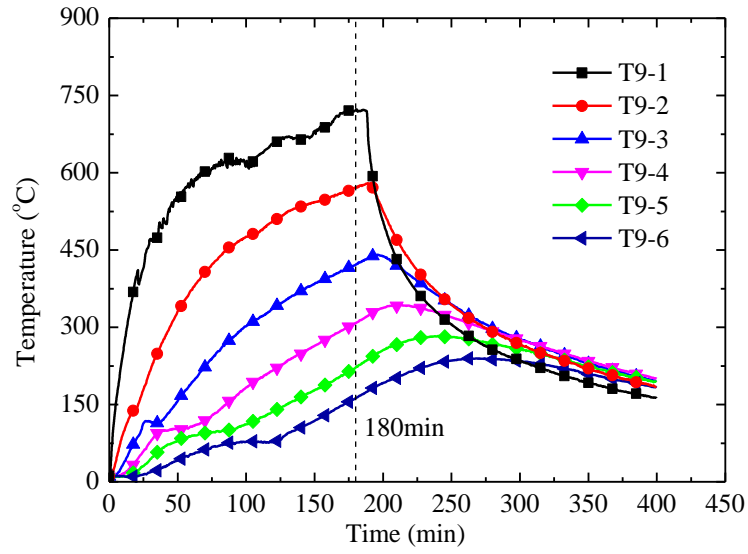
Fig.6 Temperature distributions along the thickness of the Slabs: (a) Slab S1-T4, (b) Slab S2-T1, (c) Slab S3-T3 and (d) Slab S4-T9.

Figs. 6(a)-6(d) show the temperature profiles along the cross sections of the Slabs S1 to S4. It can be found that the temperature gradients in the four slabs increased quickly with time. For instance, at 180 min, the temperatures on the bottom surface of the four slabs reached to 626 °C (S1-T4-1), 697 °C (S2-T1-1), 811 °C (S3-T3-1) and 722 °C (S4-T9-1), respectively. Meanwhile, at 180 min, the corresponding temperatures on the top surfaces of the slabs were 92 °C (S1-T4-6), 78 °C (S2-T1-6), 230 °C (S3-T3-6) and 163 °C (S4-T9-6), respectively.

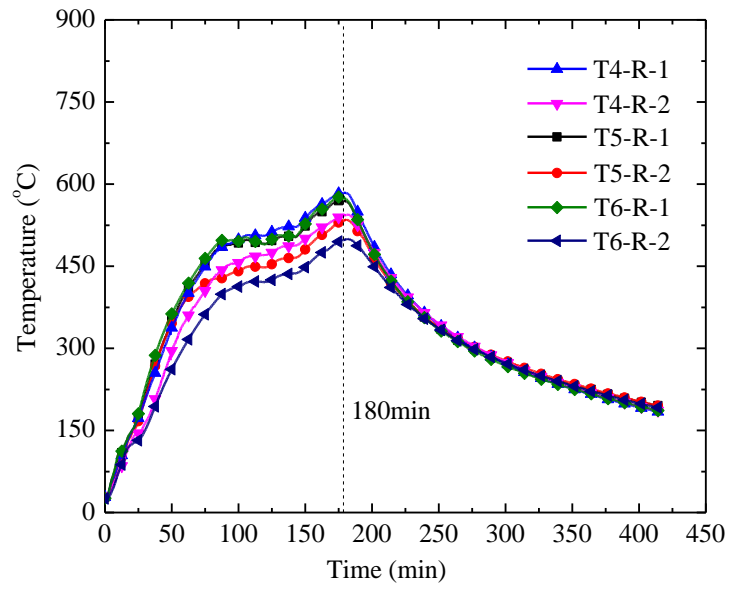
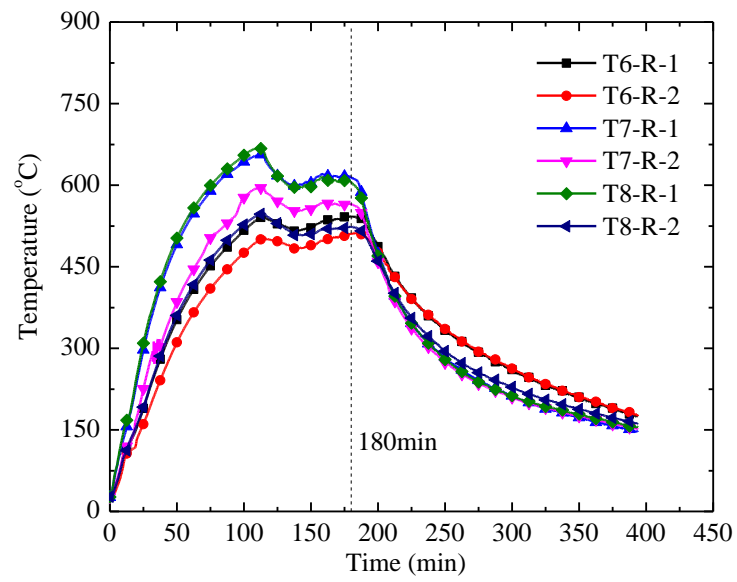
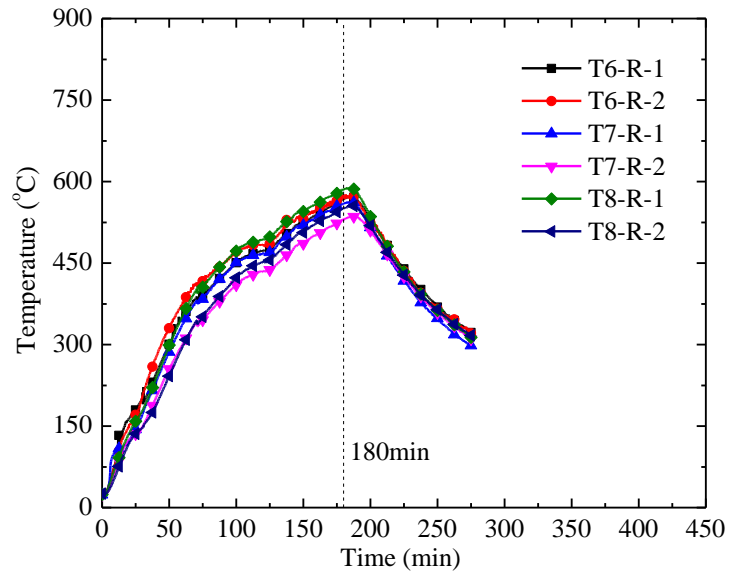
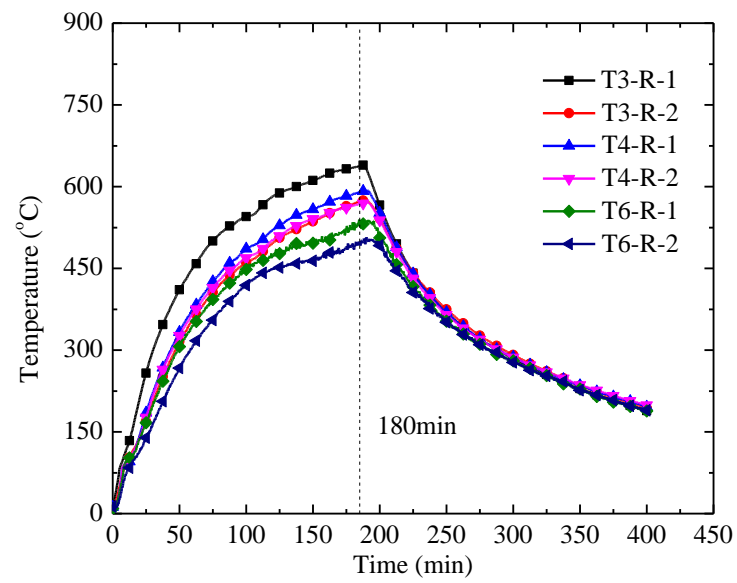
Fig.7 Temperatures of the reinforcing steels of: (a) Slab S1, (b) Slab S2, (c) Slab S3 and (d) Slab S4.

Figs. 7(a)-7(d) illustrate the temperature developments of the reinforcing bars for the Slabs S1 to S4. As expected, for each test, the measured temperatures at different points are very similar during the initial stage. As the tests continued, the temperature differences between different positions slowly increased, particularly at 180 min. This may be attributed to the water evaporation and concrete spalling. For example, as shown in Fig. 7(a), at 180 min, the maximum and minimum temperatures in the bottom reinforcing bars of the Slab S1 were 584 °C (T4-R-1) and 498 °C (T6-R-2), respectively. The similar conclusions can be obtained from the Slabs S2, S3 and S4, as shown in Figs. 7(b)-7(d).

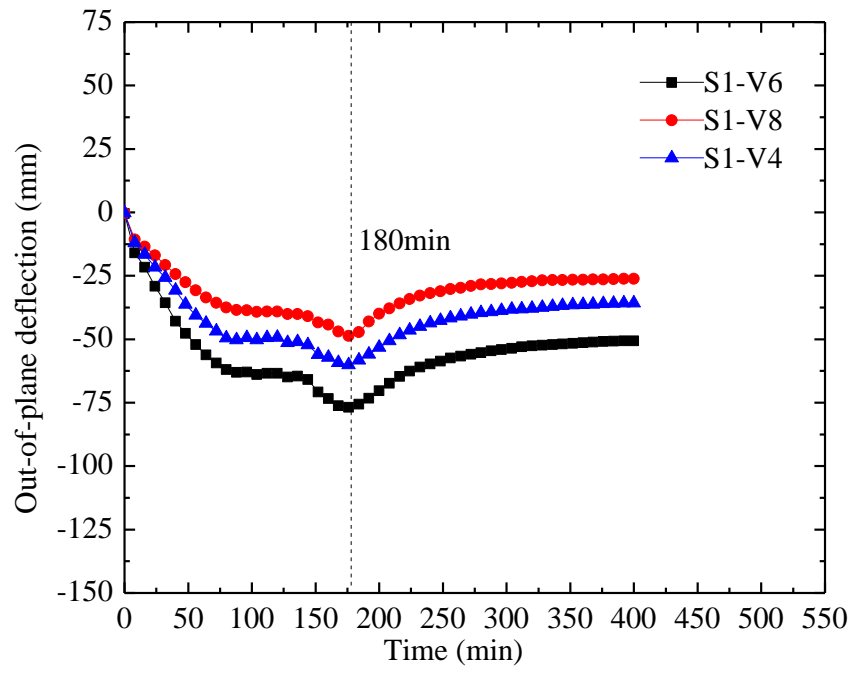
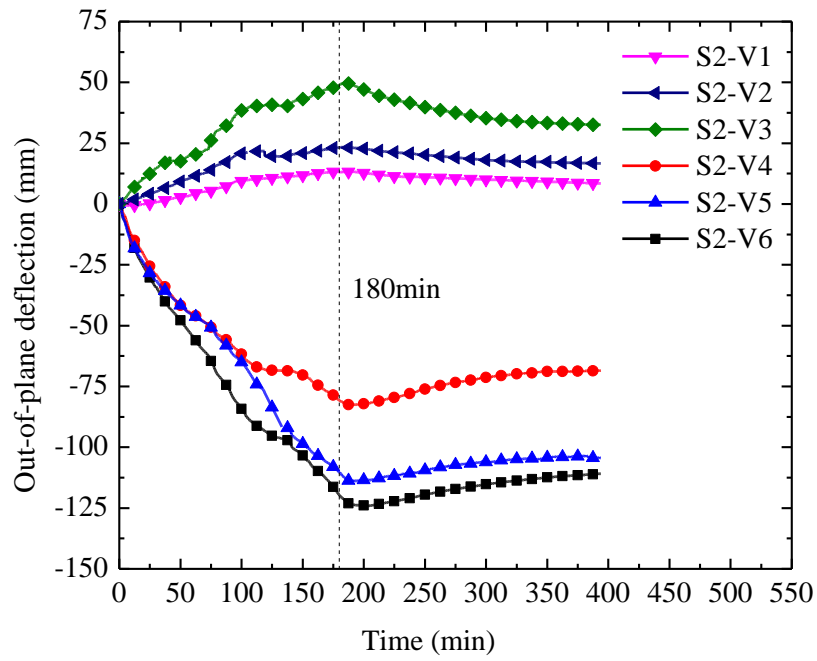
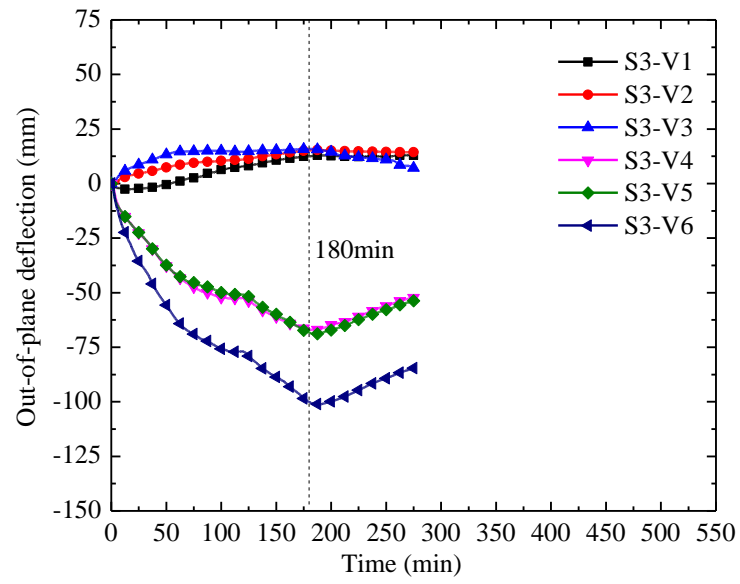
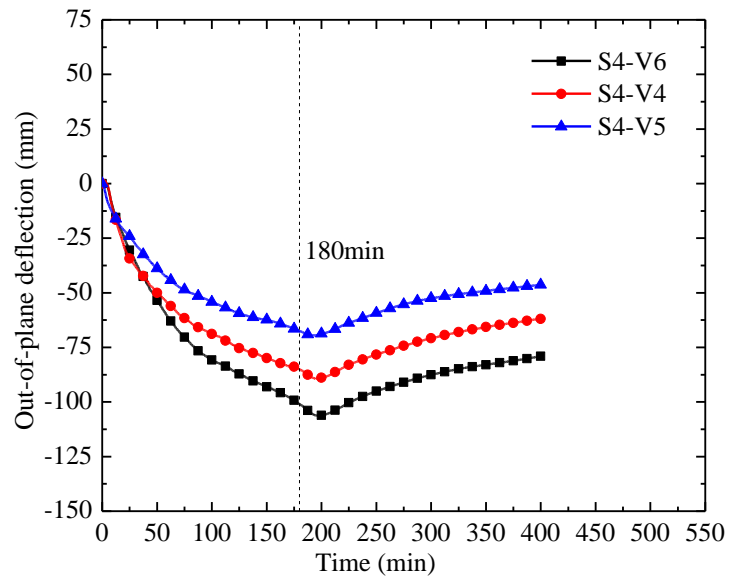
Fig. 8 Vertical out-of-plane deflections-time curves of the Slabs: (a) Slab S1, (b) Slab S2, (c) Slab S3 and (d) Slab S4.

However, as the tests continued, the effect of the uni-axial in-plane restraint forces on the deflections of the restrained slabs becomes evident, particularly at the later stages. As shown in Fig. 8(a), there is a plateau of mid-span deflection of the Slab S1 between 85 min and 120 min. This is attributed to the temperature plateau of the bottom reinforcing steel (see Fig. 7(a)). However, it is noted that there is a temperature plateau for the bottom steel of the Slab S2 due to the decreased furnace temperature (see Fig. 7(b)). In contrast to the Slab S1, the mid-span deflection of the Slab S2 always increased until the fire test was stopped at 180 min. Between 60 to 180 min test time, the mid-span deflections of the three restrained slabs are considerably greater than the slab without restraint (Slab S1). For instance, at 180 min, the mid-span deflections of the Slabs S1 to S4 were 76 mm, 120 mm, 100 mm and 101 mm, respectively. Compared with the mid-span deflection of the Slab S1, the mid-span deflections of the Slabs S2, S3 and S4 were increased by 56%, 33% and 38%, respectively. This is due to the $P-\Delta$ effect generated from the uni-axial in-plane restraint forces.

During the cooling stage, it is noted that the vertical deflections of the Slab S3 are not presented after 275 min because the instruments of data collecting malfunctioned. As shown in Figs. 8(a)-8(d), it is clear that the restrained and unrestrained concrete slabs have different deflection recovery trends during this stage. For the Slab S1, there was a nonlinear deflection

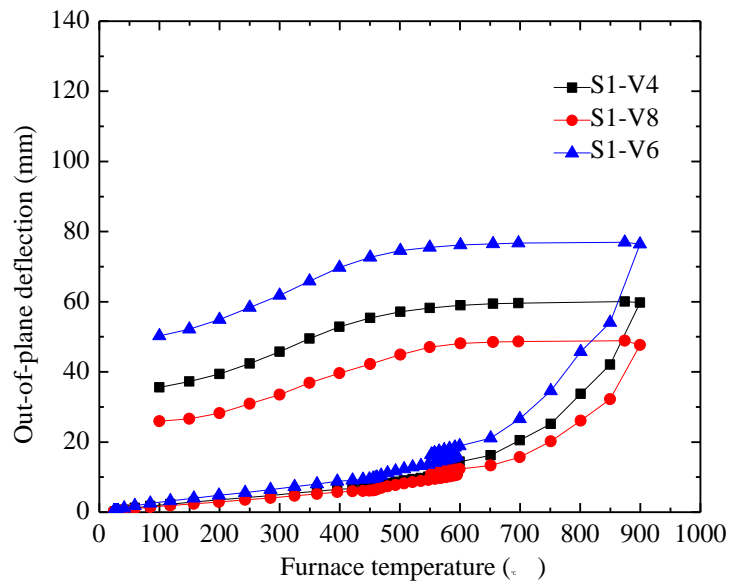
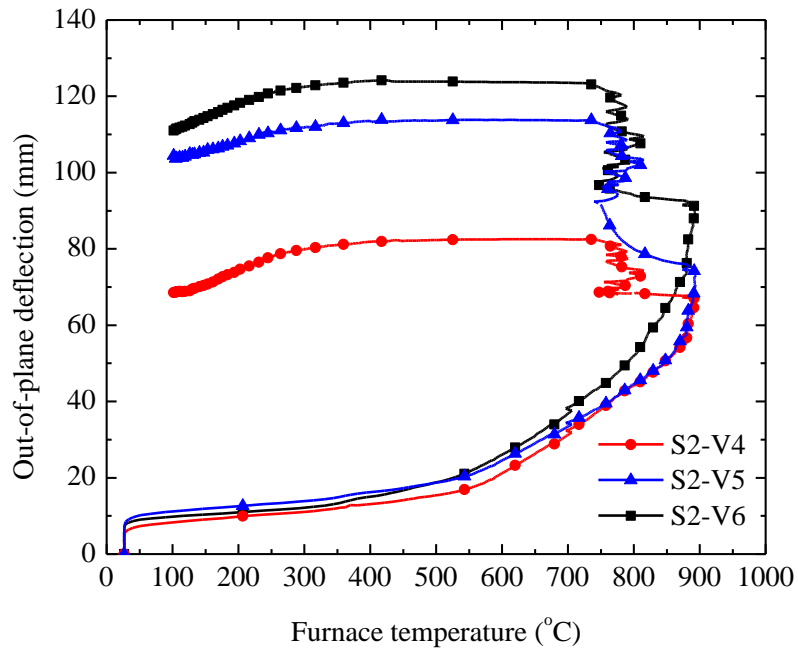
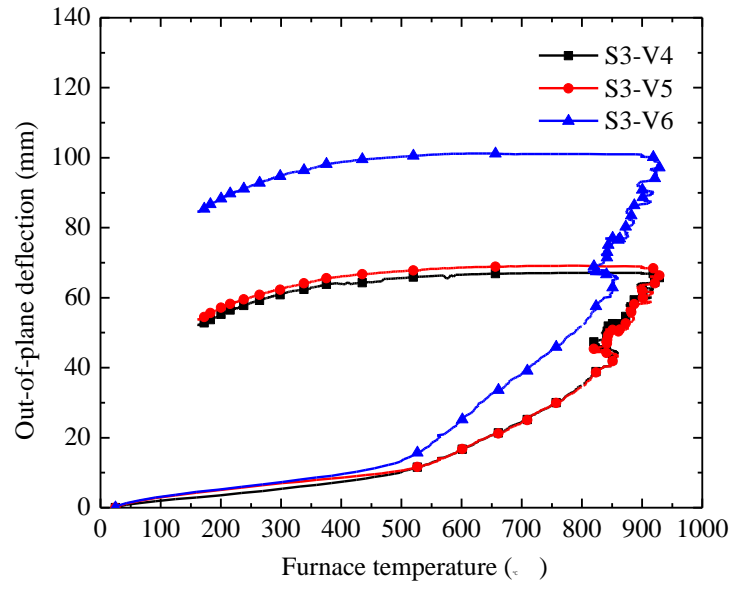
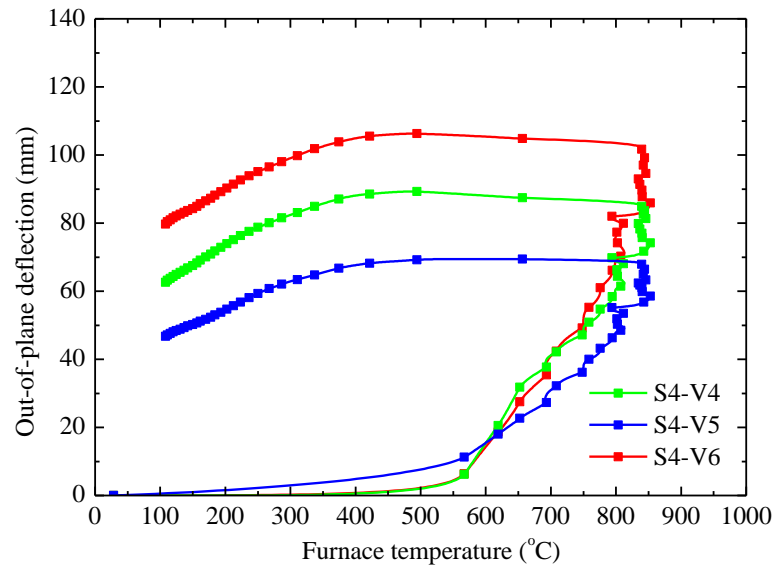
Fig.9 Out-of-plane deflections-furnace temperature curves of the slabs: (a) Slab S1, (b) Slab S2, (c) Slab S3 and (d) Slab S4.

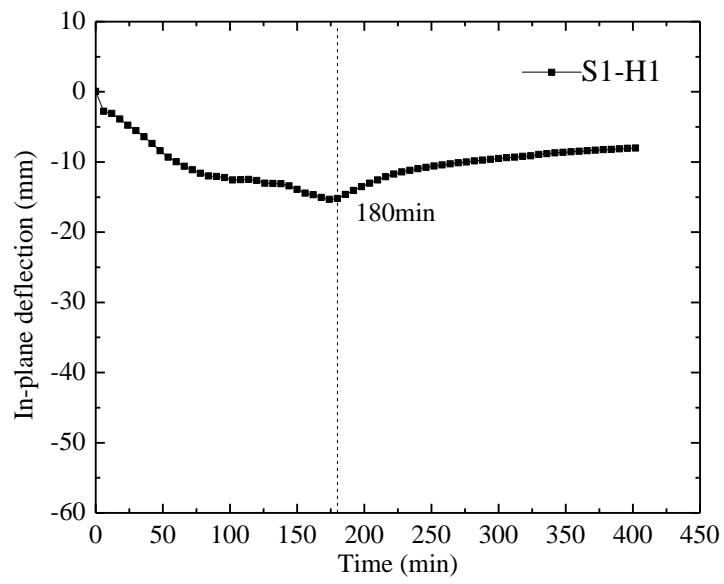
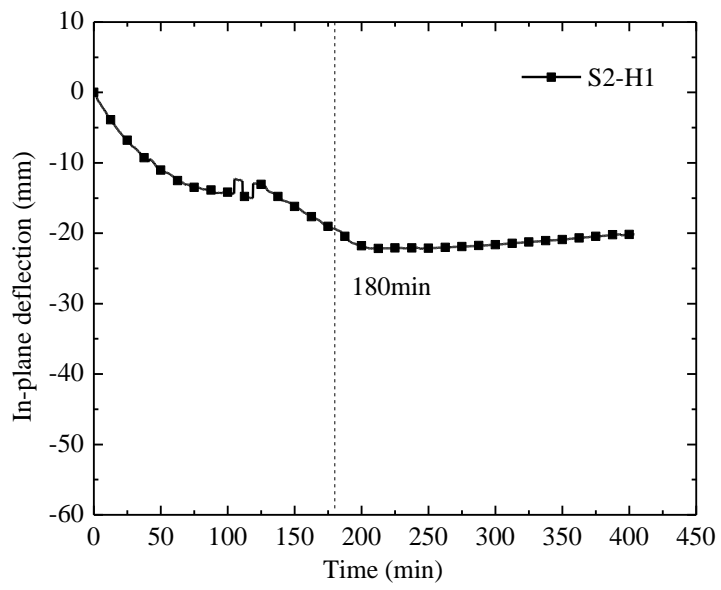
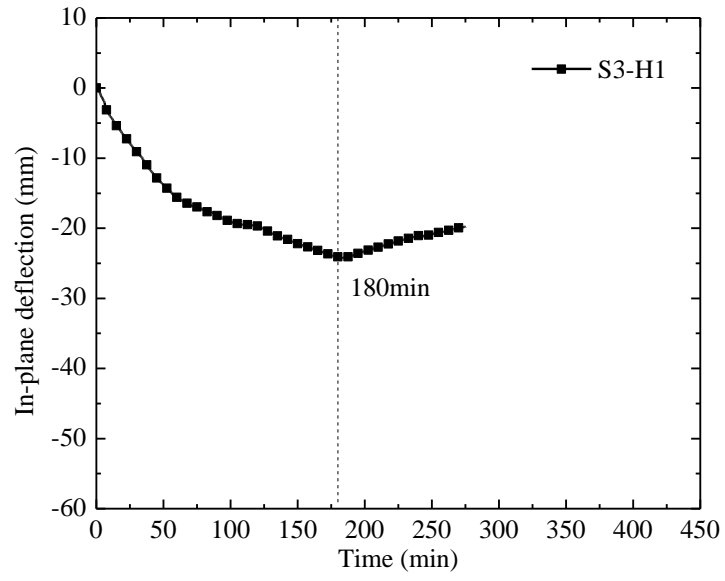
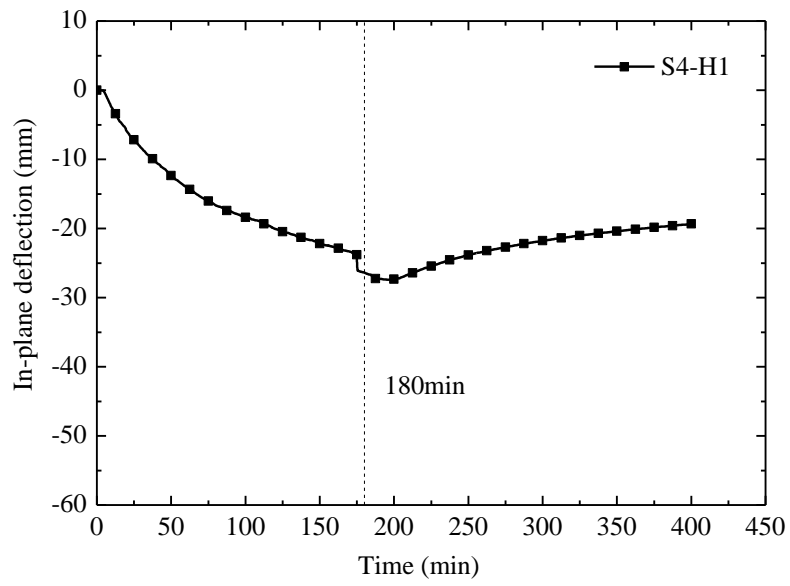
Fig.10 Horizontal deflections of the slabs: (a) Slab S1, (b) Slab S2, (c) Slab S3 and (d) Slab S4.

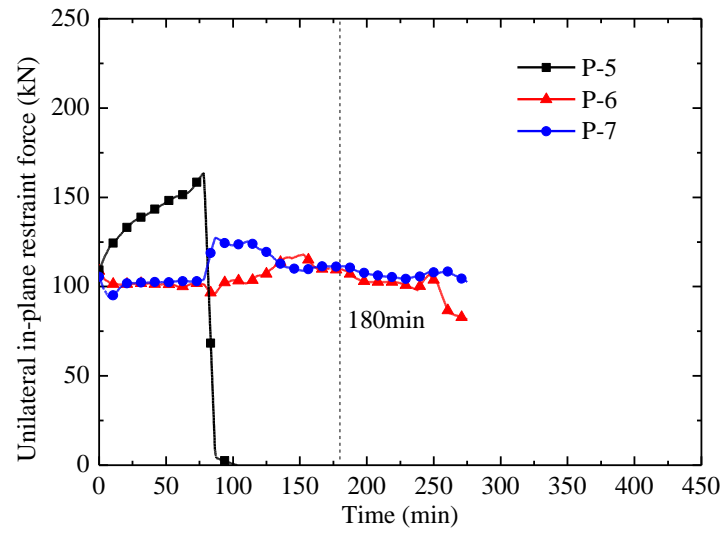
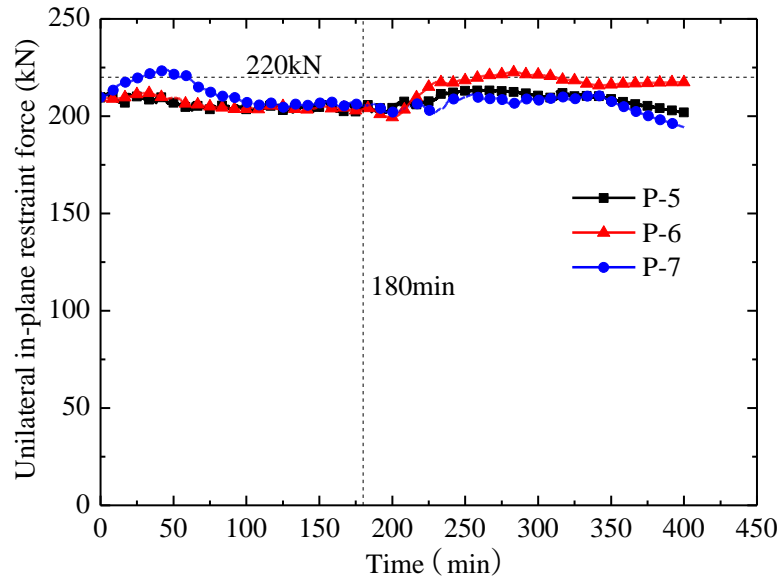
Fig. 11 Measured uni-axial in-plane restraint forces in the slabs: (a) Slab S3 and (b) Slab S4.

During the test, the uni-axial in-plane stresses of the Slab S3 were about 1 MPa, and thus the force applied by each jack was about 105 kN. Fig. 11(a) shows the uni-axial in-plane forces measured from the pressure sensors P-5 to P-7 in the fire test. As the fire started, the applied force in Point P-5 increased rapidly, reaching about 162kN at 75 min. After that, the jack started to fail, shown by the sudden decrease of force. The reason is that the jack was heated by the hot flames. At this point, the other two jacks were protected as quickly as possible by wet mineral

wool. After the jack (Point P-5) suddenly failed, the force at Point P-7 also increased very rapidly, reached to about 126 kN at 90 min. And then, this force kept constant between 100 and 130 min. In addition, for Point P-6, the force slightly increased between 75 and 150 min, reaching to about 117 kN at 150 min. Subsequently, the forces at Points P-6 and P-7 kept constant until the end of the fire test. At 275 min, the in-plane forces at Points P-6 and P-7 were 82 kN and 103 kN, respectively. The test results indicate that the protected methods used in the fire test were effective and reasonable.

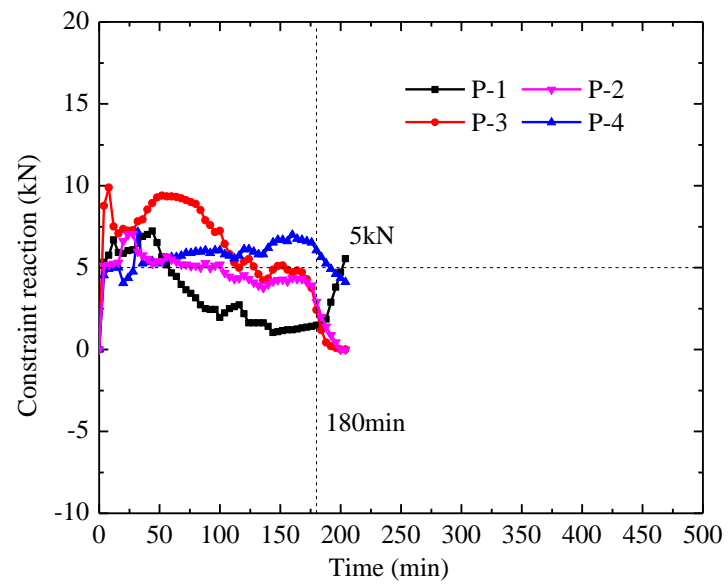
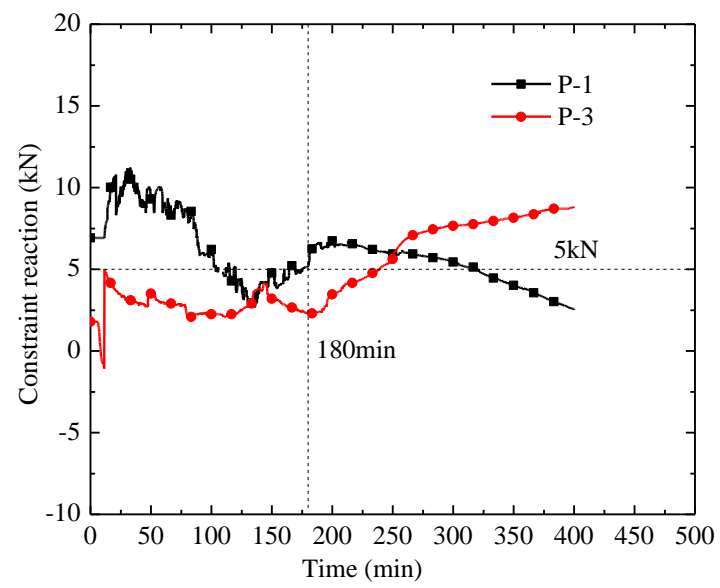
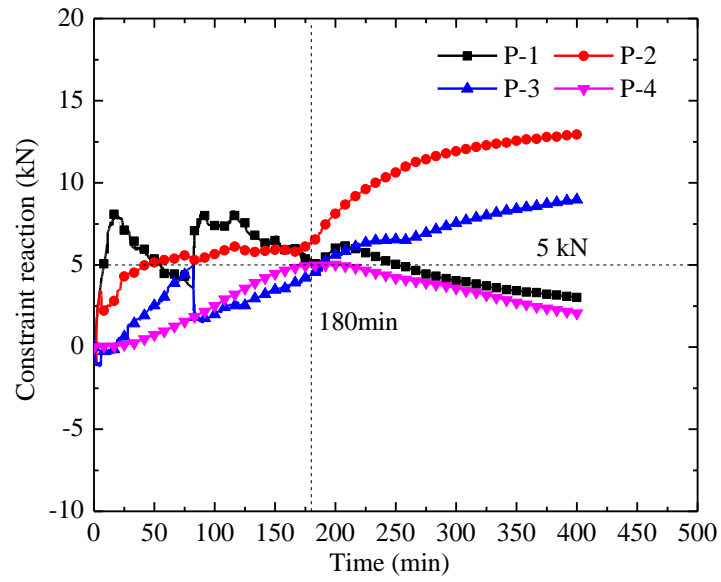
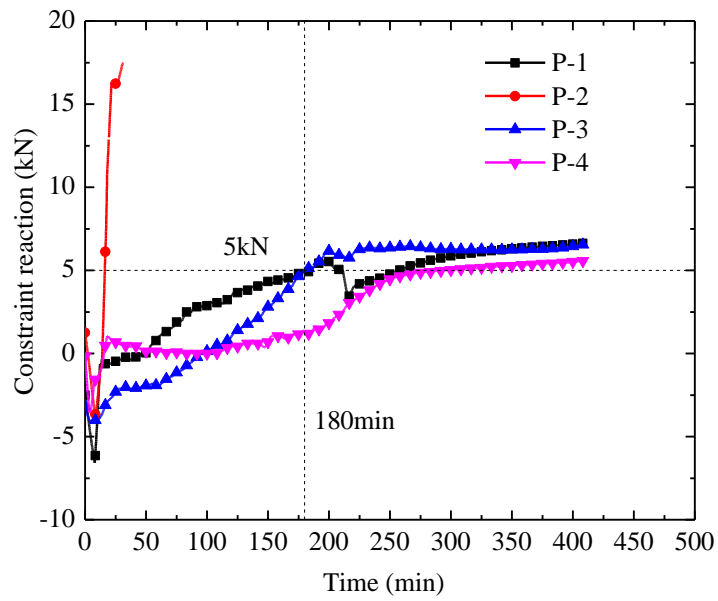
Fig.12 Restrained forces at the corners of the slabs: (a) Slab S1, (b) Slab S2, (c) Slab S3 and (d) Slab S4.

decreased, but at Point P-4 the reaction force slowly increased until 180 min. Finally, at 180 min, the reaction forces at Points P-1 to P-4 were 1.5 kN, 2.9 kN, 2.4 kN and 6.0 kN, respectively. Clearly, compared with those of the three points, the reaction force at Point P-4 was larger due to the high stiffness (less cracks). This indicates that the number and location of diagonal cracks within the slab has an important effect on the reaction forces at the corners of the slab.

Fig. 12(b) shows the reaction forces measured by pressure sensors at Points P-1 and P-3, and the data at Points 2 and 4 in the test were not recorded due to hardware problems. Similar to the Slab S1, the reaction forces at Points P-1 and P-3 rapidly increased during the initial stage of the fire, and the maximum value of two points were about 11.2 kN and 5 kN, respectively. After about 25 min, the reaction forces of two points gradually decreased due to the diagonal cracks occurring within the slab. After about 120 min, the reaction force at Point P-1 gradually increased to 5.2 kN at 180 min. In contrast, the reaction force at Point P-3 slightly fluctuated and then gradually decreased to 2.3 kN at 180 min. Clearly, the reaction force at Point P-3 was always lower than the Point P-1 during the heating stage.

The reaction forces at the four corners of the Slab S4 are plotted against time, as shown in Fig. 12(d). It is noted that the reaction force at Point P-2 sharply increased, with the value of about 17 kN at 30 min. Subsequently, the corner of the slab suddenly failed due to the concrete crushing. After that, the restraint force was not measured at Point P-2 since the pressure sensor was found to be malfunctioning. However, this corner was also clamped by the reaction beam during the entire test. Unlike the reaction force of Point P-4, the reaction forces at Points P-1 and P-3 gradually increased as the test continued. At 180 min, the reaction forces of the two points were about 5.3 kN and 5.4 kN, respectively. For Point P-4, between 30 and 180 min, the restraint force slightly increased and then maintained at steady state (about 1.1 kN).
