Experimental study on the fire behaviour of reinforced concrete slabs under combined uni-axial in-plane and out-of-plane loads

Yong Wang ^{a,b}, Guanglin Yuan ^a, Zhaohui Huang ^{c,*}, Junli Lyv ^d, Zhi-Qi Li ^a, Teng-yan Wang ^a

Abstract

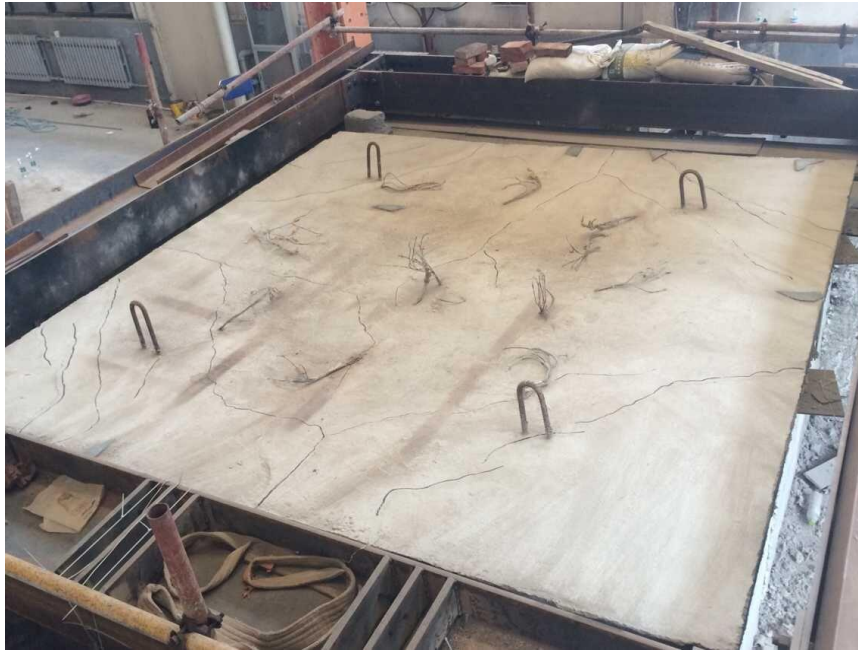
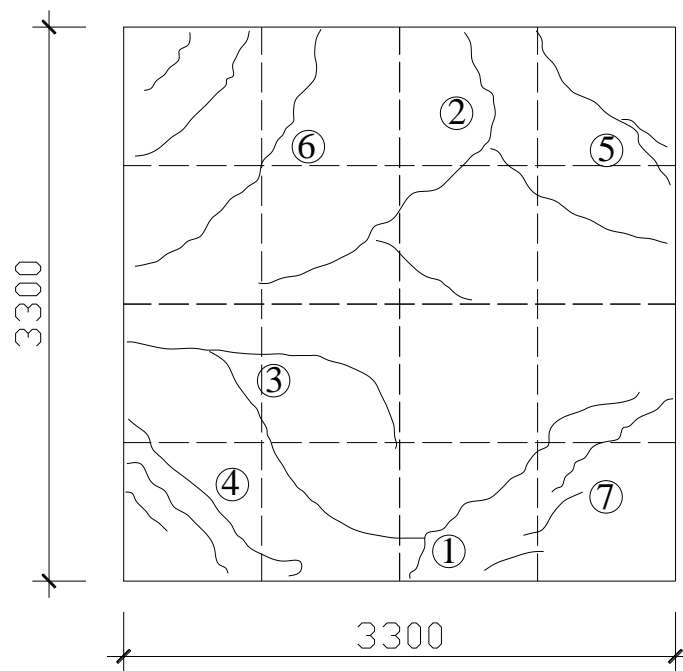
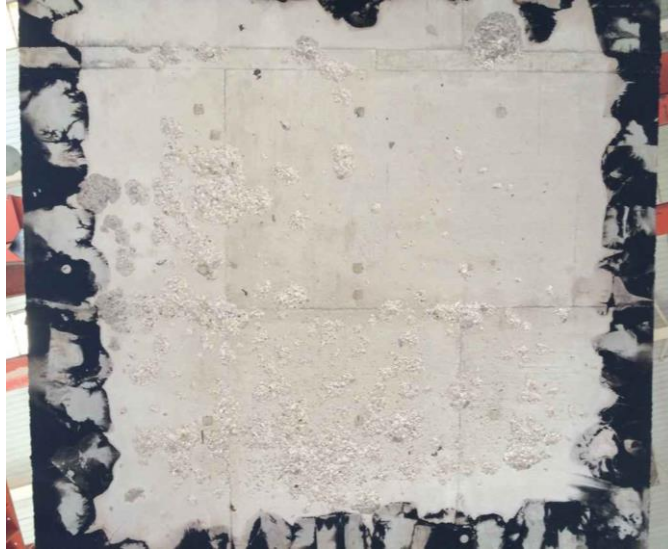
(a) Crack patterns at the top surface

(b) Cracks' development during the test

(c) Spalling at the bottom surface

Fig. 13 Failure models of the Slab S1: (a) Cracking pattern, (b) Cracks' development and (c) Spalling.

Fig. 13(a) shows the top view of the Slab S1 after the fire. Cracks were darkened with a brush to make them visible in the photograph. Clearly, two visible cracks on the top surface were in the central region of the slab. In contrast, there were several large diagonal cracks near to the four corners. These cracking patterns are similar to those observed in the Test 1 of Ref. [4].

As shown in Fig. 13 (b), during the early stage of the fire, popping noises were firstly heard from the in-plane restrained frame. At 20 min, a crack ① formed that was parallel to the south-north direction and at 1/2 span from the edge, 300 mm off the edge. After 30 min, two cracks ② and ③ normal to the edge occurred, which were at approximately 1/2 span. Water steam was emitted from the cracks as heating continued. Meanwhile, the corners of the slab started to curl upwards slightly. At about 40 min, the diagonal cracks ④, ⑤, ⑥ and ⑦ on the top surface occurred. Some cracks formed a 45° angle across the full depth to the top surface where they met the surface diagonal cracks. As the test progressed, the cracks on top surface of the slab continued to widen, particularly the diagonal cracks at the four corners. Meanwhile, a large amount of water and steam also seeped through the cracks, forming a puddle of water owing to the water accumulation in the middle of the slab. At about 120 min, the puddle of water in the middle of the slab dried up.

Fig. 13(c) shows the bottom view of the slab after the fire. Slight concrete spalling occurred, and no reinforcing bars and no full-depth cracks were seen on the bottom surface of the slab, indicating that the slab had good fire-resistant performance in terms of both stability and integrity.

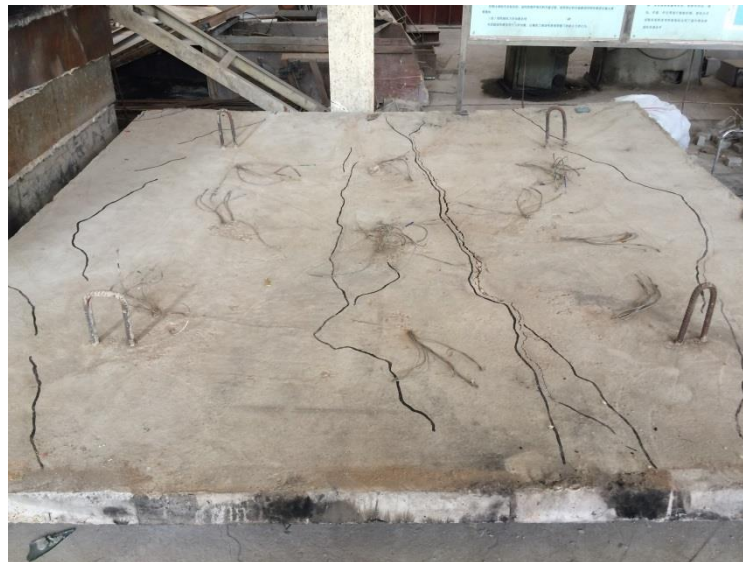
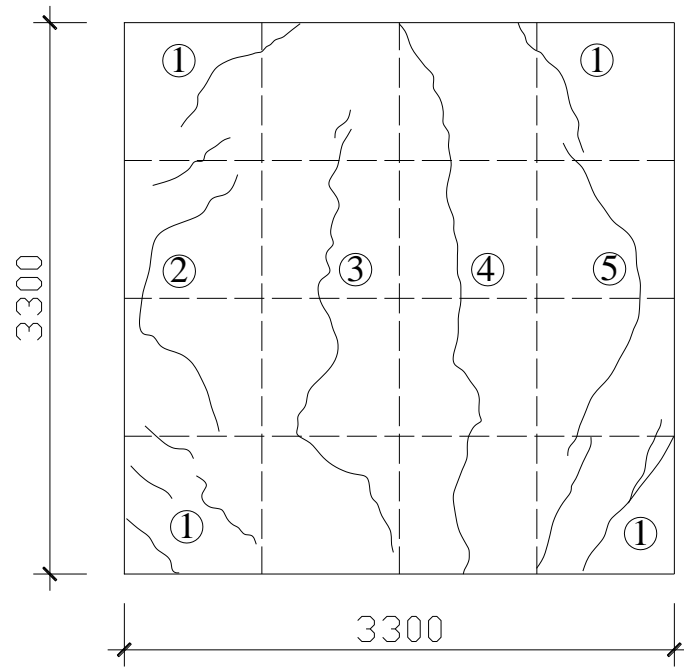
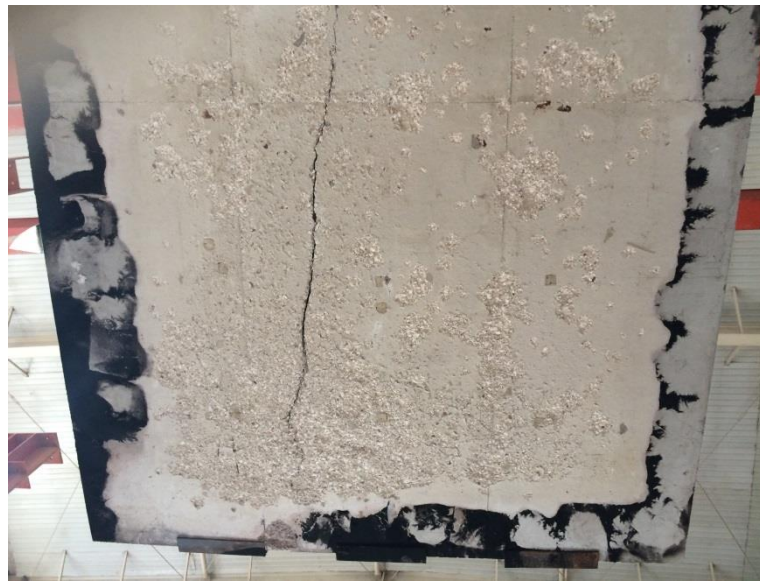
(a) Crack patterns at the top surface

(b) Cracks' development during the test

(c) Spalling at the bottom surface

Fig. 14 Failure models of the Slab S2: (a) Cracking pattern, (b) Cracks' development and (c) Spalling.

Fig. 14(a) shows the cracking pattern on the top surface of the Slab S2. Clearly, the cracking pattern of the Slab S2 was quite different compared with the Slab S1. Particularly, one full

depth crack formed across the whole length of the slab and the crack was about 3000 mm long. Although the restrained slab did not exceed the deflection limit of $\text{span}/20$, but the integrity failure criterion may be violated. As shown in Fig. 14(b), during the heating stage, several cracks ③, ④ and ⑤ of the Slab S2 firstly appeared on the top surface of the slab. Clearly, these cracks were parallel to the in-plane compressive direction and propagated from the middle of the slab towards the edges. Subsequently, diagonal cracks ① occurred at the each corner of the slab. Similar to the Slab S1, a large amount of water and steam seeped through the cracks, forming a puddle of water in the middle of the slab.

Fig. 14(c) shows the spalling of the bottom surface of the Slab S2. Compared with the Slab S1, the spalling was relatively serious. Hence, it can be seen that the in-plane compressive force has an important effect on the crack direction, integrity and spalling of the restrained slab.

- (3) The restrained slabs with large uni-axial in-plane forces tend to fail by integrity failure resulted from the full-depth crack of the slab as shown in Slab 2 (see Fig. 14). For the restrained slabs, the reduction in the number of cracks can be achieved efficiently by increasing the reinforcement ratio.

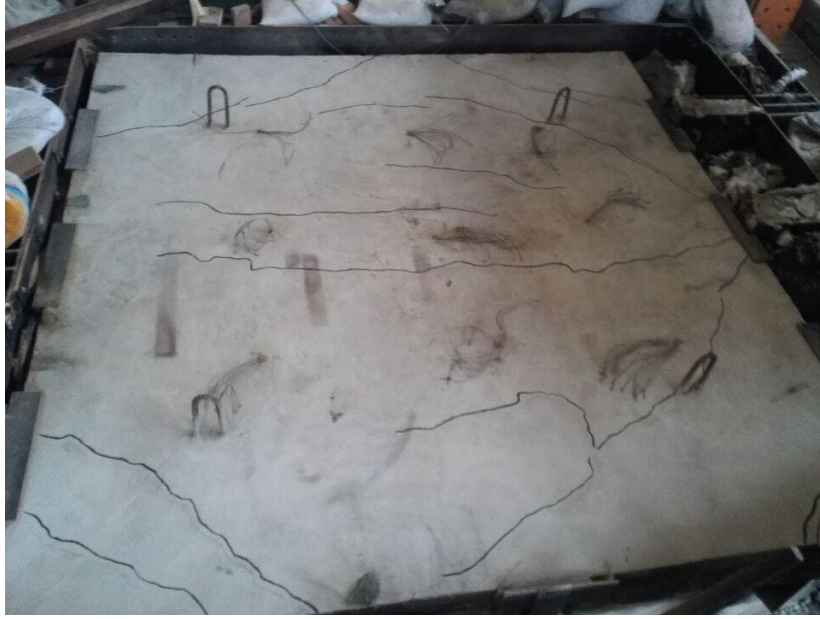
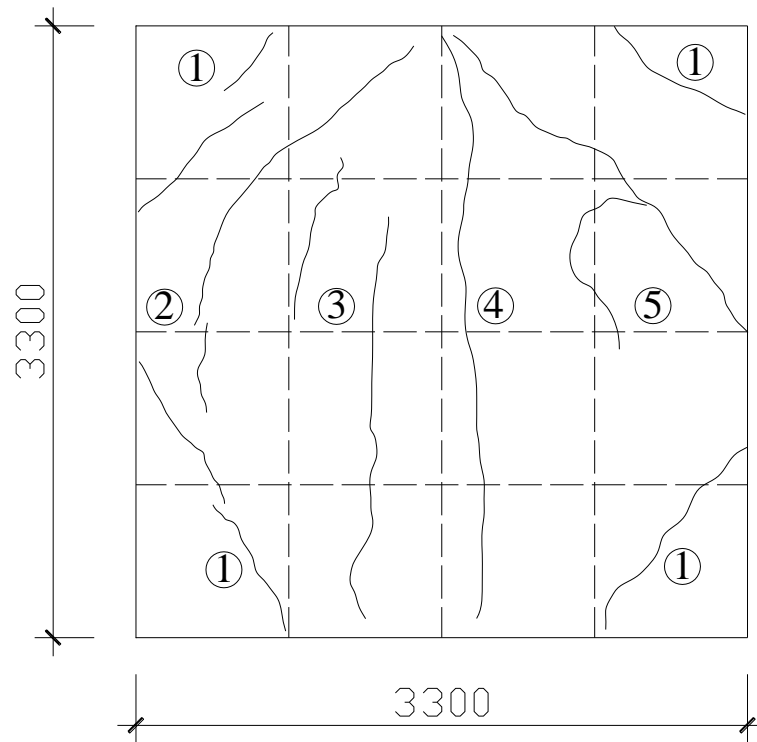
(a) Crack patterns at the top surface

(b) Cracks' development during the test

Fig. 15 Failure models of the Slab S3: (a) Cracking pattern, (b) Cracks' development.

Figs. 15 and 16 show the failure models of the Slabs S3 and S4 during the heating stage. It can be seen that the cracking pattern of the Slab S3 is similar to the Slab S2. However, it is noted that no full-depth crack was visible on the bottom surfaces of the Slabs S3 and S4. This is due to the lower uni-axial in-plane compressive forces (Slab S3) and the higher reinforcement ratios (Slab S4). Also, it is evident that the number of cracks on the top surface of the slabs was clearly different among the three restrained slabs. Compared with the Slabs S2 and S3, the cracks on the top surface of the Slab S4 which has higher reinforcement ratio were relatively

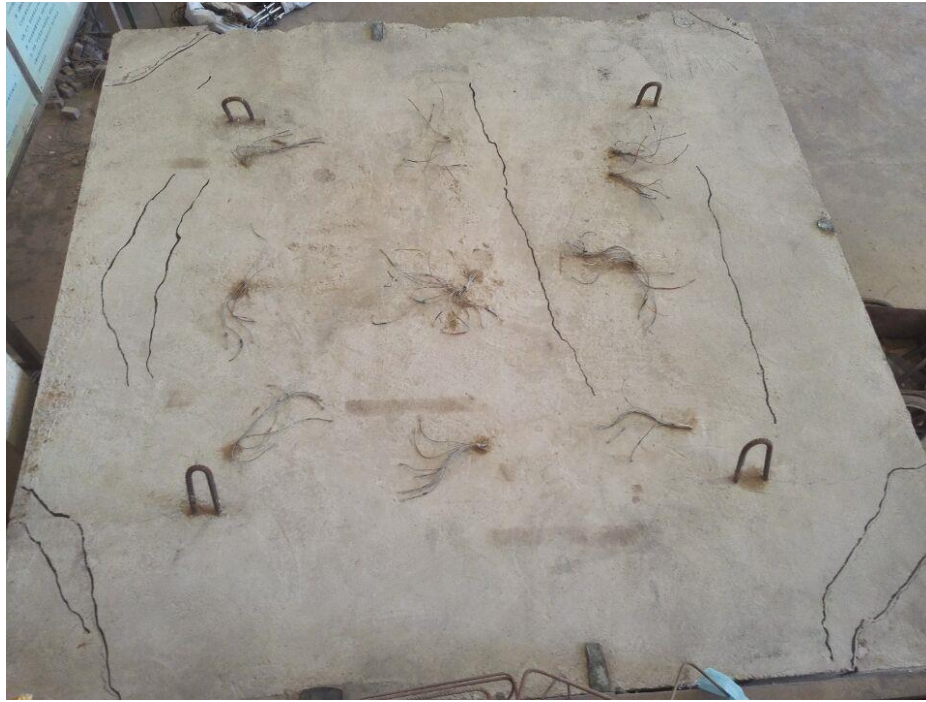
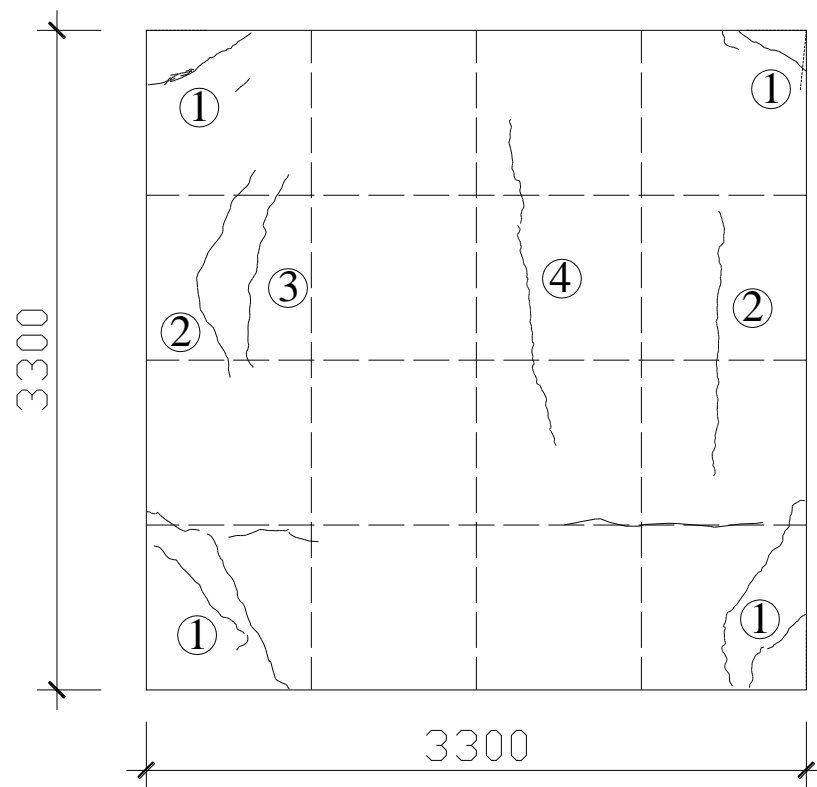
(a) Crack patterns at the top surface

(b) Cracks' development during the test

Fig. 16 Failure models of the Slab S4: (a) Cracking pattern, (b) Cracks' development.

fewer, regardless of its higher uni-axial in-plane compressive forces applied during the test. No doubt, the fire-resistant performance (stability and integrity) of the Slab S4 is the best among the three restrained slabs. Based on these analyses, it can be concluded that increasing reinforcement ratio is beneficial to decrease the number of cracks and increase the fire-resistant performance, particularly to prevent the integrity of the slab.
