Bespoke Method for Installation of VIPs on Building Walls and their Performance

ABSTRACT: This paper describes the installation method of Vacuum Insulation Panels (VIPs) externally on a demonstration wall in an operational residential building in the UK. The study assesses the effectiveness the VIPs in terms of the heat loss through the walls using temperature profiles measured in the demonstration application. The analysis of the temperature measurements show that VIPs improved the overall insulation capabilities of the wall by 200%. Thermal imaging indicates that the simplified method of application implemented is able to achieve a low thermal bridging effect.

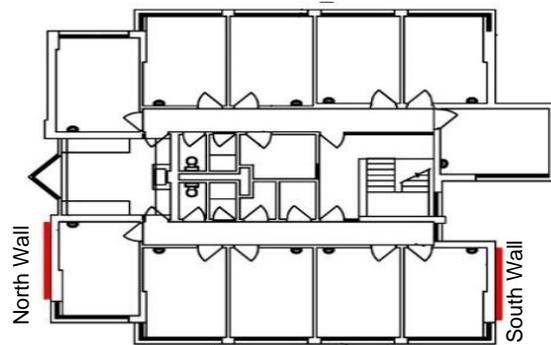
Fig.2 - Plan of the building – Ground Floor

This paper reports on VIPs which were applied on the ground floor of a student accommodation building (Figs. 1 and 2) onto two walls. The North wall has limited exposure to direct solar radiation throughout the year whereas the South wall has full exposure except early morning when is partially shaded by the adjacent building.

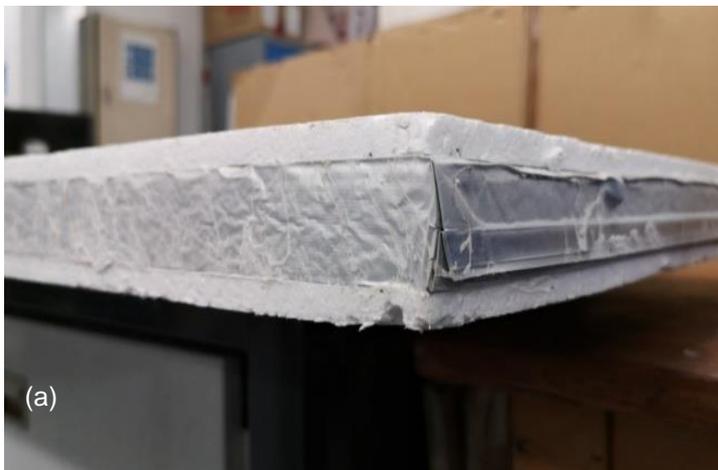
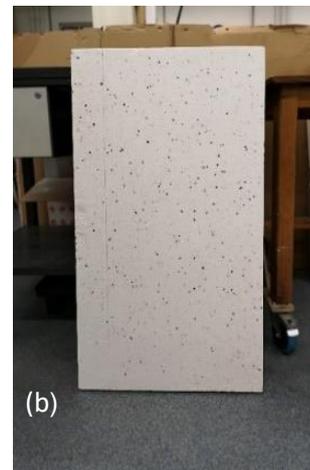
The installed VIPs were supplied by va-Q-tec AG Germany. The panels, flat in shape of size 1000x600x30mm consist of a pressed powder board of fumed silica, non-flammable (class A1) and sealed under vacuum with a gas-vapour-tight film, covered on both sides by a 10mm layer of EPS (Fig 3a and b). The aluminium laminated envelop provides a good barrier for penetrating gases and water vapours. The EPS cover on both sides of the panel not only protects from handling damage but also protects it from surface condensation.

Fig. 3 a and b -VIP panel with EPS cover on both sides

Some adaptations were made during the assembly, namely the introduction of self-adhesive neoprene strips 50mm wide to protect the sides of the VIP panels against the wooden battens, which were not protected with EPS as shown on Fig. 3a. This simplified the handling process and consequently there was no damage to any of the VIP panels.

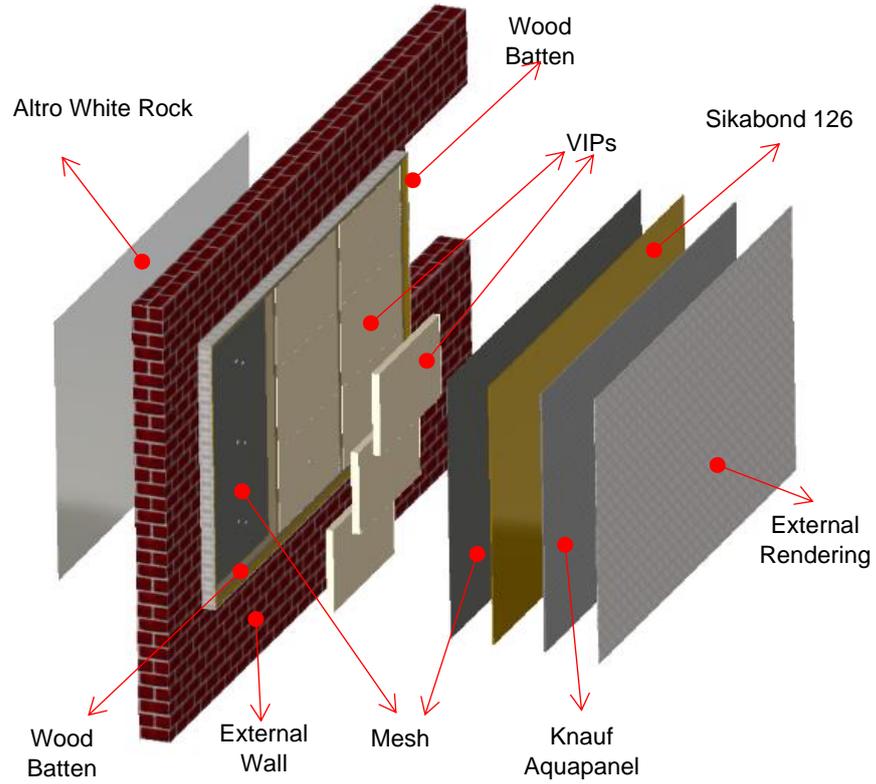
Fig.4 – VIP assembling method

With a thermal conductivity value of 0.0070 W/(mK) at 20 mm thickness, VIPs are predicted to have a service life of up to 60 years by their manufacturer, va-Q-tec. In this project, 9 VIP panels were installed on each wall supported by a wooden frame and covered by a water-proof cement board for external use. The bespoke installation procedure adopted, shown in Fig. 4 and Fig. 5, was developed by the project team after studying conventional methods and deliberations with the manufacturer.

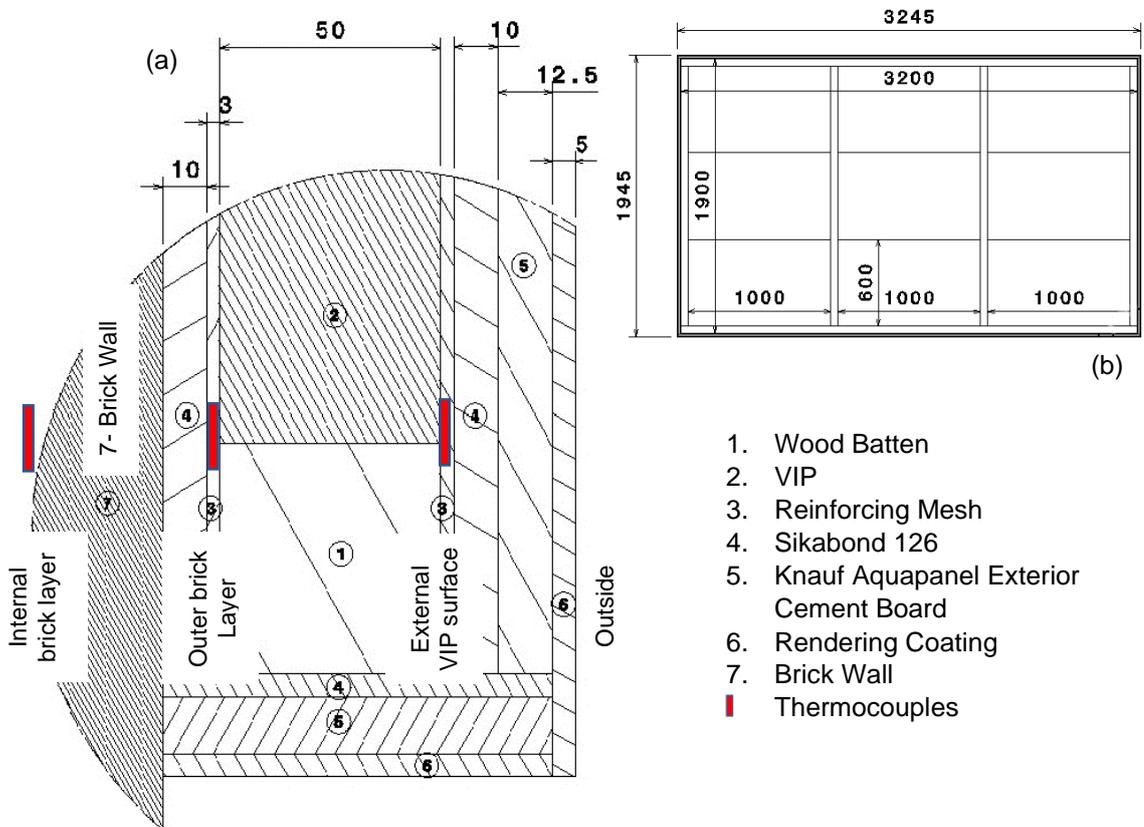
Fig 5. – (a) Side view- assembly components, (b) Assembly dimensions in mm

Thermocouples were installed at (i) internal wall surface, (ii) at external wall surface and (iii) at the outmost surface of VIPs to monitor their performance, as shown in the diagram Fig.5a. On the external surfaces a total of 16 thermocouples (Fig. 6a and c) were employed at the centre of each VIP. On the internal layout, 8 thermocouples were positioned parallel to the external layout (Fig 6g). The thermocouples were connected to 12 data loggers of 4 channels each which have been recording temperatures at 10-minute intervals since August 2019 and for the sake of economy of space only January data is shown here. The temperature difference in the two sections (VIPs and brick) is presented in Fig.9 and 10 and in more detail, the temperature difference on individual VIP panels is shown in Figs 11 and 12.

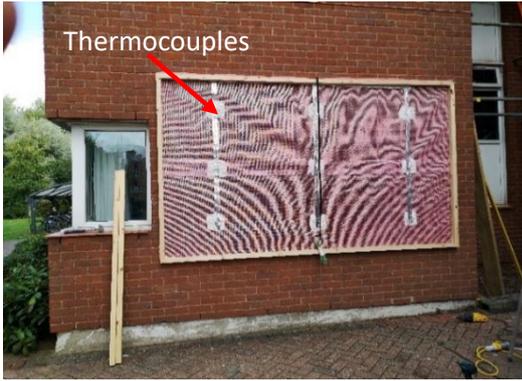
(a) Frame and inner mesh with thermocouples

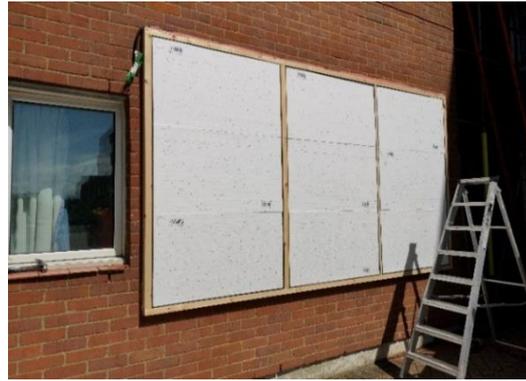
(b) VIPs with EPS covering

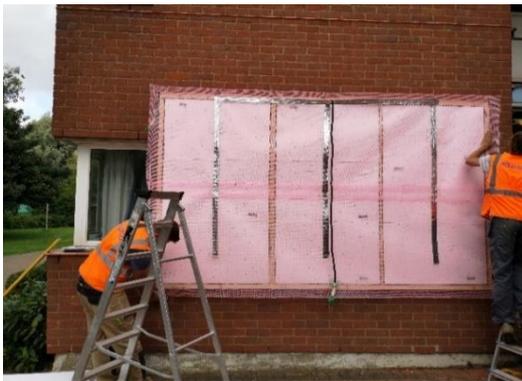
(c) Outer mesh with thermocouples

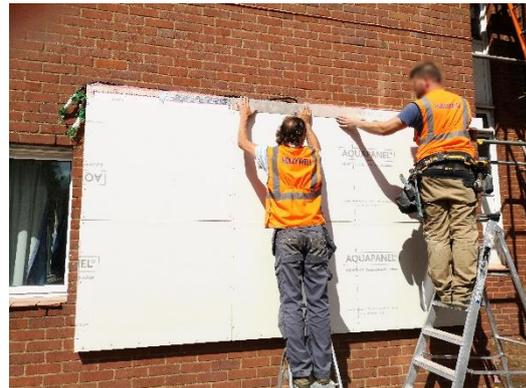
(d) Aquapanel cement board for exterior use

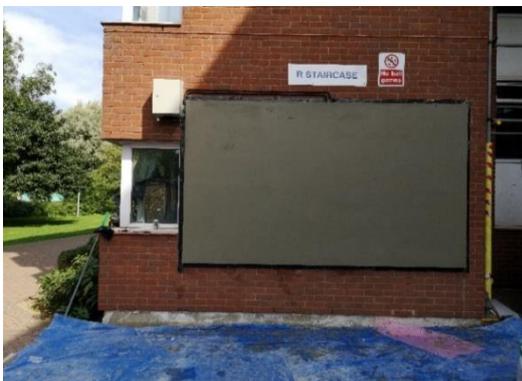
(e) External rendering

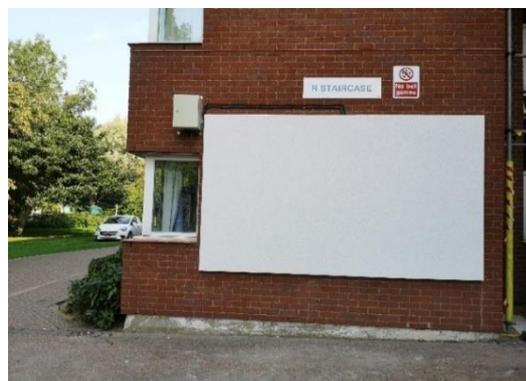
(f) Final external outcome after painting

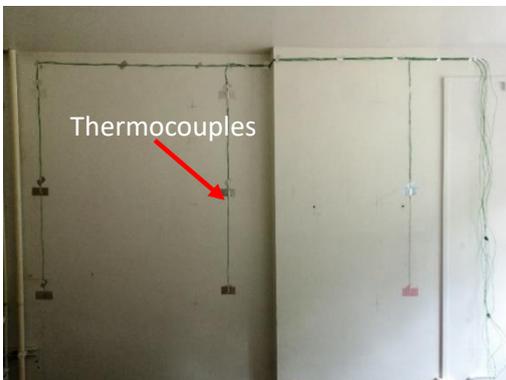
(g) Layout of thermocouples on internal wall surface

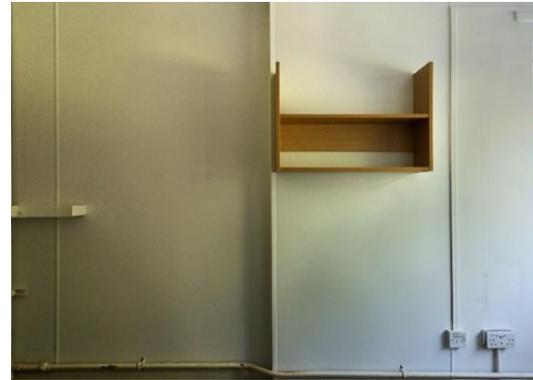
(h) Final interior outcome with Altro White Rock

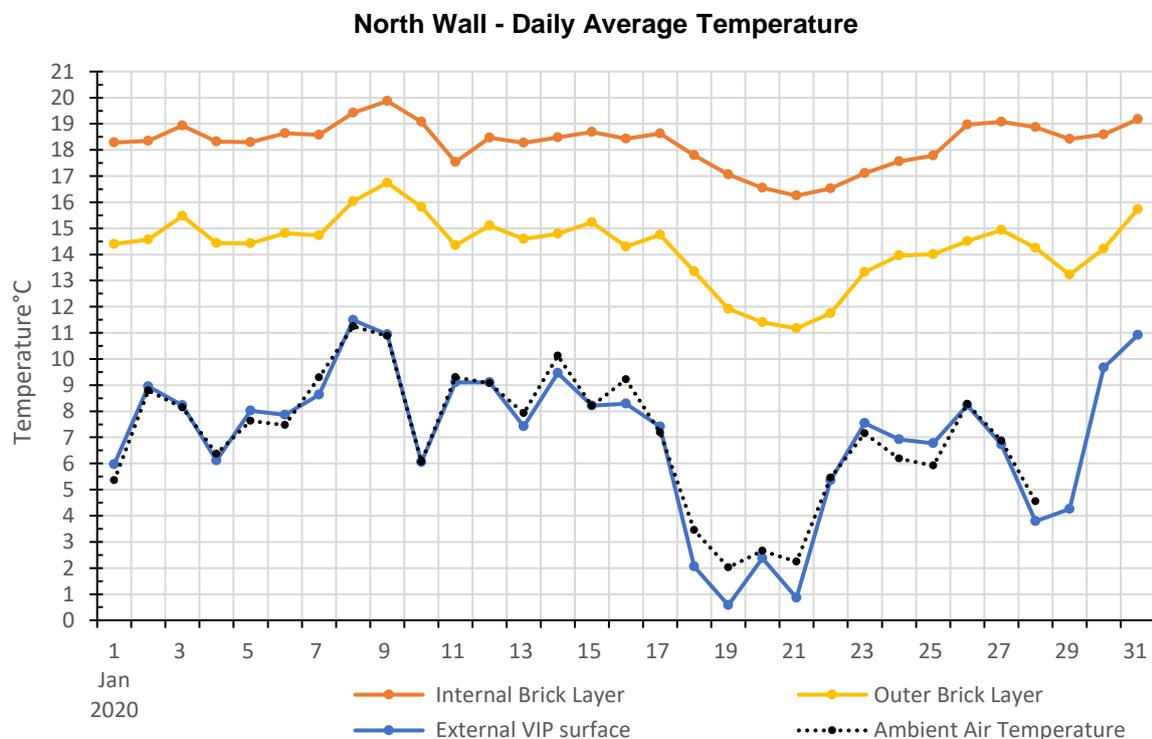
Fig. 7 Daily average temperature at three locations on the VIP north wall

Figs. 7 and 8 show that the measured surface temperatures of the different layers have followed a similar pattern to the ambient air temperature as expected. It can also be seen that the external VIP surface resulted in slightly higher temperature on the south wall as a result of solar radiation. Both walls have returned similar temperature profiles because the rooms were kept at similar temperatures and the ambient conditions were also similar.

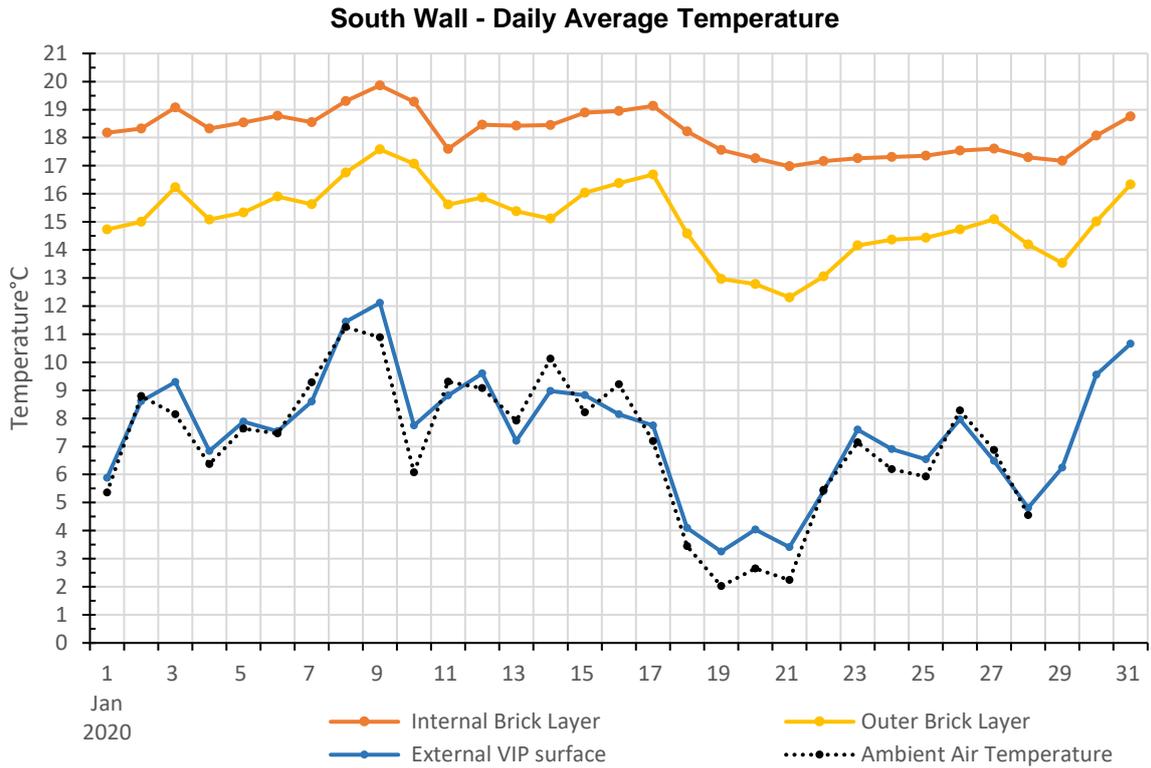
Fig. 8 Daily average temperature at three locations on the VIP south wall

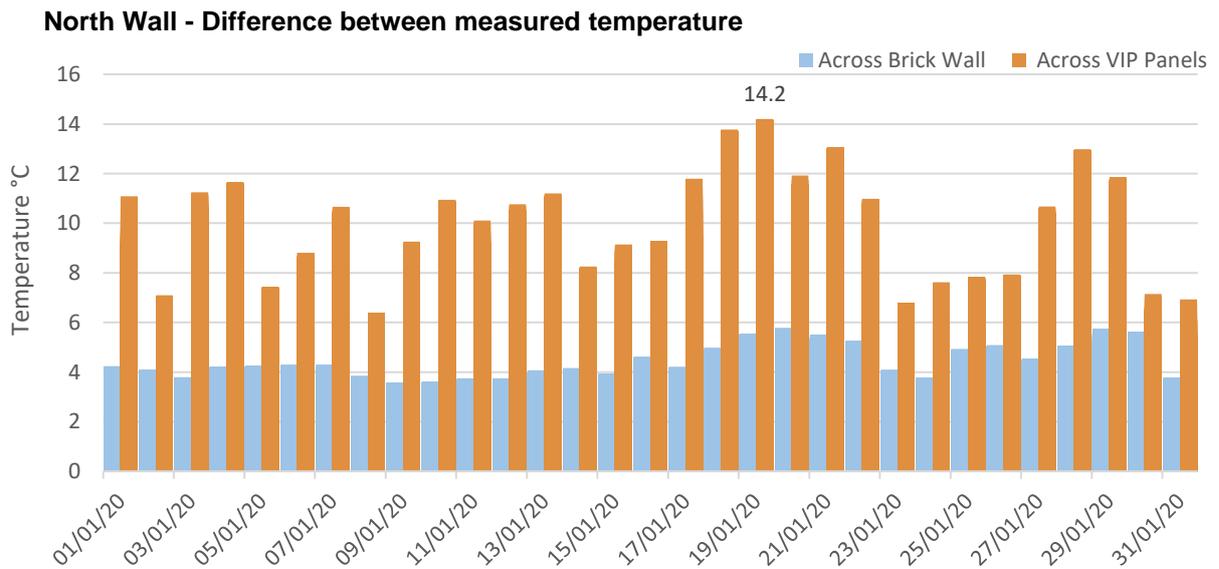
Fig. 9 - North wall - Daily average temperature difference measured across double brick wall (blue) and across VIP centre panel (orange)

Figs 9 and 10 show that the introduction of VIPs on the walls created a maximum temperature difference of 14.2 °C between the external surface of the north wall and the ambient, and 15.15 °C on the south wall implying a substantial amount of equivalent heating energy saving. Without the VIPs this energy would be wasted in raising the temperature of the outer brick layer hence reducing thermal comfort for the building occupants, or additional energy would have been used to keep similar levels of thermal comfort.

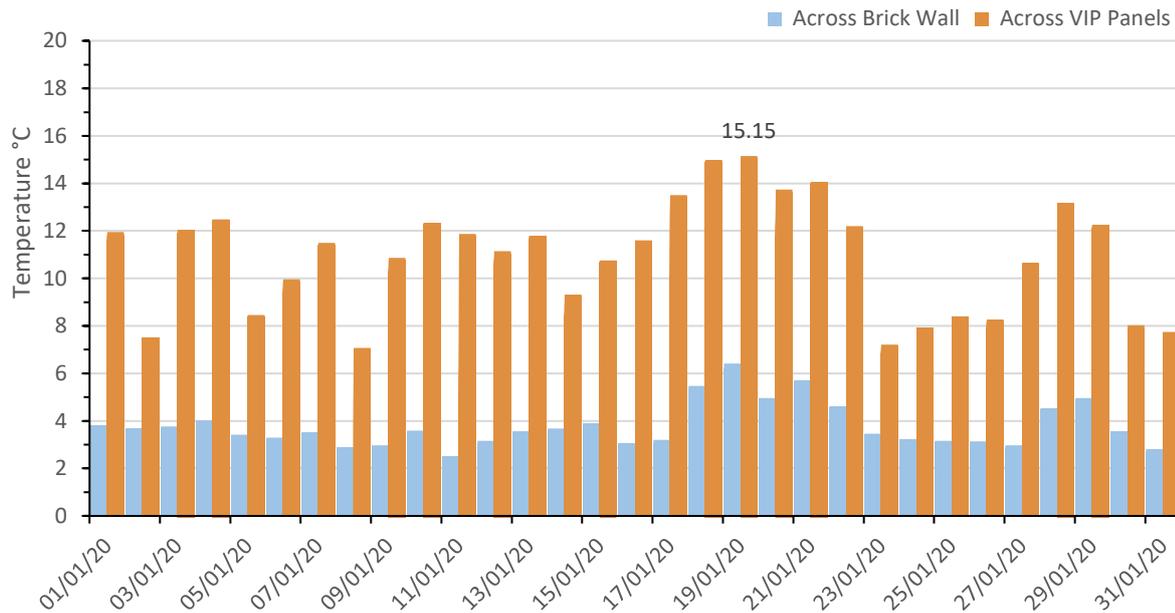
Fig. 10 - South wall - Daily average temperature difference measured across double brick wall (blue) and across VIP centre panel (orange)

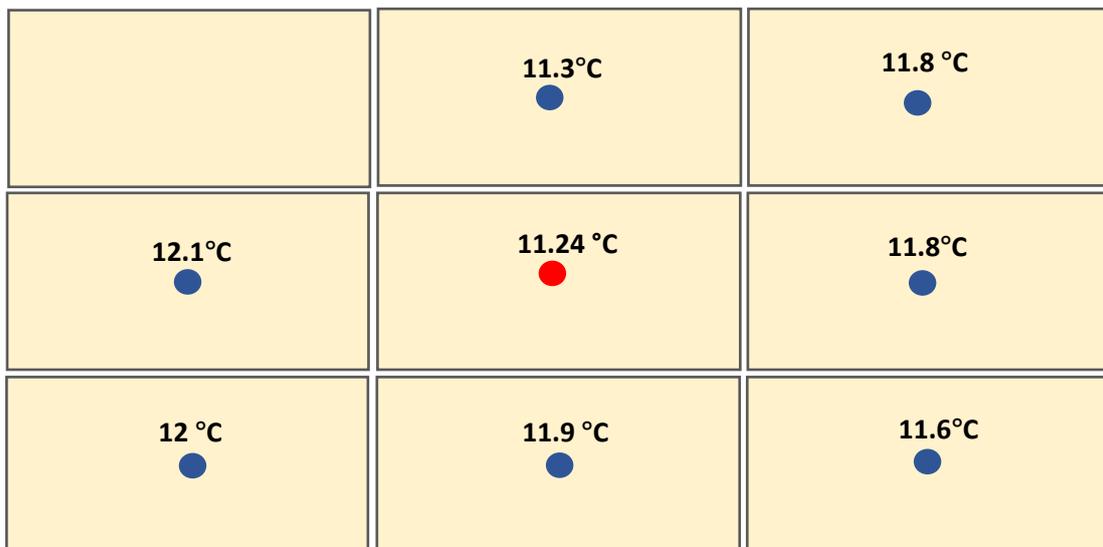
Fig. 11 - North wall - January average temperature difference between internal wall surface and external VIP surface

Fig. 11 shows that the VIPs performed consistently across the whole installation providing a stable temperature distribution to the wall. It is evident by the recorded temperatures that the installation method developed has significantly reduced thermal bridging effect between any two adjacent VIPs. A slight increase in temperature can be observed on the panels at the edge of the installation which

reflects the effect of heat lost as a consequence of the uninsulated sections of the wall relative the central panel which is surrounded by other VIPs. Similar temperature profiles were measured for the South wall are shown in Fig. 12.

Fig.12 shows the average temperature for the external wall surface on the south wall installation as opposed to the temperature difference across all installation shown in Fig. 11. It can be seen that the temperatures recorded follow a similar pattern of higher temperatures on the VIPs at the edges of the installation relative to the central VIP. This can be as a result of the uninsulated areas of the wall, nonetheless, it is worth noticing that the south wall is partially exposed to direct sunlight for most of the day which implies the effect of solar radiation might account for the higher difference in temperature from the centre VIP as shown on Fig. 14. The January average temperature was 18.1°C and 7.1°C on the inside wall surface and on the external VIP surface respectively. With an average temperature of 15.1°C at the central panel, the VIP installation proved to be an efficient barrier against heat loss.

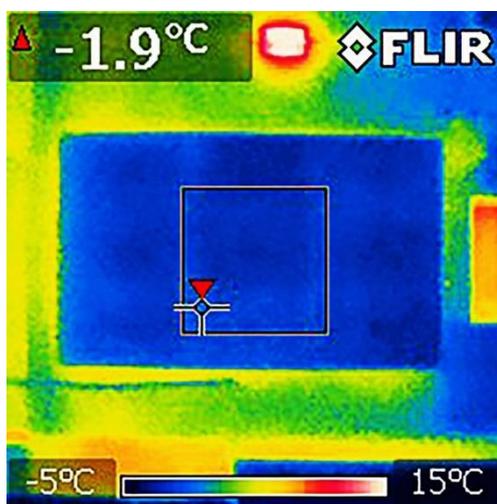
Fig. 13 - Thermal Image – North Wall

On Fig. 13 shows that the chosen installation method helped to reduce the effect of heat bridges which has been a major concern for building scientists and developers because these can lead to a complete loss of value that could be gained from VIP installations. Fig.14 shows the effect of solar radiation on the partially shaded installation on the south wall.

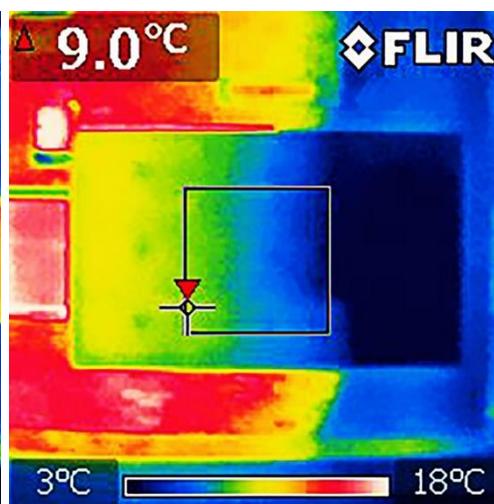
Fig. 14 - Thermal Image – South Wall
