# **A multi-hazard cascading risk model for coastal rail infrastructure:**

numerical modelling & engineering failure analysis

# **A multi-hazard cascading risk model for coastal rail infrastructure**

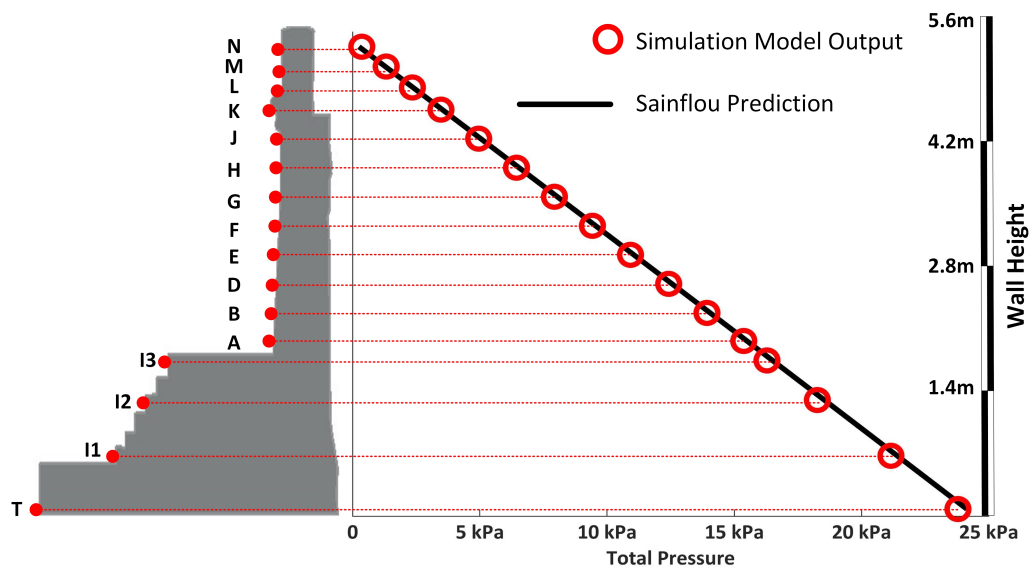
**Figure 3.6:** Validation of the computer model seawall showing the probe locations (with identifiers) where pressures are recorded and comparison of the simulated pressures for a linear wave (red circles) with those calculated using the theoretical equations of Sainflou [114]

the model by comparing them with the analytical equations of Sainflou [114], Equation 3.1, which is one of the most common sets of equations for design of coastal structures (Figure 3.6). The model was tested by running a linear wave of period 6 s and wave amplitude of 1.5 m against the wall, with a still water level of 4.5 m. It can be seen that the model results are very close to those from analytical equations of Sainflou [114], indicating that the numerical model is accurately modelling the wave-structure interaction (Figure 3.6).

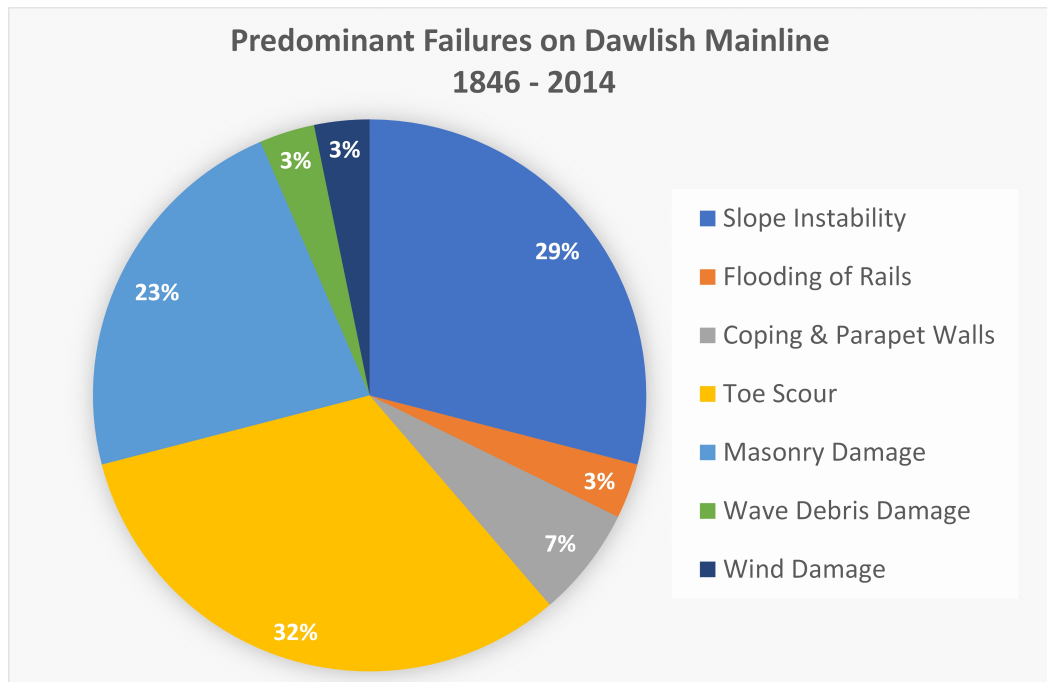
**Figure 4.1:** Relative predominance of cause of failure on the Dawlish Mainline derived from data in Table 3.1

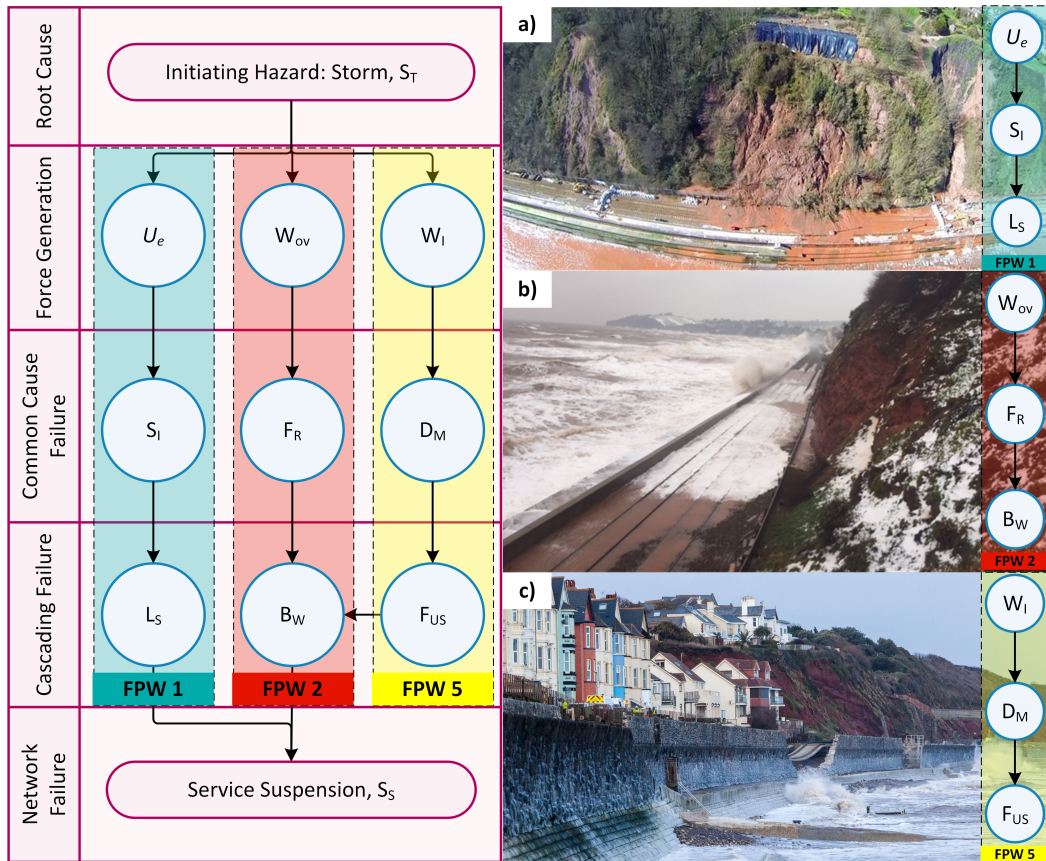
**Figure 4.8:** Event flowchart showing multi-hazard and cascading failures that led to the Dawlish network failure of February 2014. a) 20,000-tonne landslide between Dawlish and Teignmouth activating first failure path [85]. b) Failure path with significant wave overtopping flooding rails and leading to ballast washout. [89] c) Failure path of the upper sections of the seawall due to wave impact forces [84]. Where:  $S_T$ : storm;  $U_e$ : excess soil pore pressure;  $S_I$ : slope instability;  $L_S$ : landslide;  $W_{OV}$ : wave overtopping force;  $F_R$ : flooding of rails;  $B_W$ : ballast washout;  $W_I$ : wave impact force;  $D_M$ : damage to masonry elements;  $F_{US}$ : failure of upper sections of wall;  $S_S$ : service suspension; **FPW**: failure pathway.

the engineering assets of the railway. A field survey was conducted in September 2018 to examine the site of the damage and to evaluate the restoration works undertaken. The local museum in Dawlish [25] provided extensive information on the disaster, augmented by interviews with residents, engineers and emergency workers involved in the first response and subsequent rebuilding.

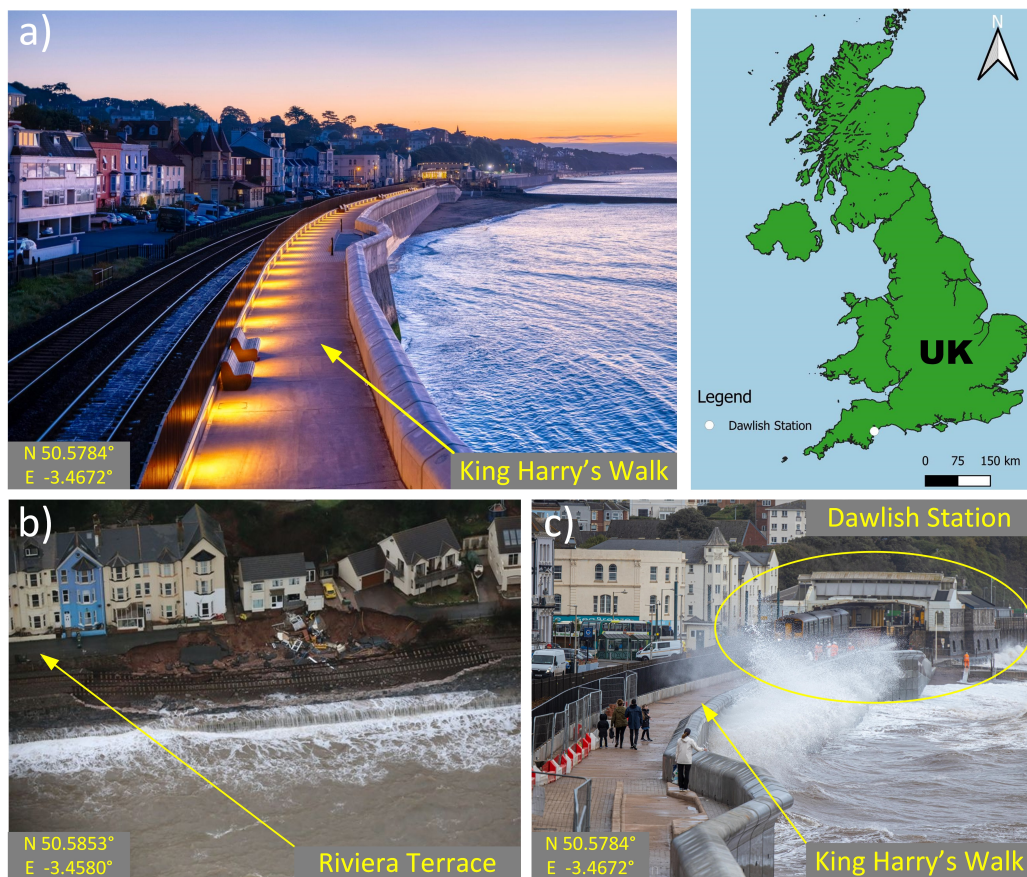
**Figure 5.1:** Location of Dawlish railway station. a) The completed section of the new seawall looking towards the train station along King Harry's Walk. b) An aerial view of the seawall damage sustained at Riviera Terrace in February 2014. c) Waves impacting the newly constructed seawall south of the station, now 2.5m taller with an integrated wave return. ©Network Rail.[92]

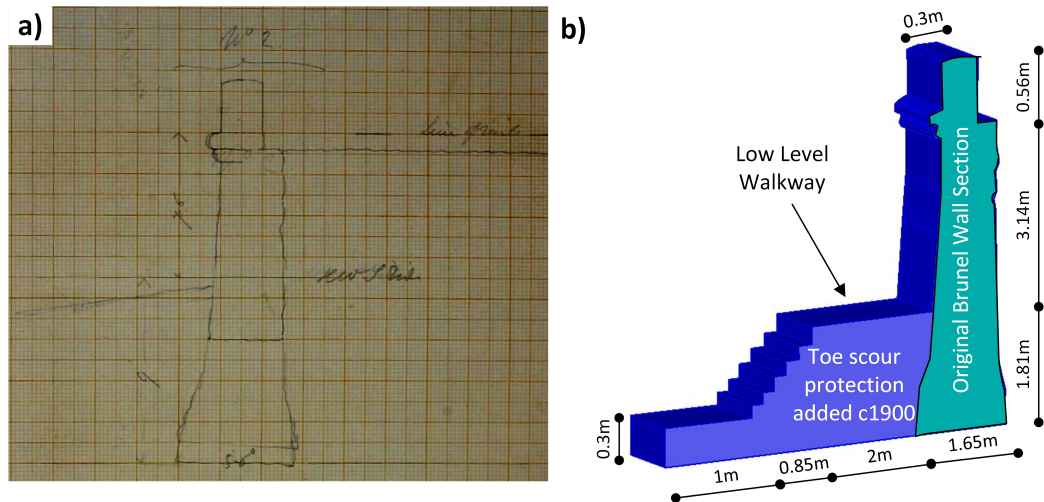
**Figure 5.2:** a) An original sketch of the Dawlish seawall made by the lead Engineer Mr Brunel around 1844–46 [14]. b) The 3D wall model created for the numerical simulations based on Brunel's sketch and subsequent additions of toe reinforcement for scour protection and low-level walkway. The original seawall section is shown in green, with later additions of toe scour protection shown in blue.

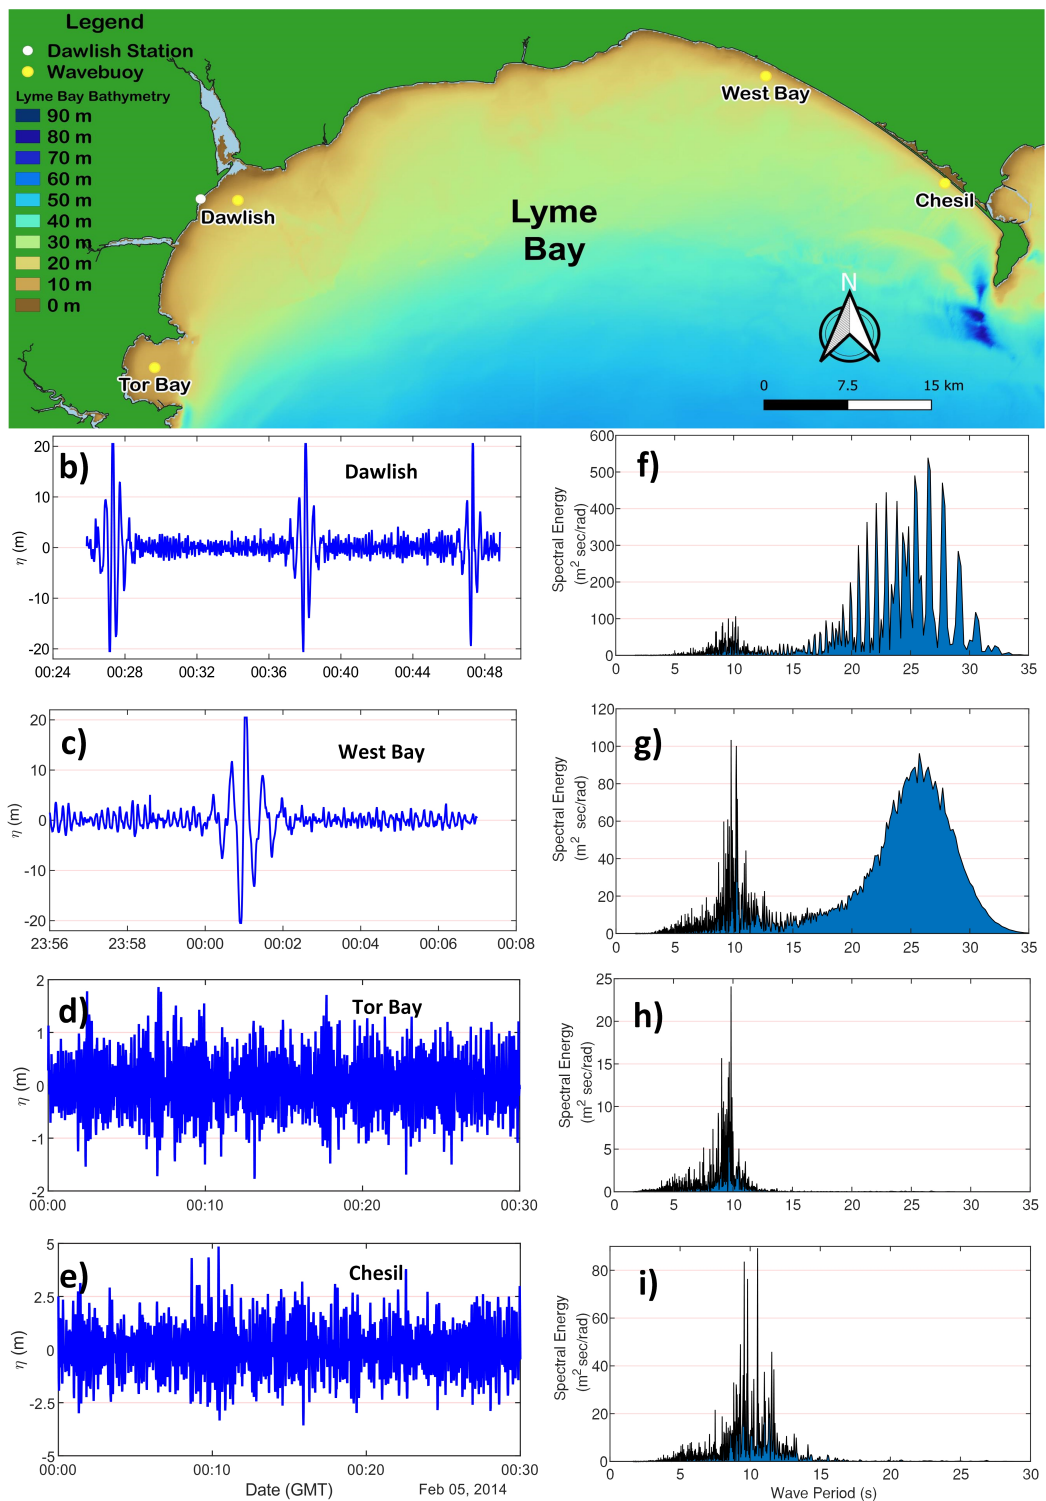
**Figure 5.4:** a) Area map showing the locations of wave buoys examined in this study. b), c), d), e) Sea level oscillations recorded at wave buoys at different locations. f), g), h), i) Corresponding spectra for each sea level record.

The results of surge and wave analyses are presented in Figures 5.3 and 5.4. A surge height of up to 0.80 m was recorded in the examined tide gauge stations (Figure 5.3b-d). Two main episodes of high surge heights are identified: the first surge started on 3rd February 2014 at 0300 h (UTC) and lasted until 4th February 2014 at 0000 h; the second event occurred in the period 4th February 2014 1500 h to 5th February 2014 at 1700 h (Figure 5.3b-d). These data imply surge durations of 21 h and 26 h for the first and the second events, respectively. Based on the surge data in Figure 5.3, I note that the storm events of early February 2014 and

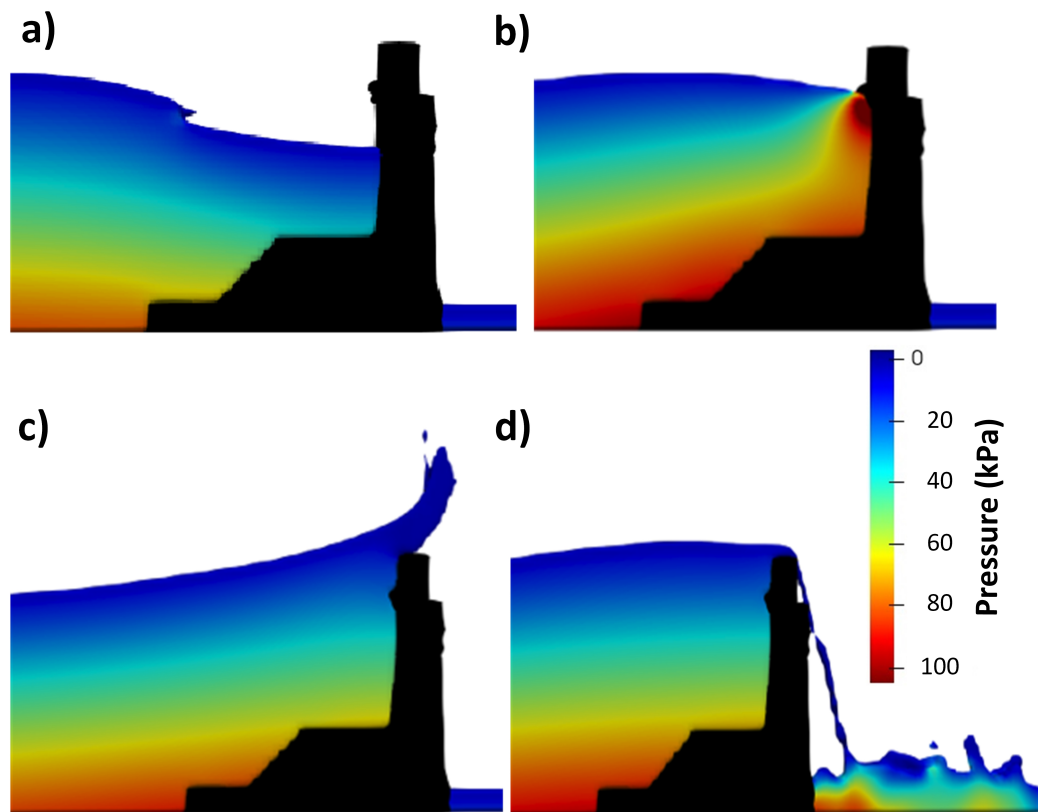
**Figure 5.6:** Wave pressure iso-surface due to Scn-15 (see Table 5.1 for details of this scenario). a) Breaking wave at  $t = 61$  s. b) Maximum breaking pressure at parapet wall  $t = 61\frac{1}{2}$  s. c) Wave overtopping wall crown at  $t = 62$  s. d) Downward overtopping pressure on rail bed  $t = 63\frac{1}{2}$  s.

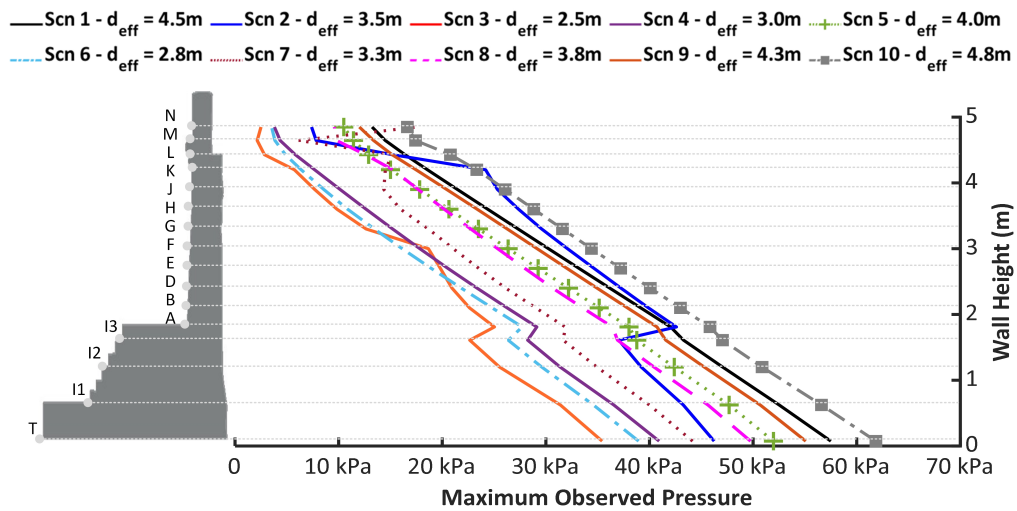
**Figure 5.9:** Distribution of maximum wave pressure along the height of the seawall from scenarios 1-10 with wave amplitude of 0.5 m.

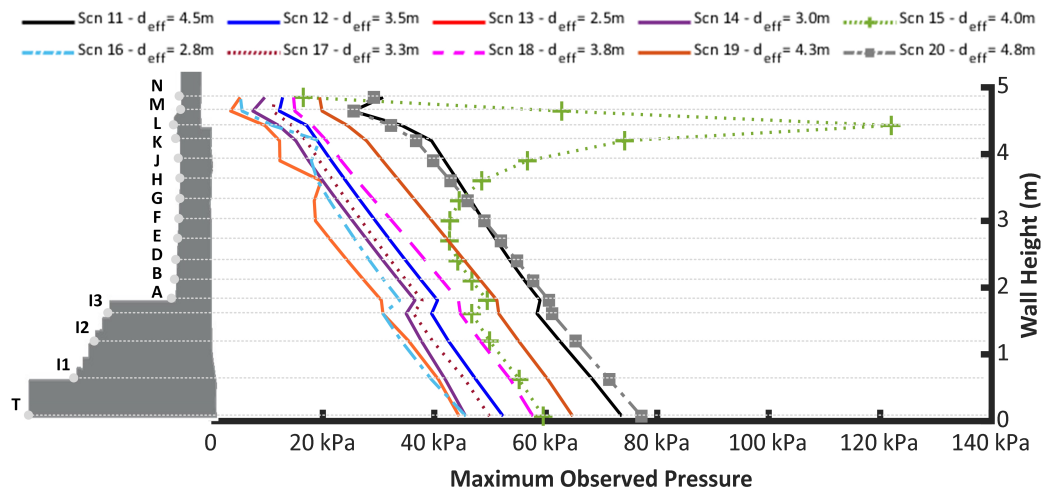
**Figure 5.10:** Distribution of maximum wave pressure along the height of the seawall from scenarios 11-20 with wave amplitude of 1.5 m.
