[Dissolution Influences on Gypsum Rock under Short and Long-Term Loading: Implications for Dams]

[Nihad B. Salih¹, Philip E.F. Collins², Stephen Kershaw³]

[¹University of Sulaimani, Iraq, ² and ³ Brunel University, London, UK]

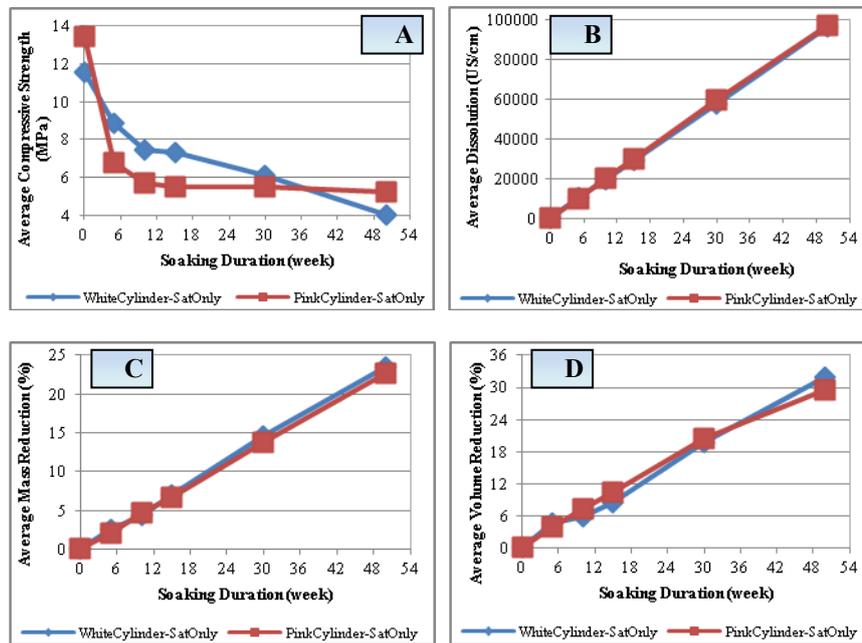
Fig. 1 Comparisons among short term loaded cylinders. A is for compressive strength. B is for dissolution. C is for mass reduction and D is for volume reduction. Each calculated values are the average of three tested cylinders.

The larger dissolution values of Iraqi samples under atmospheric pressure than white/Bantycocock samples in short-term datasets (fig. 1) were correlated with the effects of gypsum crystal size and shape in characterizing the dissolution process i.e. larger crystals dissolve less quickly than smaller crystals. Slight differences in impurities within the gypsum, as reflected by the different colours of gypsum from Bantycocock (white and pink) may also contribute to differences in response e.g. fig. 1/A where the strength of the pink gypsum declines much more quickly than the white gypsum. The shape of internal structures, determined by cracks and fissures, may also be a factor as these allow fresh water to penetrate the gypsum. In addition, many of the cracks contain impurities that have different mechanical and chemical properties to the gypsum. Samples that were soaked without loading showed more evidence of weakening through crack-enhanced dissolution than samples under constant load for 50 weeks. This may be because the high load caused the cracks to close through simple translational movement and through small amounts of creep. It should be noted that the water was under atmospheric pressure during these tests. Under pressure conditions similar to those found beneath large dams such as at Mosul, water may well be able to penetrate thin cracks.

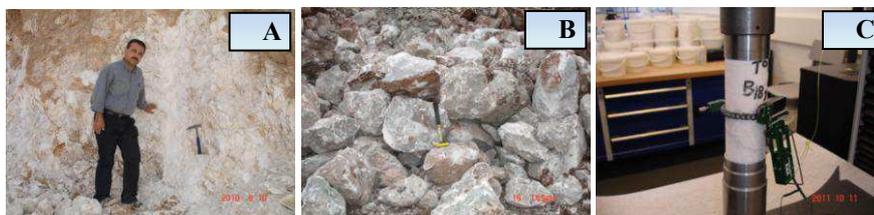
Fig. 2 A. Gypsum outcrop, Bazyan/Iraq. B. Bantycoc Mine/UK gypsum blocks. C. The extensometer in the mid-length of a cylinder.

NX cylinder samples (54 mm diameter and $L/D = 2.5$) were prepared following common practice [2, 4 & 6]. A suitable loading rate of 0.025 MPa/sec was determined following ASTM and ISRM standards [2 & 4]. A circumferential extensometer was used in the mid height of cylinders to calculate the radial strain (fig. 2/C). Ultrasonic observations were recorded for each sample in air dry state and after each of the immersion periods.

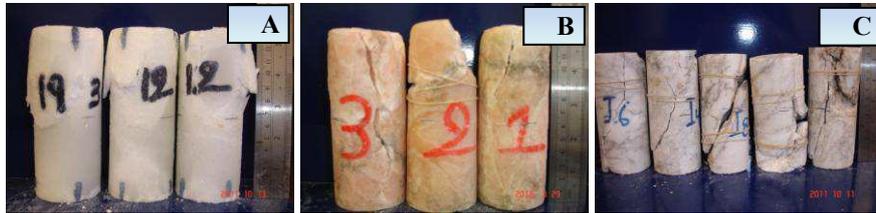
Fig. 3 The failed cylinders after short-term loading: A. the white/Bantycok gypsum. B. the pink/Bantycok gypsum. C. the Iraqi gypsum.

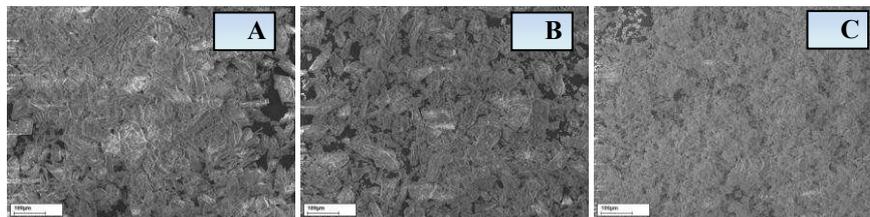
Fig. 4 Variations in gypsum crystal size, visualized using SEM: A. White/Bantycok gypsum. B. Pink/Bantycok gypsum. C. Iraqi gypsum.

Table 1 Description of the UK and Iraqi gypsum particles, the description based on *SEM* (Scanning Electronic Microscope) photos presents in fig. 4.

Gypsum Sample Type	Particle Size	Particles Gradation	Particles Shape	Notes
White/Bantycok, UK (see fig. 4/A)	4 to 114 micron	Poorly graded	Have three shapes randomly: longitudinal, semi-square and semi-circular/elliptical	Very sharp edges of particles, mostly medium size, some large and small sizes are found
Pink/Bantycok, UK (see fig. 4/B)	2 to 177 micron	Not very well graded	Mostly semi-elliptical and longitudinal	Middle and large sizes are more than fine size
Iraqi (see fig. 4/C)	1 to 28 micron	Looks well graded	Mostly semi-circular and semi-elliptical	Mostly fine particles, some concentration of fine particles with impurities/other minerals together make dense look for some places

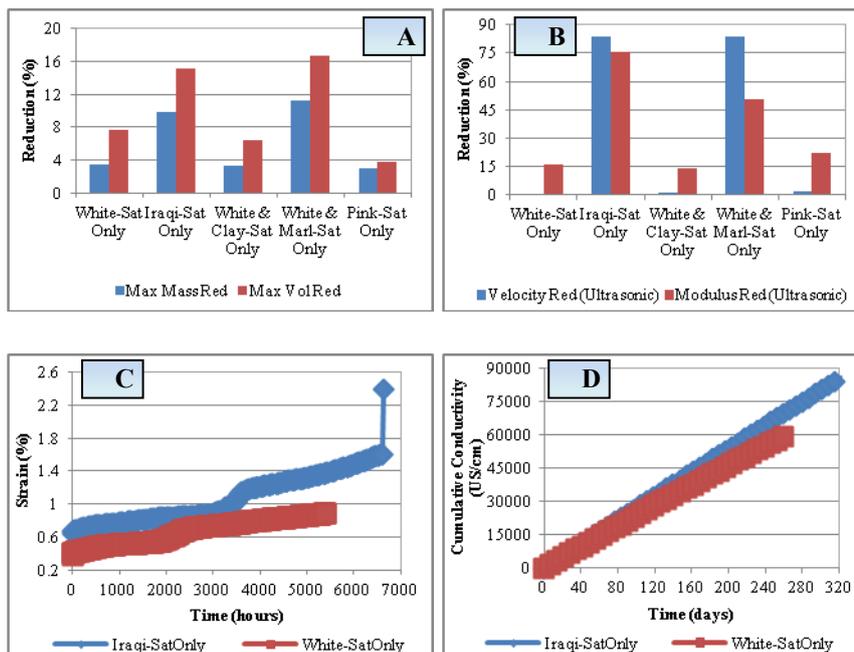
Fig. 5 Comparisons among long-term loaded cylinders. A. Volume and mass reduction after 60 days. B. Ultrasound velocity and modulus reduction after 60 days. C & D are for one year loaded cylinders, Iraqi cylinder failed after 6800 hours as shown in part C.
