# The behaviour of the power transmission tower subjected to horizontal support's movements

In this paper, two half-scaled test tower models for a typical 110 kV single-circuit power transmission tower were designed and fabricated. The scaled test tower models were tested under the horizontal support's stretching (tensile) and compressive movements with the normal working loading conditions. The deformations of the tested tower models and stresses within the different bracing members were fully measured. A large amount of comprehensive test data was generated. Also a finite element (FE) model using software ANSYS was developed and validated by the test data. The research indicated that the designed half-scaled test tower model can reasonably represent the behaviour of the whole transmission tower under the horizontal support's movements. The magnitude of the stresses was reduced from the bracing members at lower part to the bracing members at higher part of the tower. The effect of the ground surface deformations is more significant on the truss members closed to the supports. Hence, for the design of transmission tower against the horizontal support's movements, it is important t

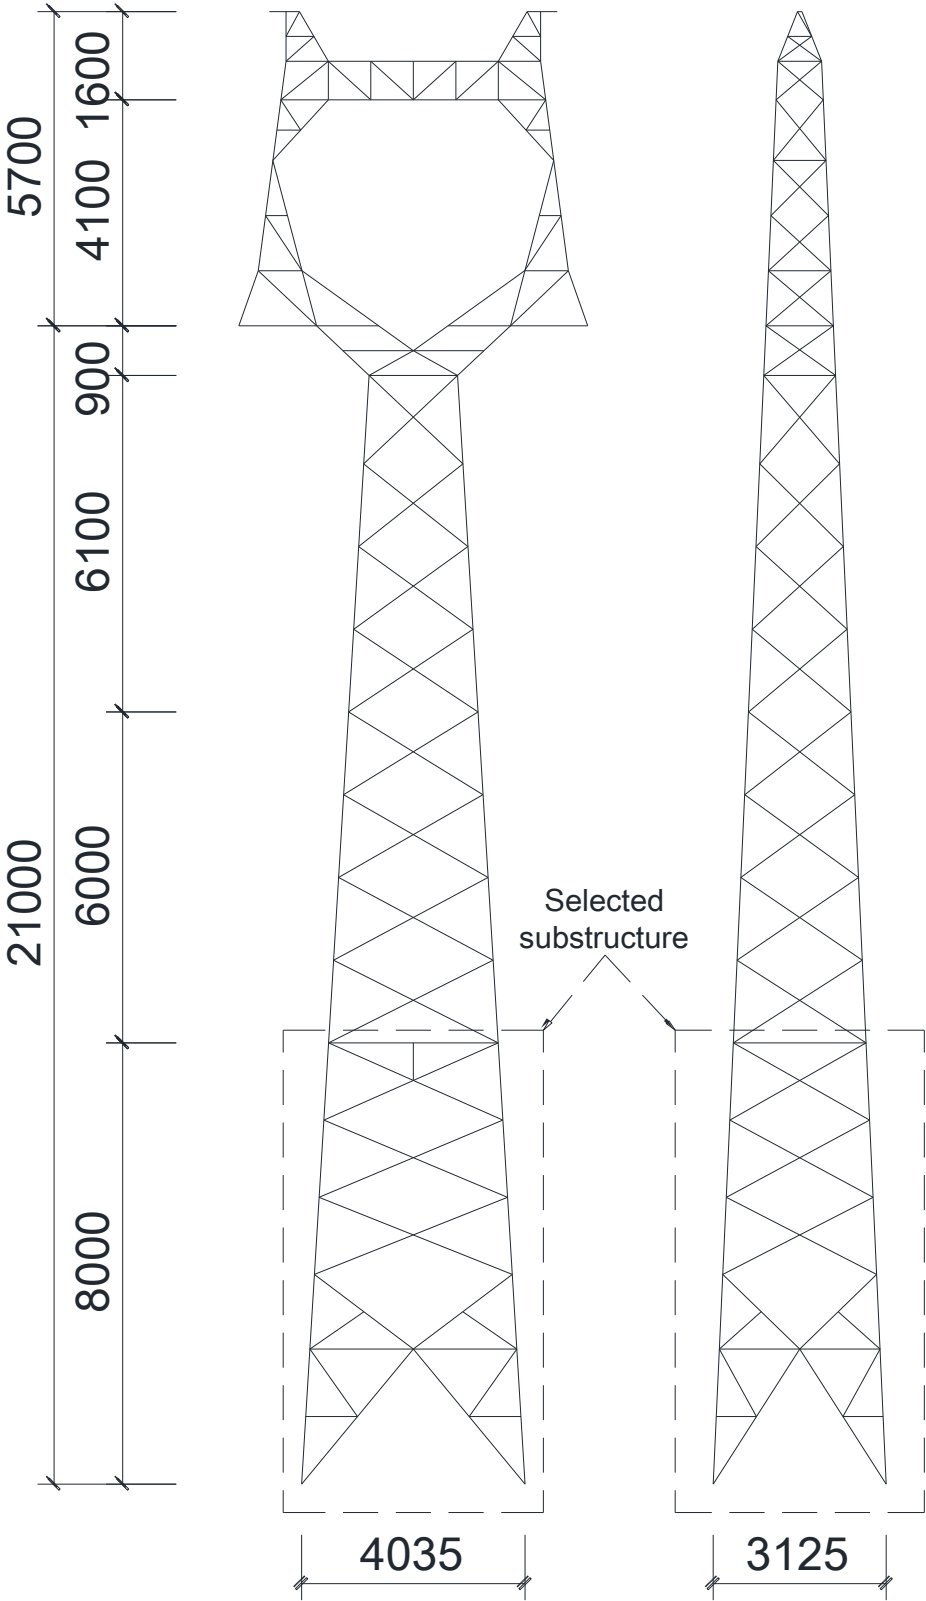
Fig. 1 A prototype of 110 kV single circuit transmission tower (all dimensions in mm).

The prototype of the scaled test tower model is a typical 110 kV single circuit Cat-head like 1B-ZM3 transmission tower. As shown in Fig. 1, the tower is 26.7 m high; the support spaces are 4.035 m perpendicular to the line direction and 3.125 m along the line direction. In order to design the scaled test tower model (substructure) which is a good representation of the full-scale tower, a FE model by using ANSYS was developed for modelling the full-scale tower subjected to horizontal supports' movements. The predicted overall deformations and stress states of the tower structure were analysed in detail to identify the influence scope within the tower, caused by the horizontal deformations of ground surface.

decreased upwards along the tower height. At above the second diaphragm member (8 m up from the support's level, in Fig. 1) the influence due to ground surface deformations is negligible. According to the results of the FE analyses, the selection of steel angle members for the scaled test tower model, and available loading equipment in the lab, only part of the tower below the second diaphragm member was selected as the substructure for the scaled test tower model (in Fig. 1). The scale of the test tower model was set to be half-scaled (1:2), so the cross section area of the truss members for the scaled test tower model was 1/4 of the cross section of the truss members for the original full-scale tower. As shown in Fig. 2, the height of the scaled test tower model was 4 m, and the sizes of the top and bottom sections of the scaled test tower model were 2018×1563 mm and 1530×1200 mm, respectively.

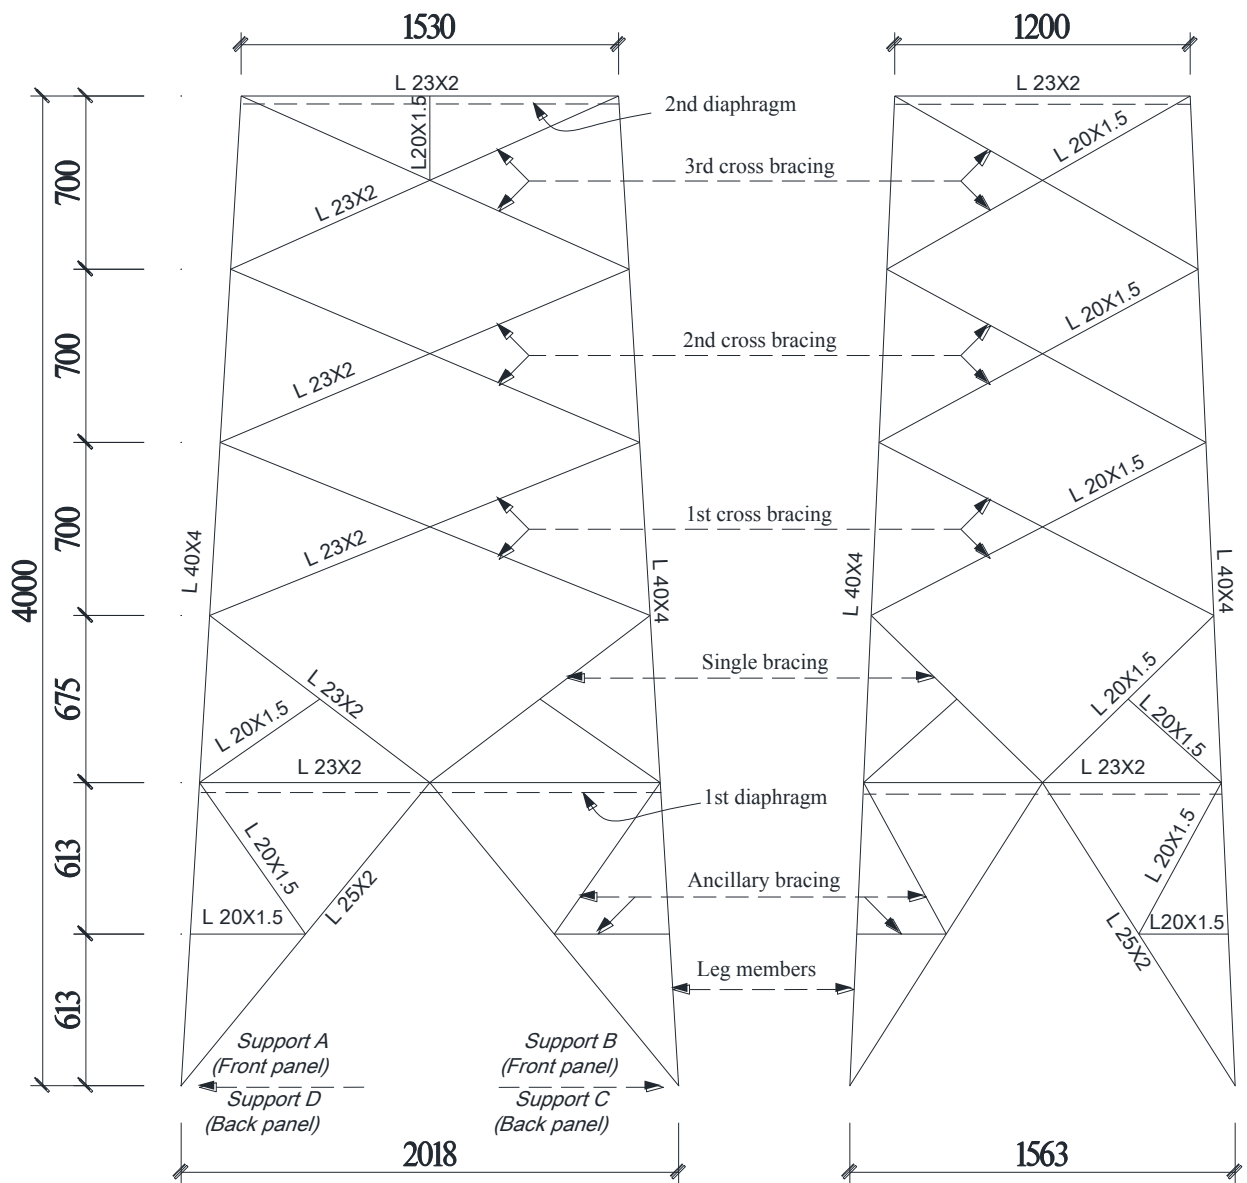
Fig. 2 The half-scaled test tower model (all dimensions in mm).

Due to limited space, only the case with the horizontal tensile stretching of the supports in the direction perpendicular to the line is presented here. In this case, the horizontal distances between supports A(D) and B(C) (Fig. 2) were stretched. For the case with the compressive supports' movement, the horizontal distances between A(D) and B(C) (Fig. 2) were reduced.

supports A(D) and B(C) (Fig. 2) were stretched. For the case with the compressive supports' movement, the horizontal distances between supports A(D) and B(C) (Fig. 2) were reduced.

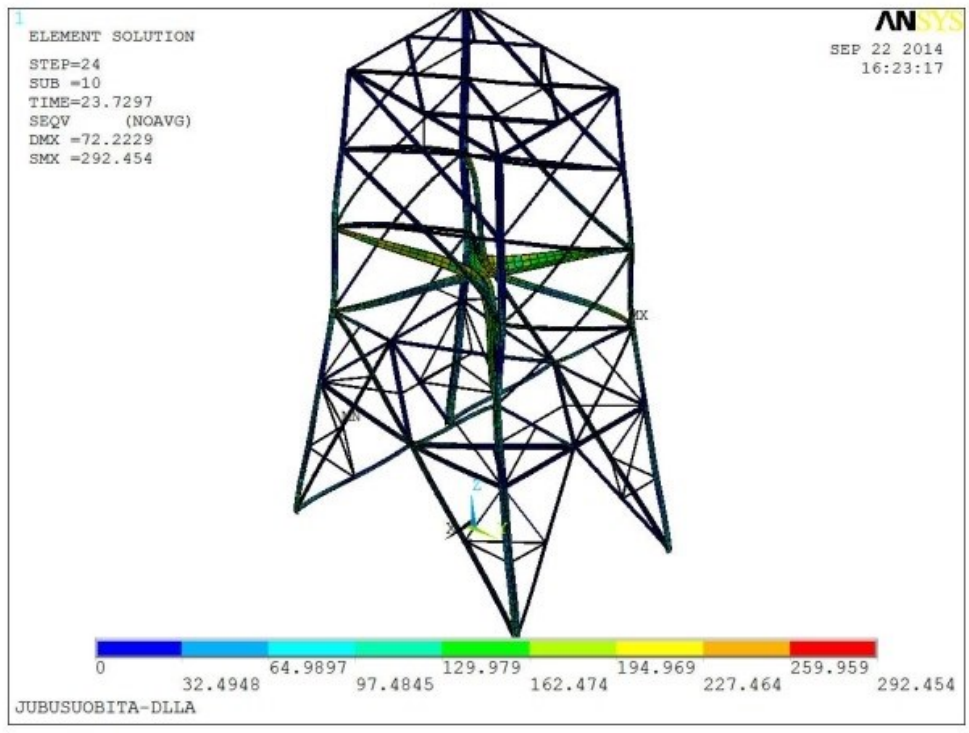
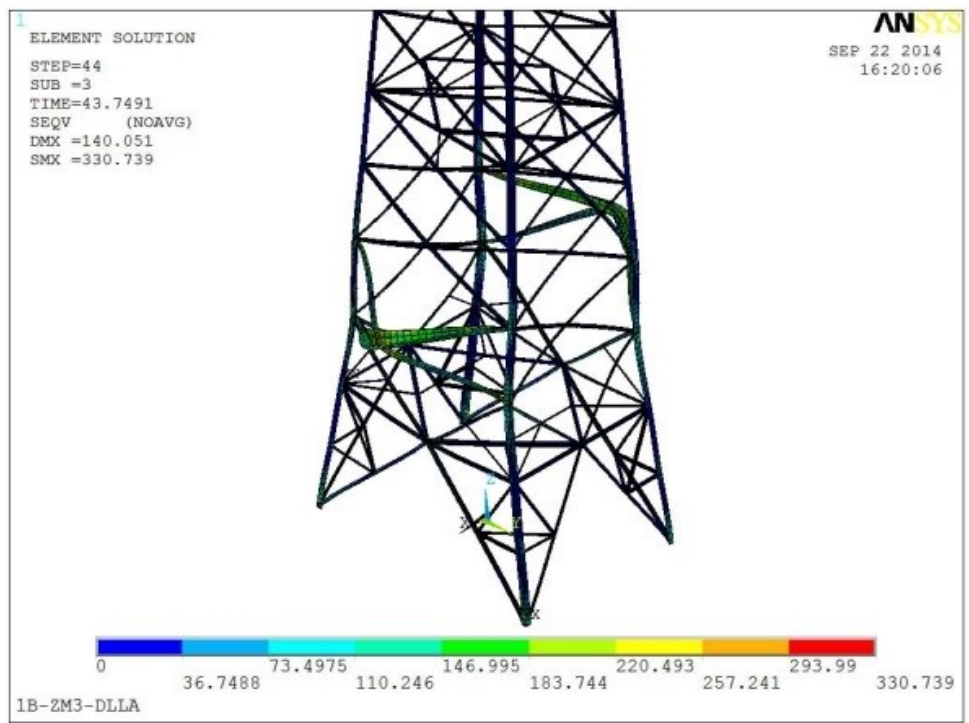
(a) The scaled test tower model

(b) The original whole tower

Fig. 3 The comparison of predicted deformed shapes between the scaled test tower model and the original whole tower (enlarged 10 times).

Fig. 3 shows the comparison of predicted deformed shapes between the scaled test tower model and the original whole tower subjected to the horizontal stretching of the supports. It can be seen that similar deformations were happened within the substructure represented by the scaled test tower model for both FE analyses. The deformation was mainly related to the out-of-plane buckling of the first cross bracing member in the plane perpendicular to the line direction. The deformations were mostly happened around the first diaphragm member. There was no significant deformation around the second diaphragm member (Fig. 2 for the members' positions).

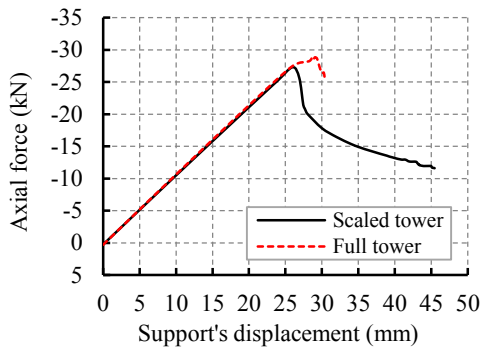
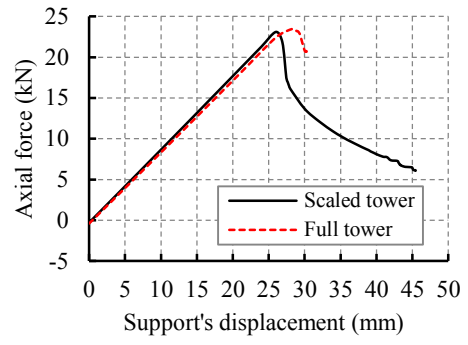
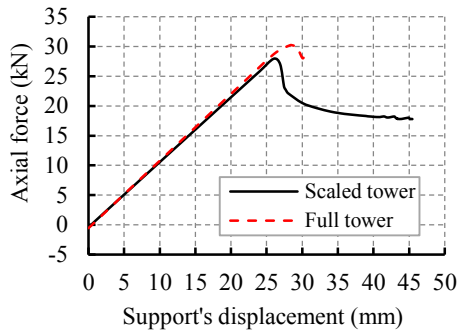
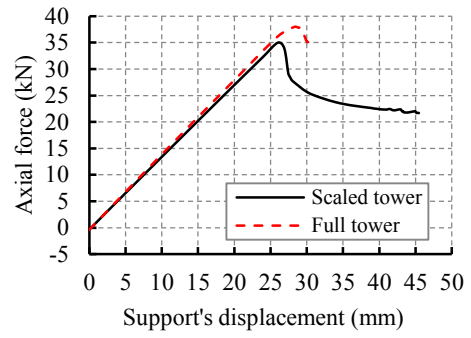
(a) The axial force of 1<sup>st</sup> cross bracing member

(b) The axial force of 2<sup>nd</sup> cross bracing member

(c) The axial force of tower leg member

(d) The axial force of single bracing member

Fig. 4 The comparisons of the axial forces of some key members for both FE analyses.

Fig. 4 shows the comparisons of the axial forces were changed with the displacements of the supports under horizontal stretching in some key members for both FE analyses. It is clear

that the curves are closed to each other, especially before descending. The maximum support displacements at the peak axial forces for both analyses were 28.00 mm and 29.73 mm, respectively, with only a difference of 5.82%. Also, the difference between the peak axial forces of both analyses was within 10%. Therefore, the structural behaviours between the scaled test tower model and the whole tower structure were very similar. Hence, the scaled test tower model can be confidently used to represent the whole tower structure in this research.

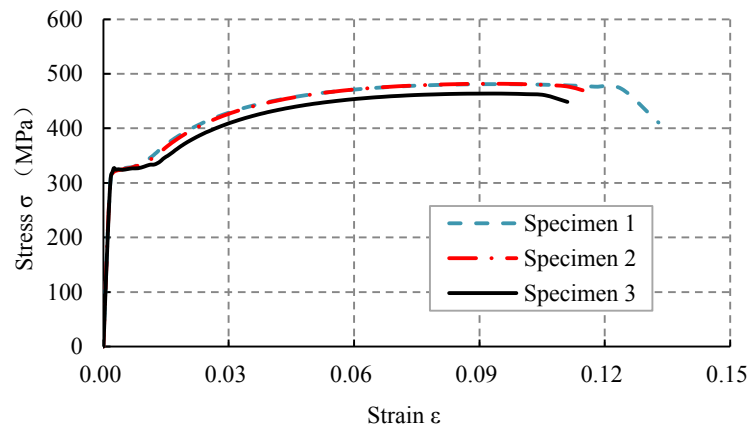
Fig. 5 Tested stress-strain curve of L40×4 angle.

The material properties of the angles used for the scaled test tower model were tested on the MTS810 system. The average tested yield strengths for hot rolled and cold worked angles were given in Table 2. Fig. 5 shows the stress-strain relationship of the typical hot rolled angle specimen of L40×4.

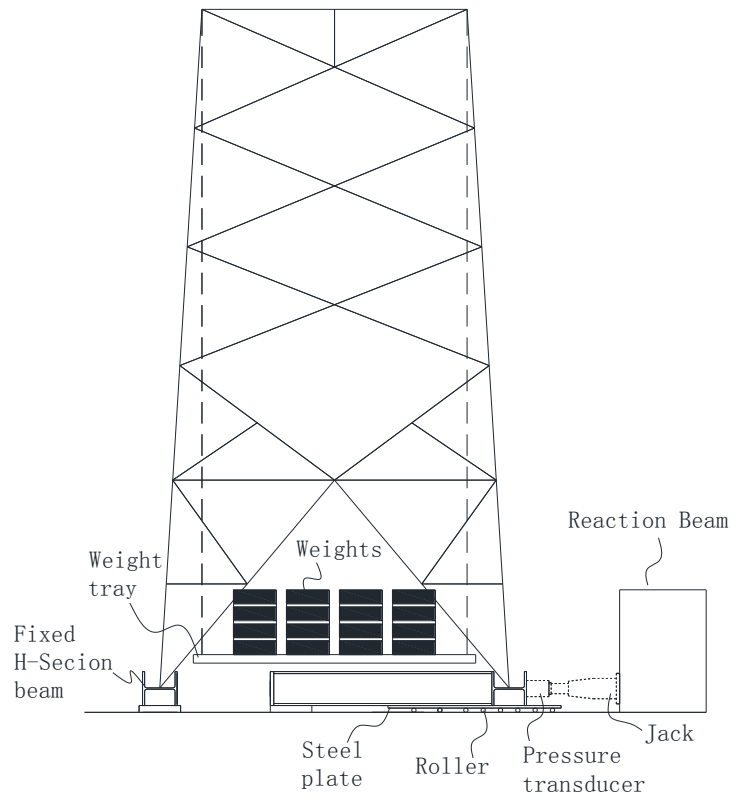
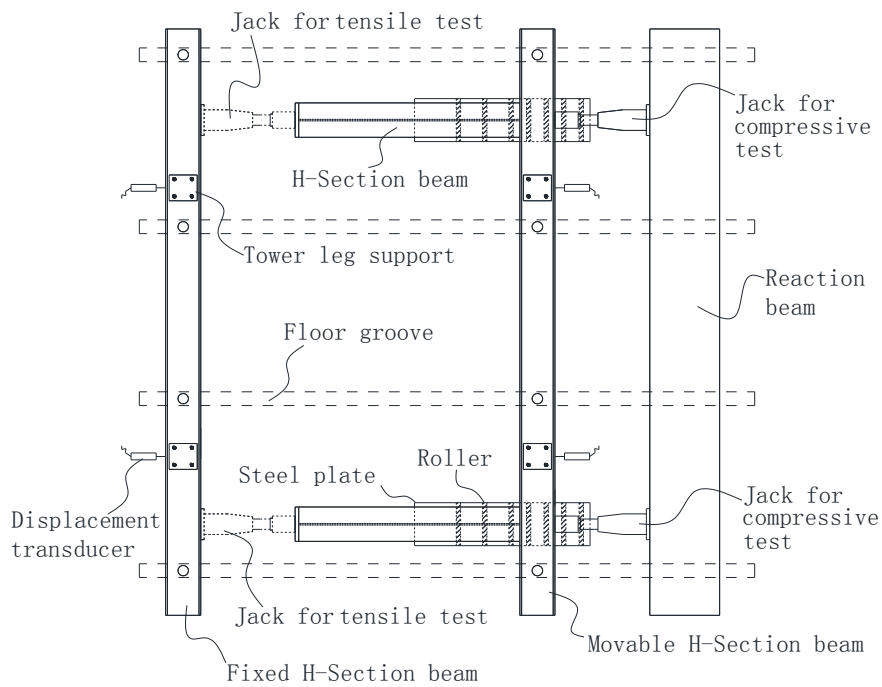
(a) Front Elevation

(b) Plan View

Fig. 6 The arrangements of the loading and horizontal support's movements along the direction perpendicular to the line.

As shown in Fig. 6(b), the horizontal motions of the supports of the scaled test tower model were generated through a special platform, made with two H-section steel beams. The four supports of the scaled test tower model were fixed on the two H-section steel beams with high strength bolts. Two jacks were mounted in between the two H-section beams ( Fig. 6(b)). The H-section beam on one side of the platform was bolted to the ground as the fixed end and another H-section beam on the other side of the platform could be moved horizontally by the jacks. Steel rollers were placed under the moving H-section beam to facilitate the horizontal tensile supports' movements of the scaled test tower model (Fig. 6(b)). As shown in Fig. 6(b), the two jacks were mounted on a large fixed reaction beam outside of the H-section frame to generate the horizontal compressive displacement loading on the supports of the scaled test tower model.

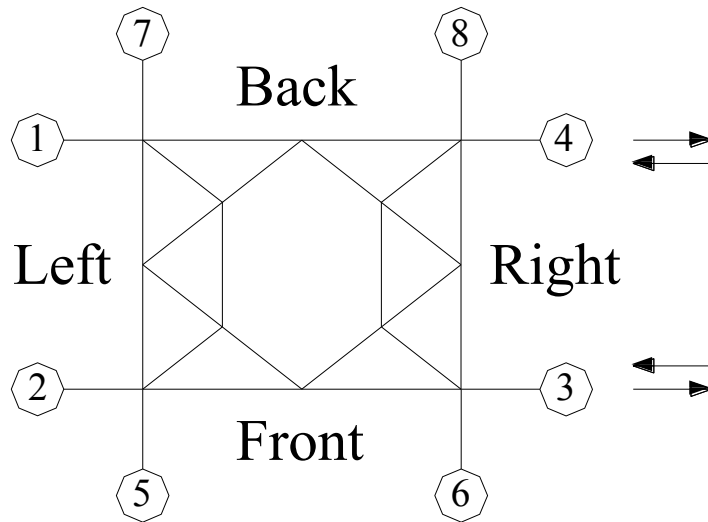
Fig. 7 Arrangement of 8 guyed displacement meters at 4 top corners of the scaled test tower model.

meters were used to measure the displacements on the top of the scaled test tower model. As shown in Fig. 7, 2 displacement meters were used at each top corner for detecting the horizontal displacements of the top corner along and perpendicular to the supports' displacement. There were total 8 DH801-750 guyed displacement meters were used at 4 top corners of the scaled test tower model. Those displacement meters were mounted on a steel pipe scaffold.

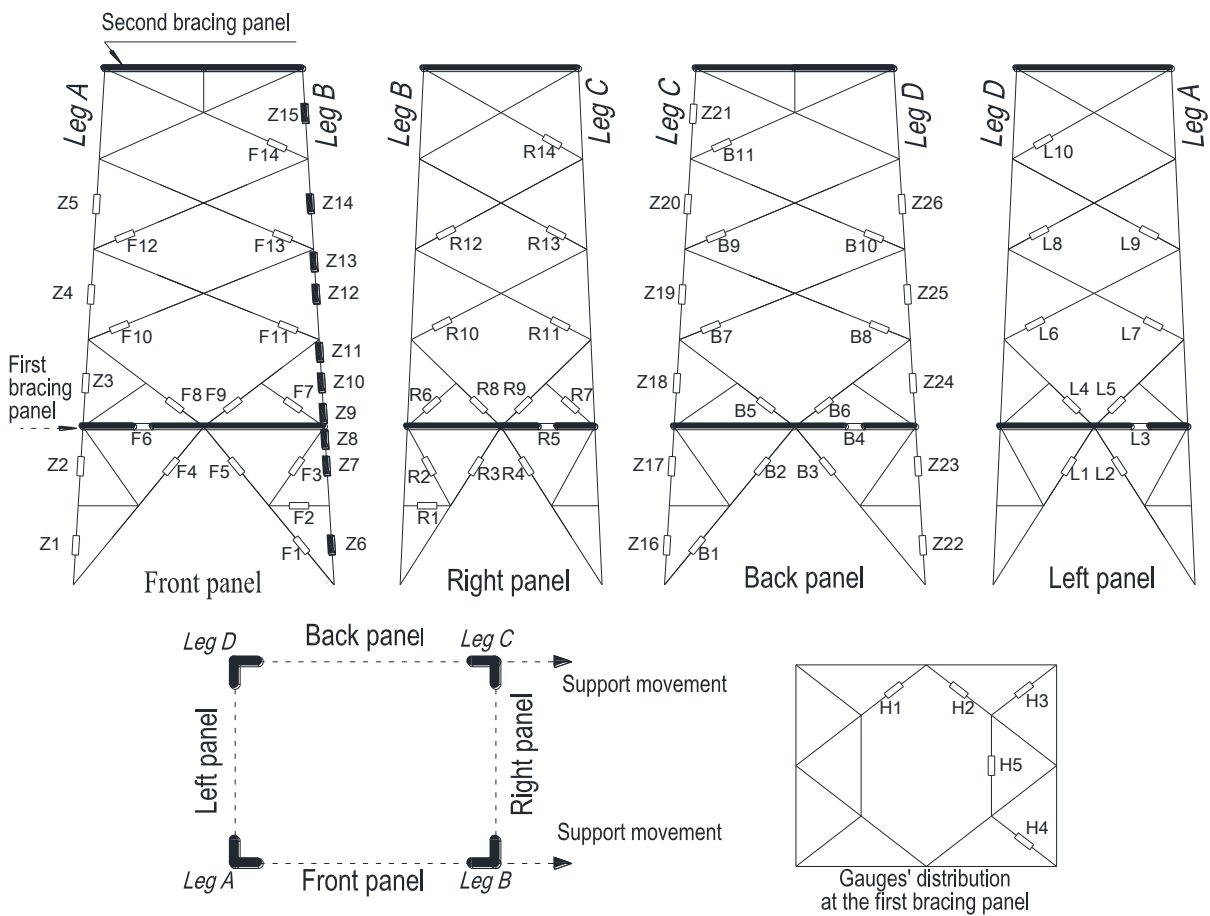
Fig. 8 The arrangement of the strain gauges in the truss members of the scaled test tower model.

In this study, BX120-3AA strain gauges were used to measure the strains in the truss members. The arrangement of the strain gauges is illustrated in Fig. 8. The black filled dots along one of the tower legs (Fig. 8) mean that there were three strains gauges fixed at that position. Two of them fixed at each end of the flanges of the angle member, and the third one fixed at the corner of the angle member, as shown in Fig. 9(a). All three strains gauges were orientated in the axial direction of the angle member. The axial force and bending moment in the tower leg can be calculated using these three strains measured. For other measuring positions only two strain gauges were used. They were attached at each external surface of the angle member and orientated in the axial direction of the angle member for measuring the axial strains, as shown in Fig. 9(b). The reaction forces of the supports were measured by the pressure sensors which were mounted on the top of the jacks (Fig. 6(a)).

As shown in Fig. 8, the strain gauge' numbers are used as the truss member's numbers here for the rest of the paper. In this test, the horizontal spacing of the supports for the scaled test tower model was gradually increased in the direction normal to the line. When this support's tensile displacement was reached to 10 mm, the first cross bracing (X-bracing) member parallel to the support displacement direction (F10 & F11 and B7 & B8, in Fig. 8) was

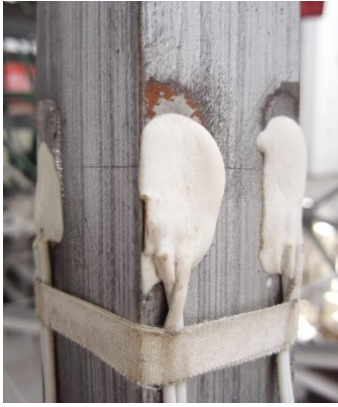
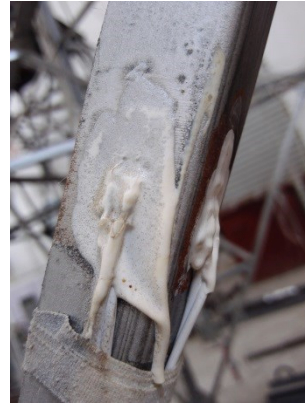
(a) Strain gauges fixed on the tower's legs

(b) Strain gauges fixed on other truss members

Fig. 9 Details of the strain gauges attached on the structural members.

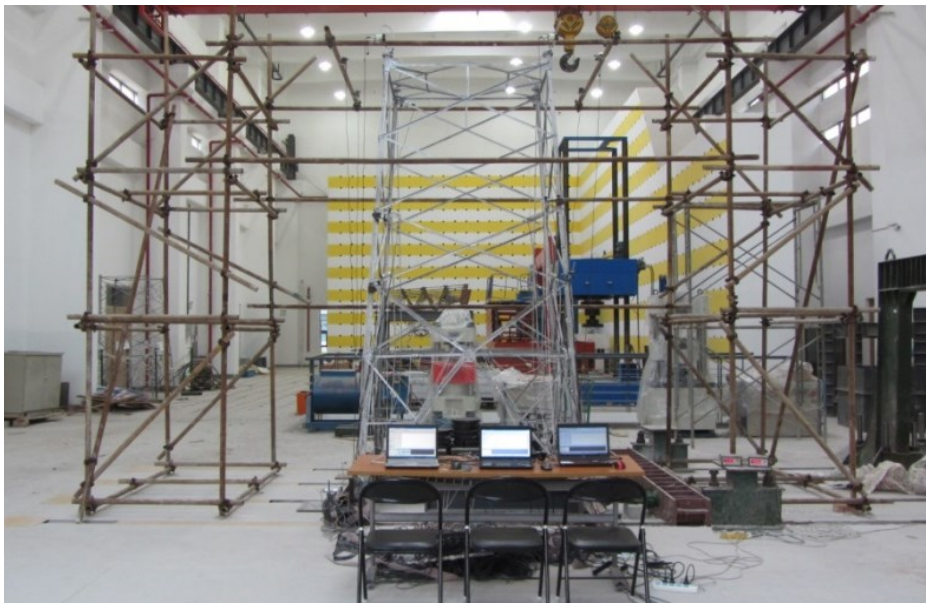
Fig. 10 Panorama view of the test.

Fig. 10 shows the panorama view of the test.

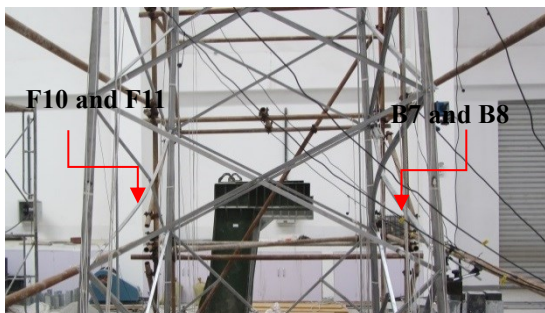
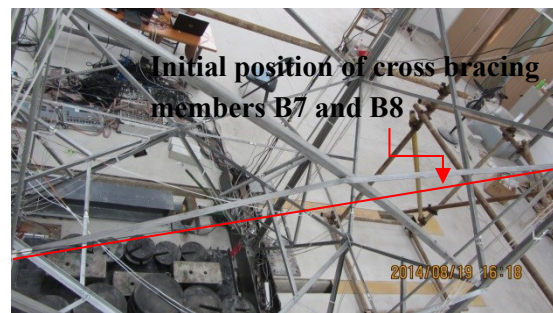
(a) Deformations of members F10, F11, B7 and B8

(b) Deformations of members B7 and B8

Fig. 11 The deformations of the first cross bracing members.

Due to the truss members of the transmission tower are mostly the members with large slenderness ratio; the main failure mode of the tower is the buckling failure of the truss members. As shown in Fig. 11, the cross bracing members F10 and F11 had significant buckling deformations. This was confirmed in Fig. 19 that the maximum compressive stresses of F10 and F11 were less than 80 MPa which was well below the yield strength (235MPa) of Q235 steel.

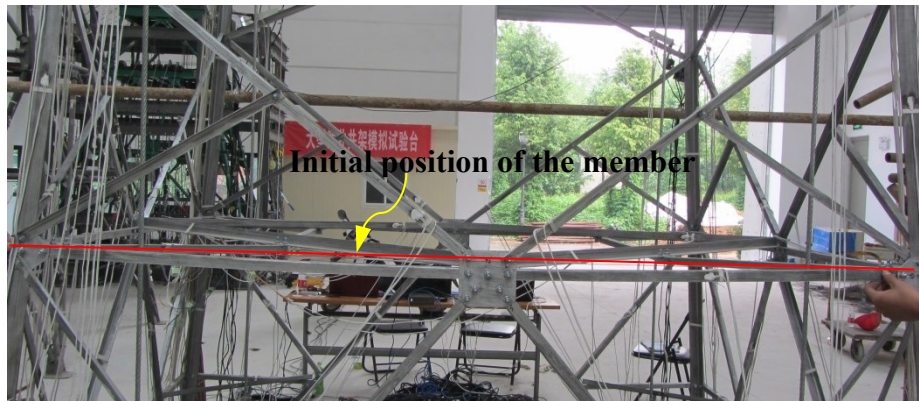
Fig. 12 The deformations of the first diaphragm members.

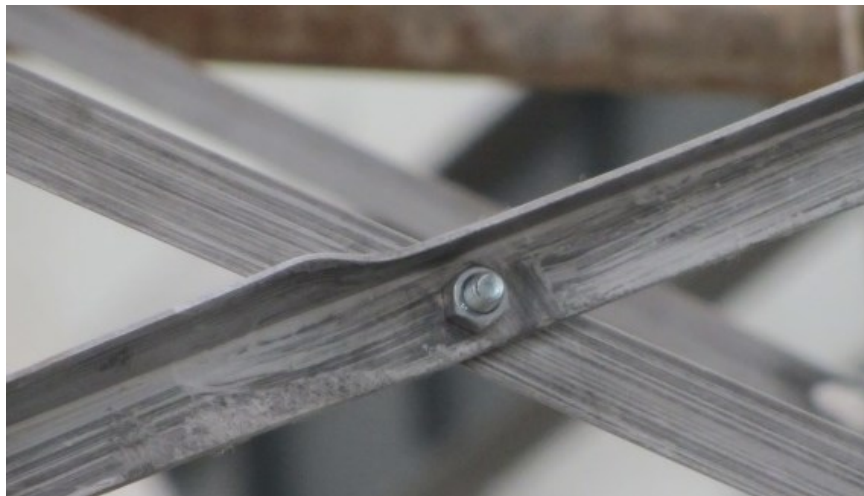
Fig. 13 Angle buckling near the center bolted connection node of the first cross bracing members.

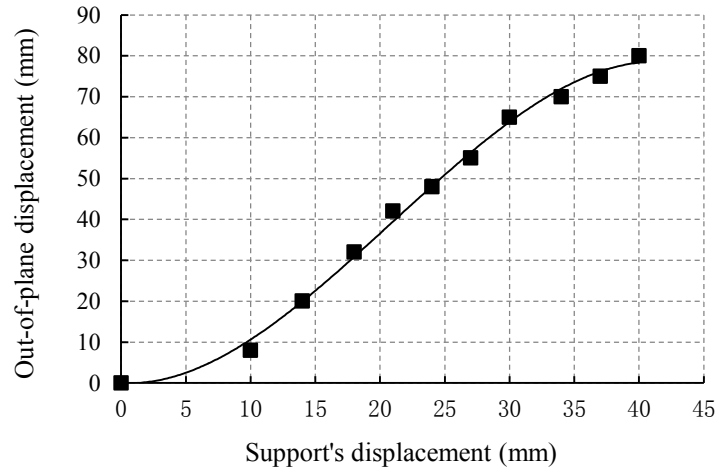
Fig. 14 The outward out-of-plane displacement at the first cross bracing joint (F10-F11) against the support's displacement.

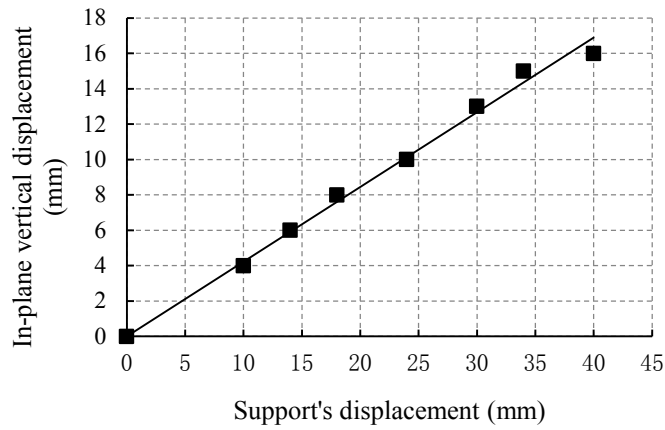
Fig. 15 The in-plane vertical displacement at the midpoint of the horizontal diaphragm member F6 against the support's displacement.

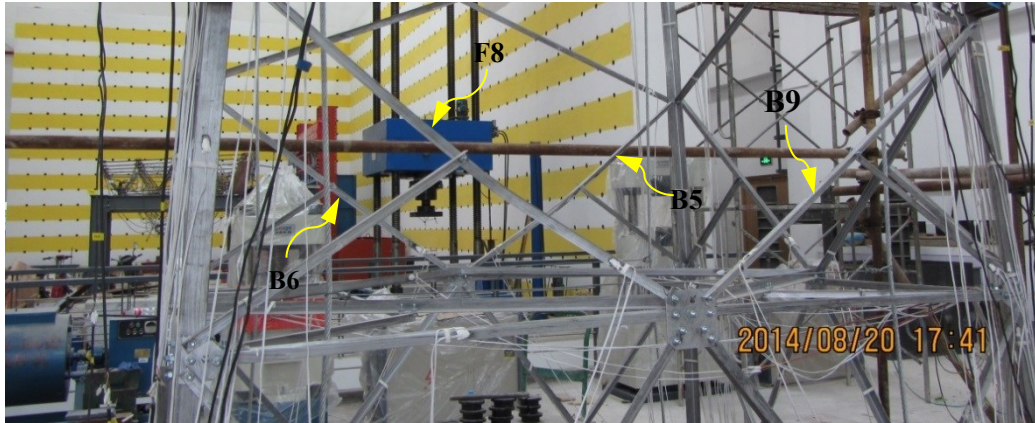
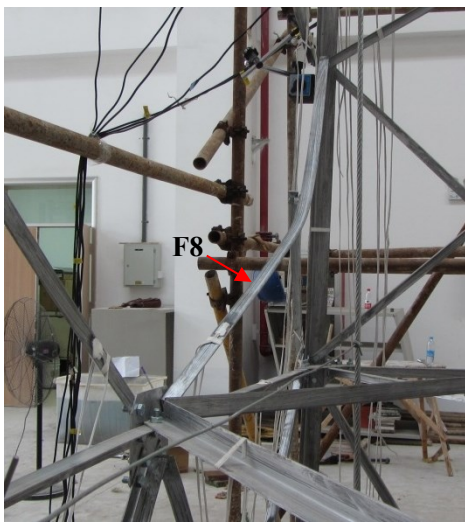
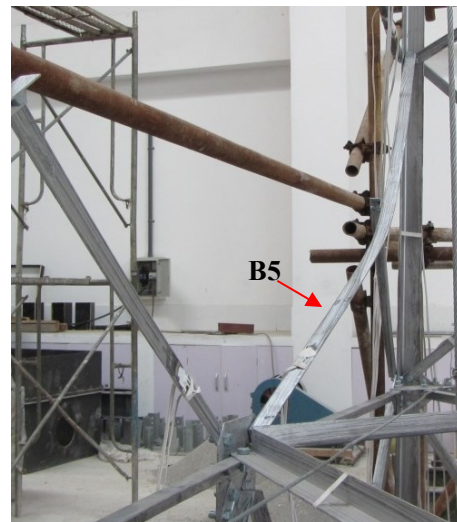
(a) Members F8, B5, B6, B9

(b) Member F8

(c) Member B5

Fig. 16 The deformations of some key truss members.

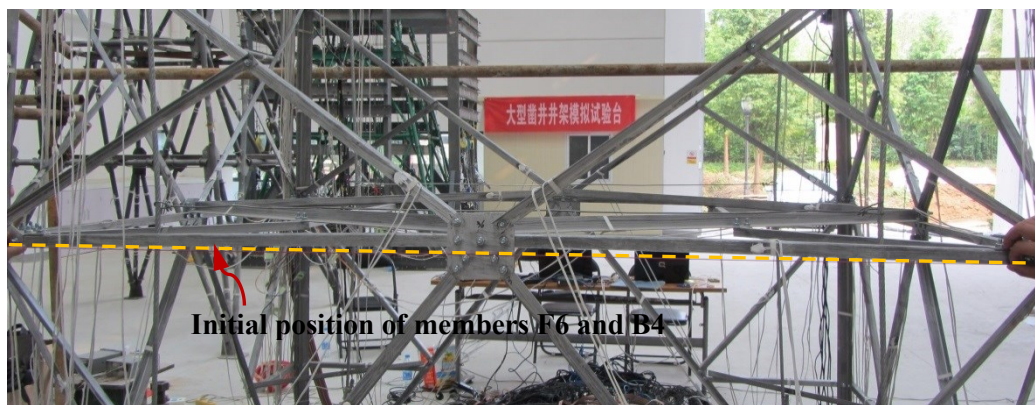
Fig. 17 The deformations of the first horizontal diaphragm members F6 and B4.

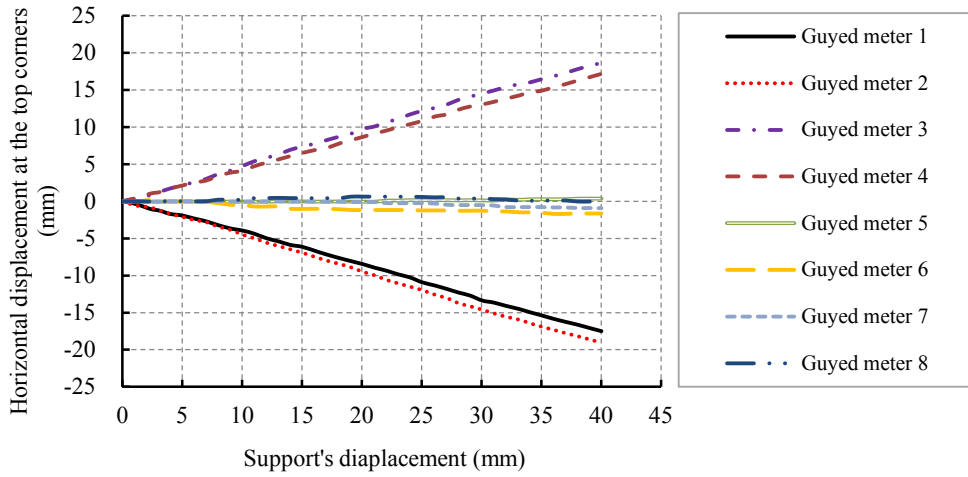
Fig. 18 The horizontal displacements at the top corners of the scaled test tower model versus the tensile support's displacements (in Fig. 7 for the positions of the guyed meters).

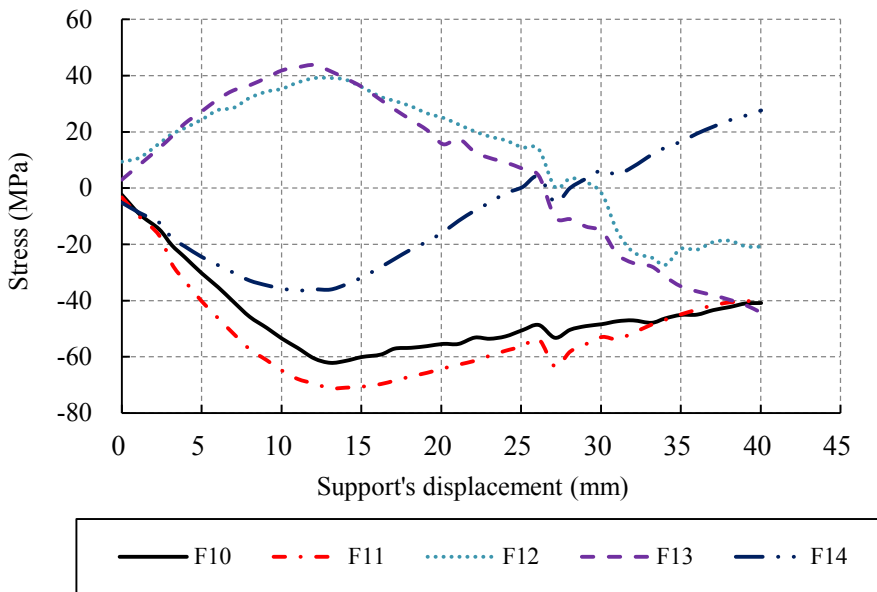
Fig. 19 The stresses of the cross bracing members versus the tensile support's displacements.

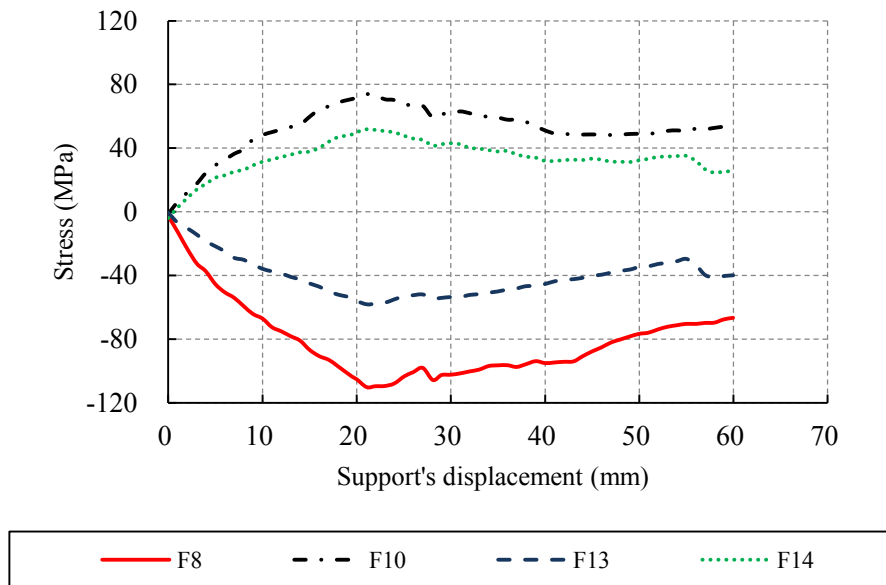
Fig. 21 The stresses of the cross bracing members versus the compressive support's displacements.

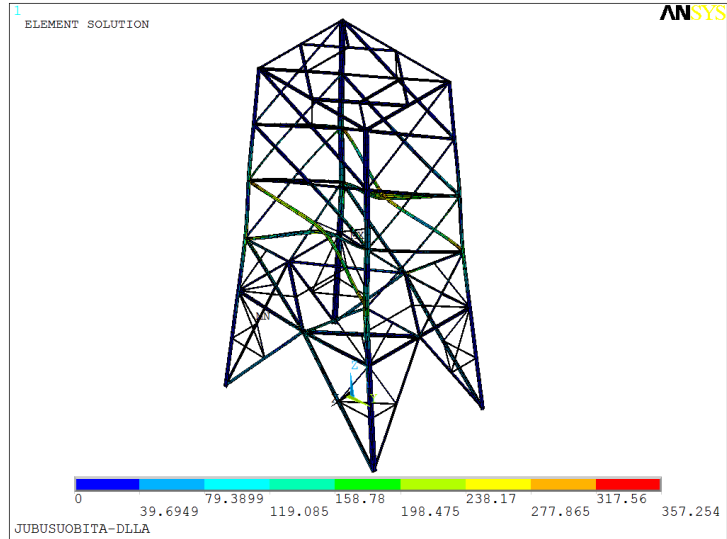
Fig. 22 The predicted deformations of the scaled test tower model (tensile test).

Fig. 22 shows the predicted deformations of the scaled test tower model. It can be seen that the largest deformation appeared within the first cross bracing (in Fig. 2 for the position) which is similar to the tested observation. Hence, in this test the predicted main failure mode of the scaled test tower model was the compressive buckling failure of the first cross bracing, which was also observed in the test.

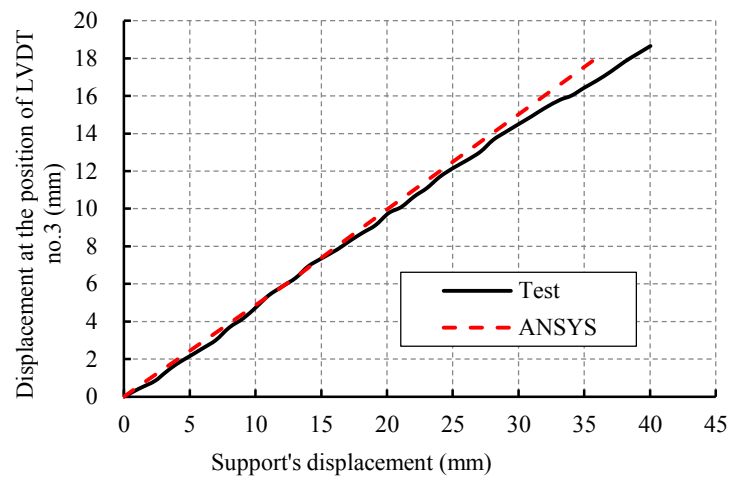
Fig. 23 The comparison of the predicted and measured displacements at the position of LVDT no. 3 (tensile test).

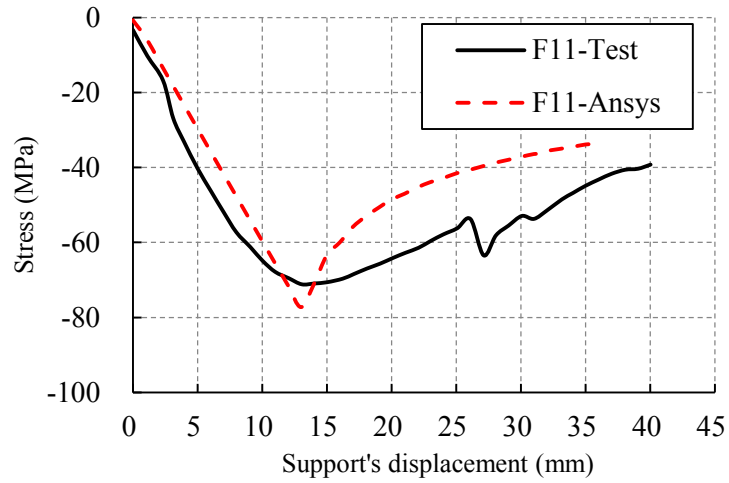
Fig. 24 The comparison of the predicted and measured stresses within the first cross bracing member F11 (tensile test).

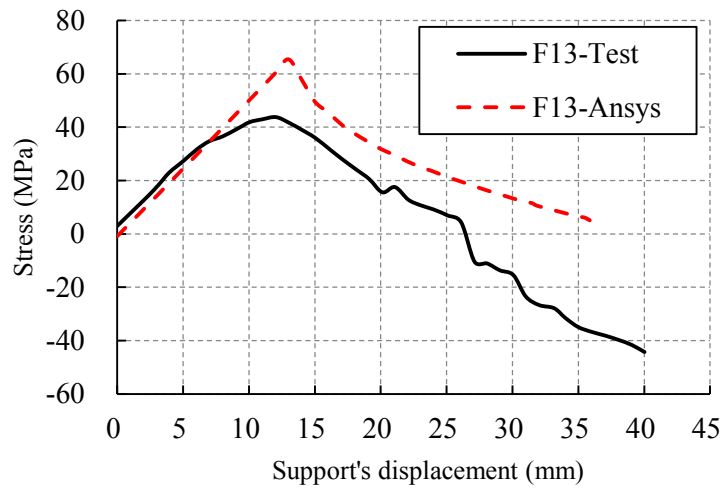
Fig. 25 The comparison of the predicted and measured stresses within the second cross bracing member F13 (tensile test).

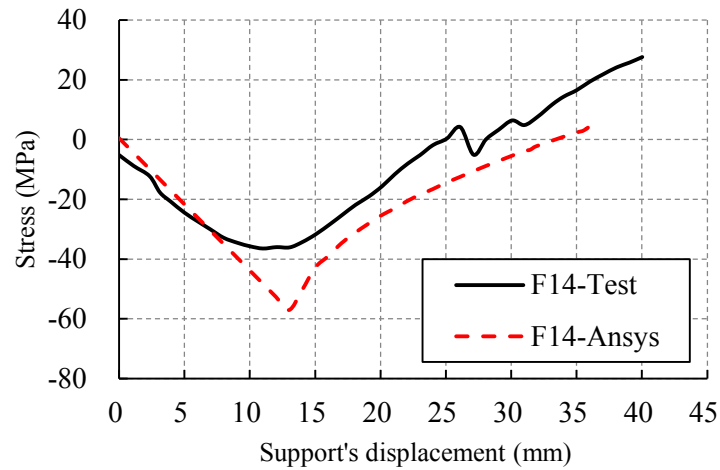
Fig. 26 The comparison of the predicted and measured stresses within the third cross bracing member F14 (tensile test).

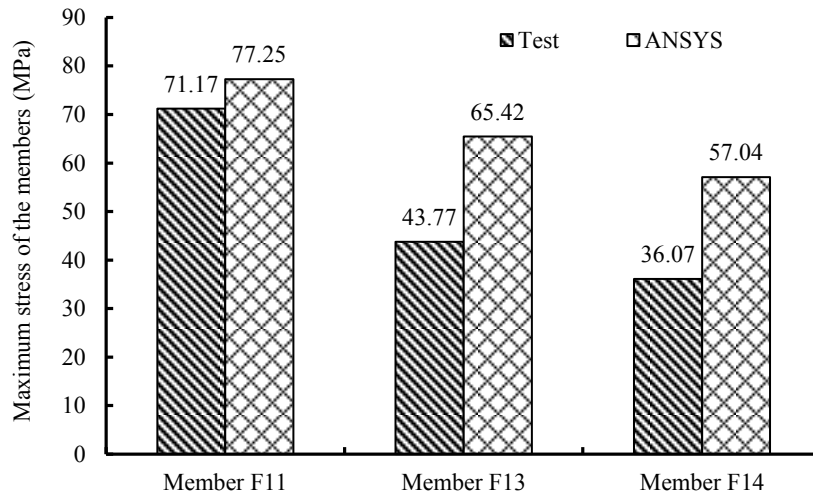
Fig. 27 The comparison of the predicted and measured maximum stresses within the cross bracing members (tensile test).

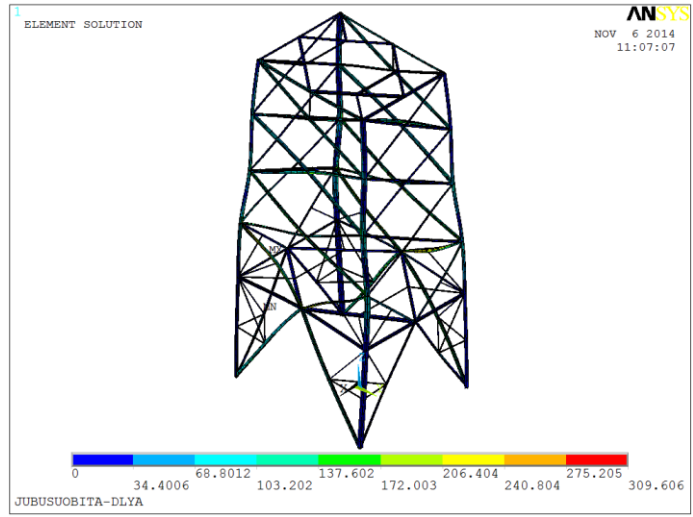
Fig. 28 The predicted deformations of the scaled test tower model (compressive test).

The predicted deformations of the scaled test tower model are shown in Fig. 28 for this test. It can be seen from the figure that the most significant deformation was appeared within the diagonal bracing member F8 above the first horizontal diaphragm (Fig. 8). The second cross bracing member was deformed slightly. The main failure mode was the compressive stability failure of the diagonal bracing member F8 along the support's displacement direction, which was the same as the test observation.

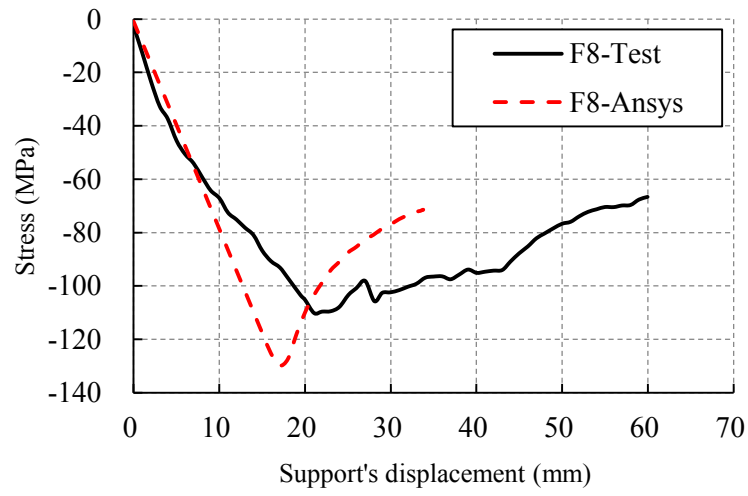
Fig. 29 The comparison of the predicted and measured stresses within the bracing member F8 (compressive test).

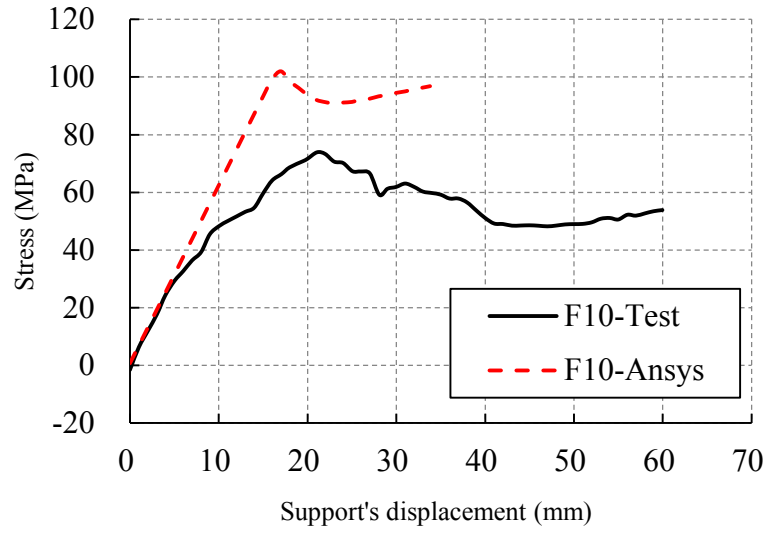
Fig. 30 The comparison of the predicted and measured stresses within the bracing member F10 (compressive test).

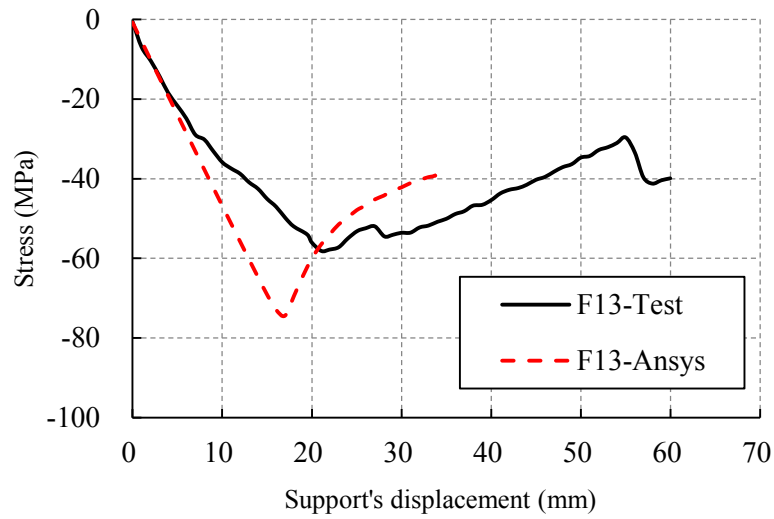
Fig. 31 The comparison of the predicted and measured stresses within the bracing member F13 (compressive test).

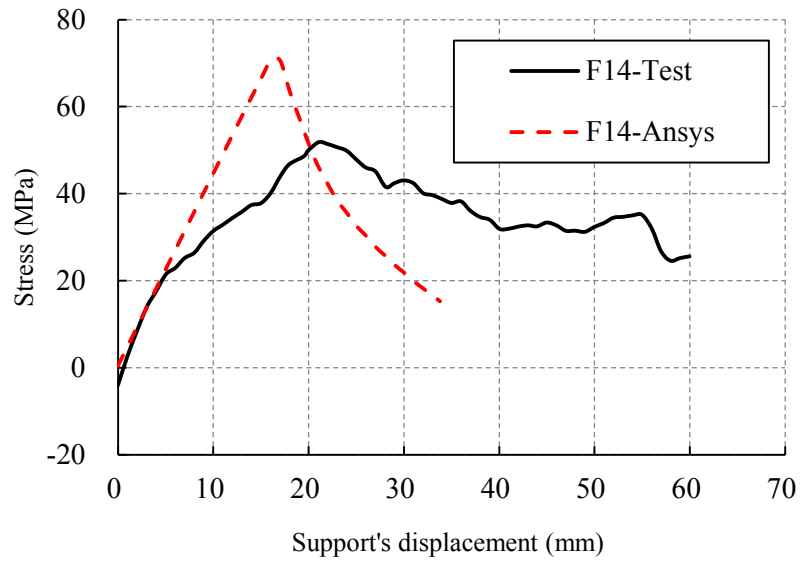
Fig. 32 The comparison of the predicted and measured stresses within the bracing member F14 (compressive test).

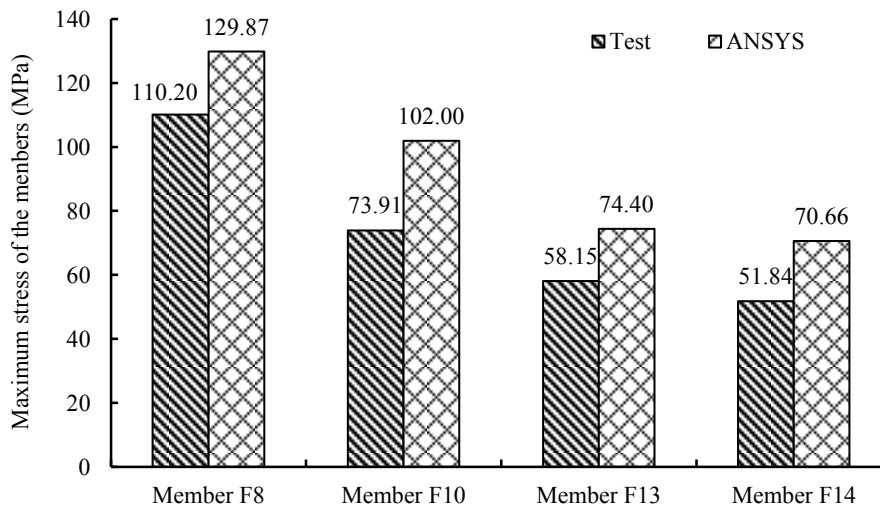
Fig. 33 The comparison of the predicted and measured maximum stresses within the cross bracing members (compressive test).
