International Journal of Automotive
Engineering and Technologies
Vol. 2, Issue 1, pp. 40 – 54, 2013

Review Article

Turbocharger Lubrication - Lubricant Behavior and Factors That Cause Turbocharger Failure

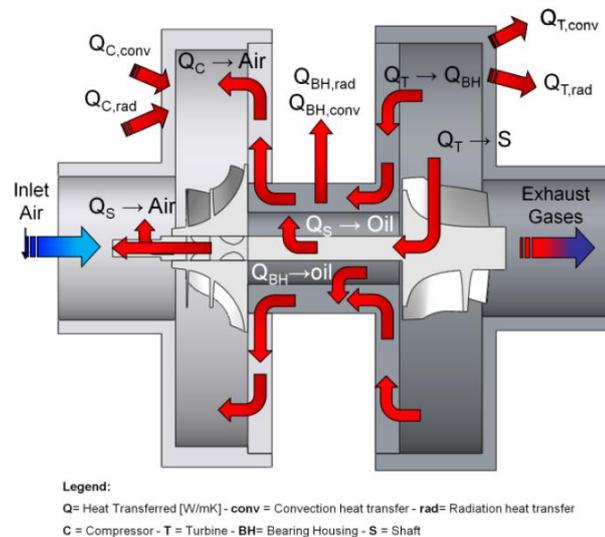
Figure 1: Reduced order heat transfer model in a turbocharger [2]

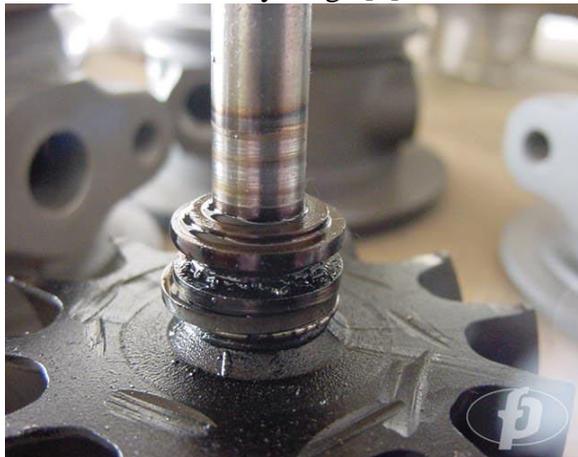
Figure 2: Charred oil residues accumulated in the piston ring region [1]

Some of the reasons responsible for oil coking are: a) the supply of oil with inadequate high temperature capability, b) excessive heat in the bearing section, c) extended oil change intervals and d) oil with a wide multiviscosity range [3].

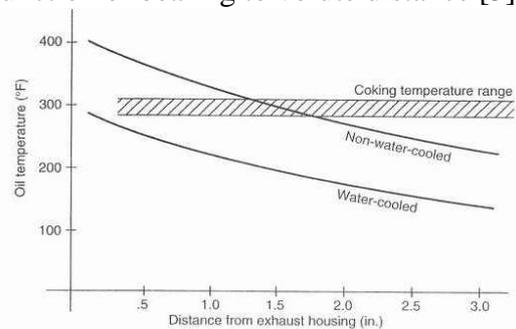
Figure 3: Lubricant temperature of a water cooled turbocharger compared to the lubricant temperature of a non water cooled turbocharger, as a function of bearing exhaust housing distance [3]

In Figure 3, the lubricant temperature of a water cooled turbocharger is compared to a lubricant-cooled turbocharger, as a function of bearing to volute distance [3].

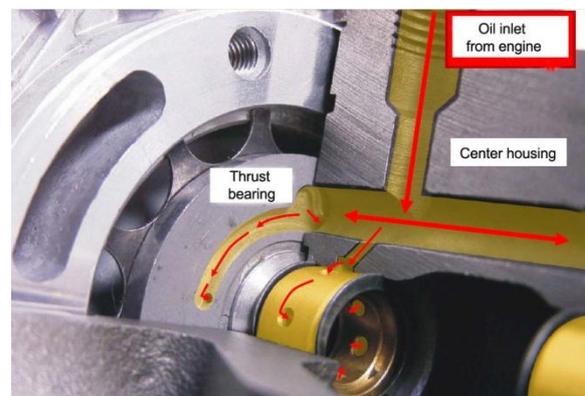
Figure 4: Lubricant flow through the thrust bearing [5]

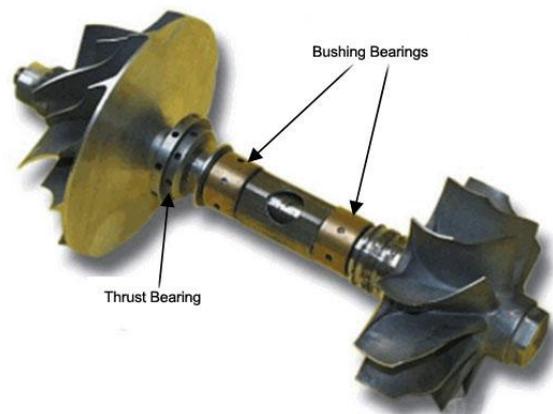
Figure 5: Turbocharger shaft support by the use of floating bushing bearings [8]

Full floating bushing bearings are not attached to the turbocharger but there is a tolerance between the bearing and the bearing housing bore surface (Figure 5). In between these two surfaces an oil film is provided by the oil supply system. The lubricant circulates between the shaft and

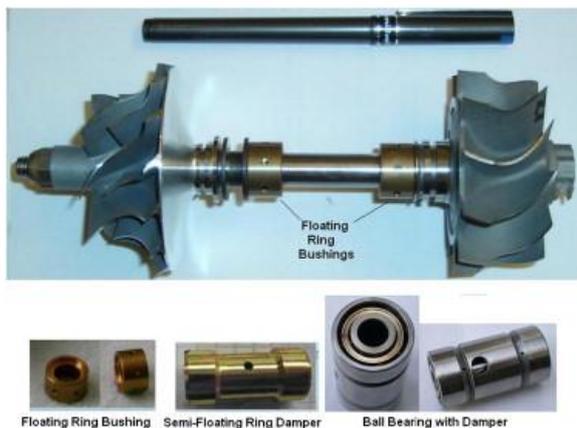
Figure 6: Different turbocharger bearing types with semi-floating dampering the middle [9]

This most recent turbocharger shaft support method relies on sliding bush bearings, and is achieved by the use of semi-floating bushing bearings (Figure 6). These bearings are attached to the bearing housing and their rotation as well as their axial

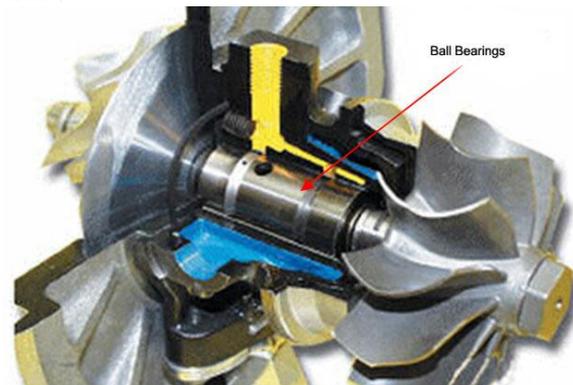
Figure 7: Ball Bearing Turbocharger [10]

The use of ball bearings (angular contact ball bearings) in vehicles turbochargers in recent years (Figure 7) is due to the fact that they provide significant advantages over the floating bush bearings. In particular ball bearings provide: a) a lower friction coefficient, b) smaller (oil) tolerances, and c) less oil consumption (because low friction reduces the required amount of oil).

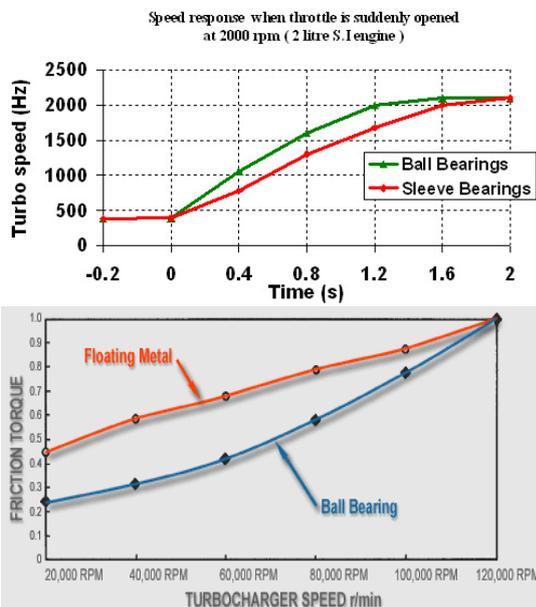
Figure 8. a) spool-up time of a ball bearing turbocharger compared to the spool-up time of a bushing bearing turbocharger [11]
 b) The friction torque of a ball bearing turbocharger is compared to the friction torque of a floating bushing bearing turbocharger [12]

In Figure 8, a ball bearing turbocharger is compared to a floating bush bearing turbocharger. In particular in Figure 8a, the spool-up time of a ball bearing turbocharger is compared to the spool-up time of a floating bush bearings turbocharger, as a response to a wide open throttle command. In Figure 8b, the friction torque of a ball bearing turbocharger is compared to the friction torque of a floating

bush bearings turbocharger, as a function of the turbocharger shaft rotating speed. As indicated, in both cases the ball bearings turbocharger exhibits superior performance.

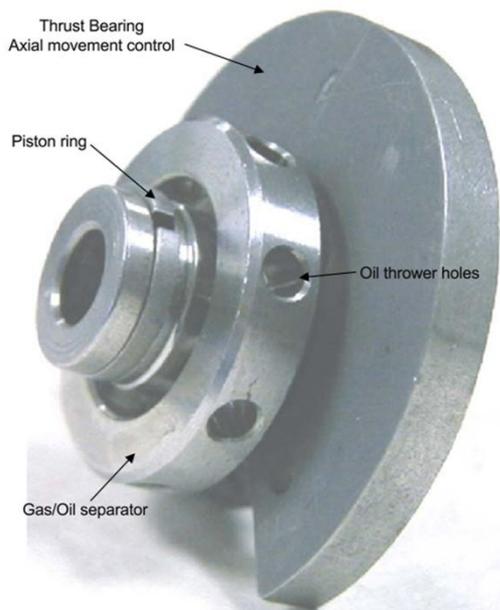
Figure 9: Thrust bearing with a gas/oil separator mechanism [5]

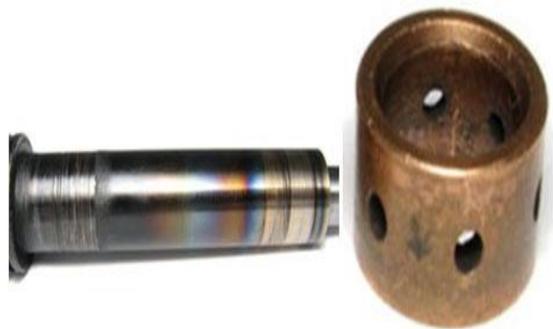
Figure 10. Shaft and bearing wear caused by the lack of lubrication. Shaft discoloring (bluing) is noticeable [13].

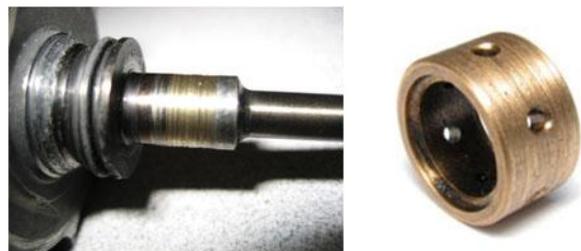
Figure 11: Shaft and bearing wear caused by contaminated oil [14]

The existence of foreign objects or dirt in the lubricating circuit (contaminated oil) can cause turbocharger wear or failure. These particles drift with and follow the same path as the lubricant flow, increasing in this way the danger to enter or be trapped (if they are small enough) within the inner and outer clearances of the shaft bearings. In such a case, they can cause both bearing and shaft surface engraving wear (Figure 10).

Engraving equals with an increase of either the inner or the outer shaft-bearing clearances, and leads to oil film disorder resulting, consequently, in the increase of shaft vibrations. As a consequence of this increase in vibrations, turbocharger efficiency and its longevity are reduced. In the case that particles are large enough, they can block the internal oil passages, as well as the circumferential holes of the bearings, causing a reduction or interruption of the oil flow through the shaft-bearing clearances. All these can result in an excessive increase of temperature in the bearing housing which can initially lead to melting of the operating parts and thereafter to their welding and eventual turbocharger failure [4].

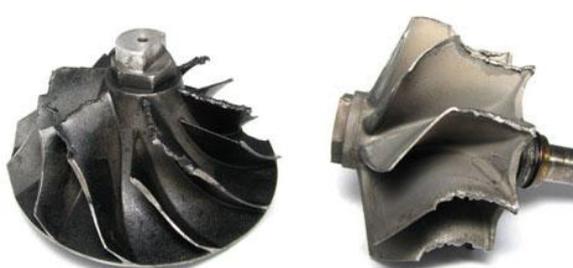
Figure 12: Foreign object damage [13].

inappropriate filter type) while the turbocharger is in operation, it causes damage to the compressor blades (Figure 11). When the object has a significant size, in particular, it causes bending of the compressor blades (mainly at the leading edges) or their fracture. This is more pronounced when the object is of sufficient hardness and while the turbocharger is operating at high speed. In the case that these small particles enter the engine cylinders after travelling down the exit of the compressor through the intake manifold, they can cause serious damage to the moving parts inside the cylinders.

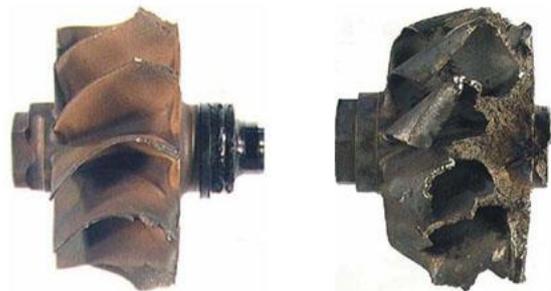
Figure 13: (Left) Turbine blade wear due to overspeeding. (Right) Turbine wheel burst due to overspeeding [15].

combination (comparatively too small turbocharger) in order to reduce turbocharger lag or due to turbocharger aftermarket tuning requirements. Turbocharger overspeeding may lead to turbocharger failure and for this reason it is analysed in this section. The effect of overspeeding is the partial or total wear of the bearing system as well as the distortion of the turbine wheel [4]. Moreover, overspeeding can cause loss of a portion of the turbine blades due to the excessively high centrifugal stresses incurred during such an event (Figure 12). Regarding the damage to the bearing system, it is caused by oil coking as a result of the high temperature build-up in this area, due to overspeeding [15].

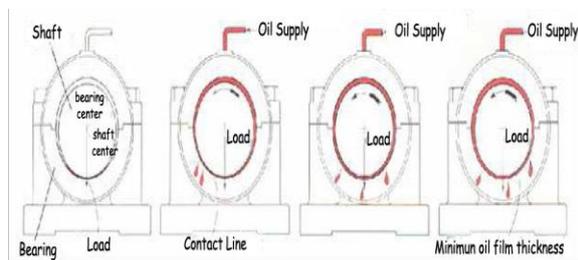
Figure 14: Hydrodynamic Lubrication Process Stages [18].

rotation, causing a reduction of the clearance between them (compared to the clearance of the rest of the circumferential area). The convergence of the two surfaces forces the oil to move into the confined space, creating a lubricant wedge. Within the converging film region, the oil film thickness approaches its minimum value, while the oil pressure rises towards its peak. The partial contact between the two surfaces stops occurring, when a specific rotational speed (called the critical speed) of the shaft is achieved. In this case a full liquid contact (hydrodynamic lubrication) takes place as the oil film increases its load-carrying capacity [18].

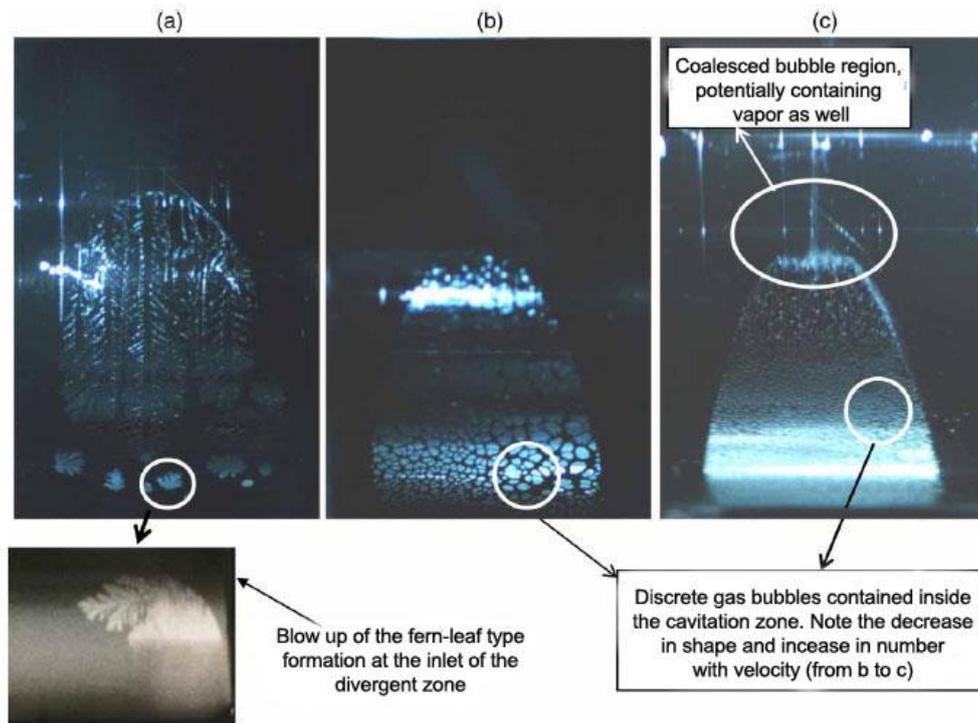
Figure 15: Lubricant cavitation zones [20].

In the divergent region of the bearing, the thickness of the oil film increases locally compared to its pressure which drops to ambient or even lower levels. When a significant drop of pressure occurs, lubricant cavitation takes place (Figure 14) [19]. Cavitation is connected with the existence of dissolved gases (air or minute dirt particles) within the lubricant, which are responsible for oil flow separation when the appropriate conditions are present. These dissolved gases either co-exist in the oil mass or are external to it and cavitation is formed because of the negative pressures that sometimes occur (for instance air sucked in to the oil mass) [20]. When oil pressure drops to its vapor pressure point, in particular and in combination with the oil operating temperature rising at the same time, an amount of oil is evaporated. The evaporation of oil generates vapor bubbles trapped in the oil flow, which are subjected to tensile stresses, as well as to high pressure, until their sudden collapse onto the surfaces (vaporous cavitation). Moreover, when the oil pressure becomes lower than the dissolved gas saturation point, air bubbles are generated into the lubricant and cause oil rupture (gaseous cavitation). Gaseous cavitation is more intense when bearings with open ends are used, and an amount of air is sucked into the oil film flow because of the sub-atmospheric pressure occurring in that region. The air bubbles

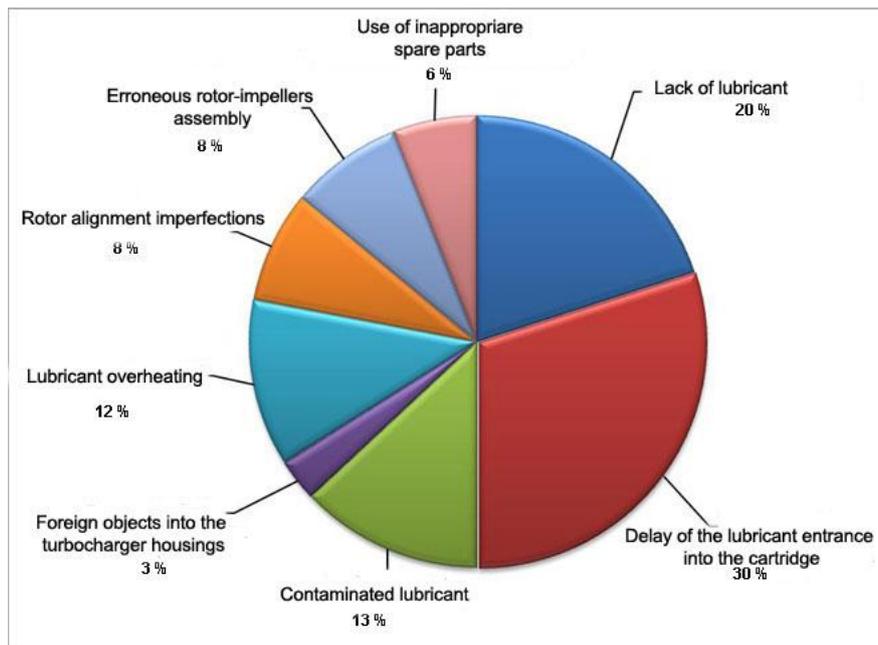
Figure 16: Percentage attribution of the turbochargers failure causes.

In Figure 15 the attribution of causes responsible for turbocharger damage and failure is provided [1]. The values of these statistics and their significance may vary from country to country, depending on the climate – environmental conditions that the turbocharger has to operate in, as well as the type of operational use made from the individual users.

As is shown in Figure 15, 50% of turbocharger failures is related to their lubrication (30% is attributed to the delay of lubricant entrance into the turbocharger and 20% is attributed to the lack of sufficient lubrication). As has been already mentioned in Section 4.1, the delayed or interrupted oil flow through the turbocharger, in combination with the increase in both shaft speed and its load, results in the dry contact of surfaces and consequently, their wear.

Two other causes which lead to turbocharger failures, are (in connection to those previously mentioned): a) lubricant overheating which corresponds to 12% of failures, and b) contaminated lubricant or existence, in general, of dirt particles into the lubricant circuit, which correspond to 13% of failures. Any delay in the feeding of lubricant flow through the bearing clearances means that the amount of oil which already exists into this region, is subject to higher thermal loads (heat transferred by the exhaust gas and heat generated through friction which is not dissipated by sufficient levels of oil flow). These thermal loads cause oil overheating and changes of its viscosity, increasing in this way the danger of oil coking. The phenomenon of oil contamination (except for the causes which are responsible for its creation) becomes more intense as a result of the presence of charred oil residues. These two factors are responsible for 25% of turbochargers failures.

Foreign objects into the turbocharger housings contribute to 3% of all turbochargers failures. The rest of the causes that contribute to turbochargers failure such

as: alignment imperfections (8 %), incorrect rotor-impeller assembly (8 %) and the use of inappropriate spare parts (6%), are attributed to the human error.
