Construction and performance of the Karkheh dam complementary cut-off wall: an innovative engineering solution

Mohammad Heidarzadeh¹ · Ali A. Mirghasemi² · Habib Niroomand³ · Faramarz Eslamin³

Keywords Earth dam · Water tightening system · Cut-off wall · Plastic concrete · BC-40 trench-cutter

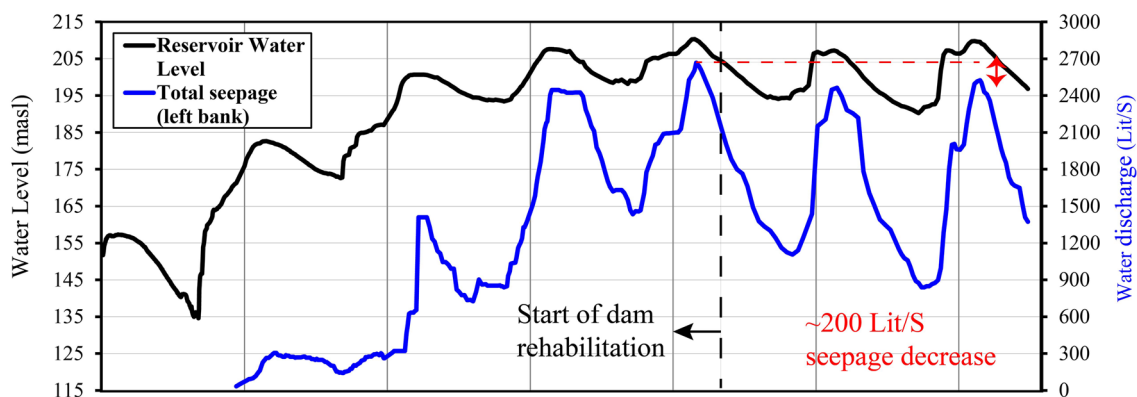
(a) Left bank

(b) Right bank

Fig. 3 Seepage through the Karkheh dam's left and right banks. The start time of the dam rehabilitation and the effect of remedial works on seepage control are shown in this figure

was observed through the dam foundation and abutments (Fig. 3). Figure 3 shows that the total seepage volumes through the left and right banks of the dam were 2700 and 1900 Lit/S, respectively, at the maximum water level of 210.5 masl. The high hydraulic gradient values were also a significant concern as they were around 0.2 at some parts of the dam. Such unexpected excessive water seepage was attributed mostly to the inaccurate estimate of the dam foundation permeability coefficient [8].

0+850, 10 m water elevation reduction was observed at the piezometers installed downstream of the new cut-off wall, between mud (+2) and mud (+3). Additionally, the hydraulic gradient was reduced from 0.154 to 0.13 between mud (+2) and mud (+4). The total water seepage was reduced around 200 Lit/S (Fig. 3). The piezometers installed at the opposite side of the HPP wall, P1 (US) and P1 (DS) in Fig. 8a, showed ~20 m of water level decrease after the construction of new cat-off wall 3. Figure 8b reveals a significant decrease in water seepage through the left bank following the construction of this new wall (segments 1 and 2).

around half of this wall, the seepage amount at the right bank is reduced about 25% (300 Lit/S, Fig. 3), and the hydraulic gradient was reduced from 0.2 to 0.095. Figure 9 shows that the piezometers installed at the downstream of the complementary wall, P2 (DS) and P3 (DS) in Fig. 9, have flat water levels which indicate these observation wells receive no seepage from the dam’s reservoir. In other words, the downstream side of the wall is almost dry.

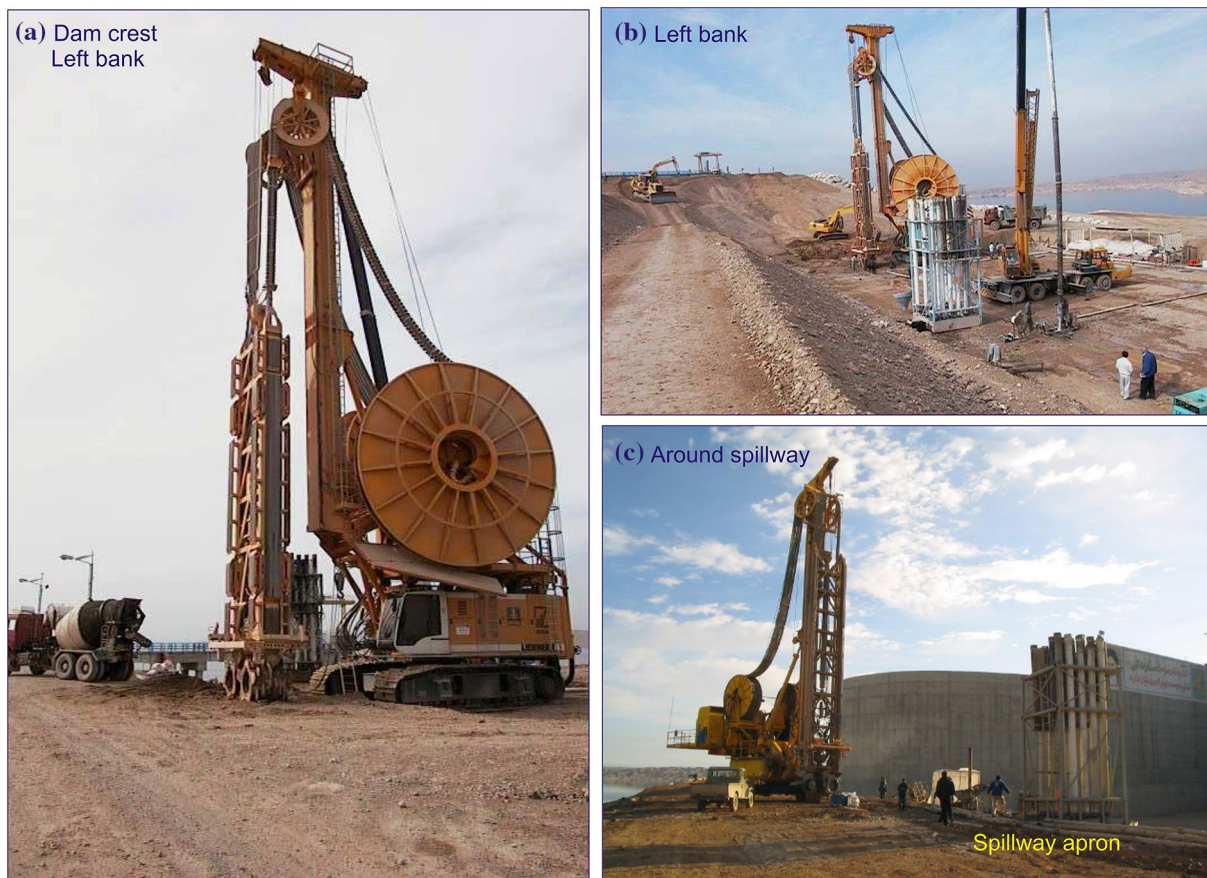
Fig. 4 The BC-40 trench-cutter working at various part of the Karkheh dam during the construction of the complementary cutoff wall

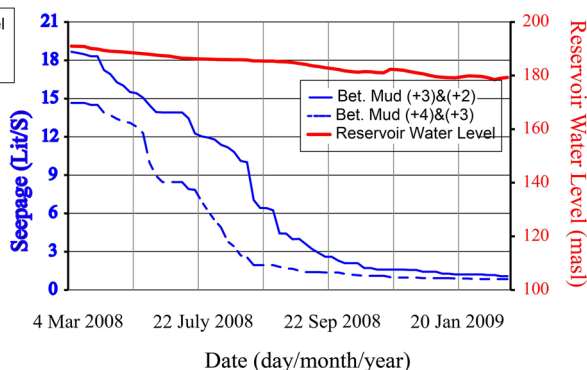
(a) Effect of the new wall on the peizometric water level

(b) Effect on the seepage control

Fig. 8 Effects of the construction of the new cut-off wall segments 1 (left bank) and 2 (around HPP) on the seepage control
