Study on the wear resistance of laser cladding iron-based alloy by heat treatment

Abstract

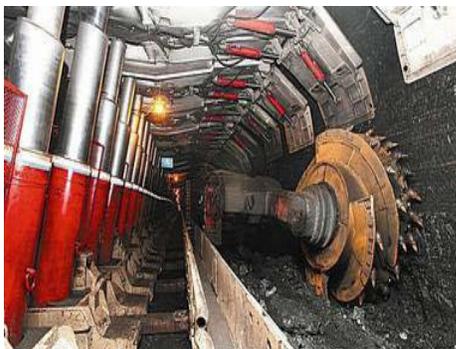
Figure1. Coal mine hydraulic support

The surface of the column is corroded and worn on account of the severe underground environment and the high strength working mode of the hydraulic support. In this study, 27SiMn steel is the column base material of mining hydraulic support which is selected as the substrate material of laser cladding. Its chemical component is shown in Table 1. According to the failure form of the column, the iron-based alloy powder was selected as the cladding layer material. Its chemical component content in the following Table 2, Cr of 15-17%, Mn of 0.3-0.7% and B of 0.5-1.1%, respectively, which will significantly improve the hardness of the material, in which the content of Cr more than 12%, there are good high temperature anti-oxidation and oxidation resistance in steel. Besides, the contents of Si and Ni are 1.0-1.5% and 3.5-4.0%, which improve the corrosion resistance of the material. Therefore, the composition of the iron-based alloy satisfy the experimental requirements by analyzing the content of the components.

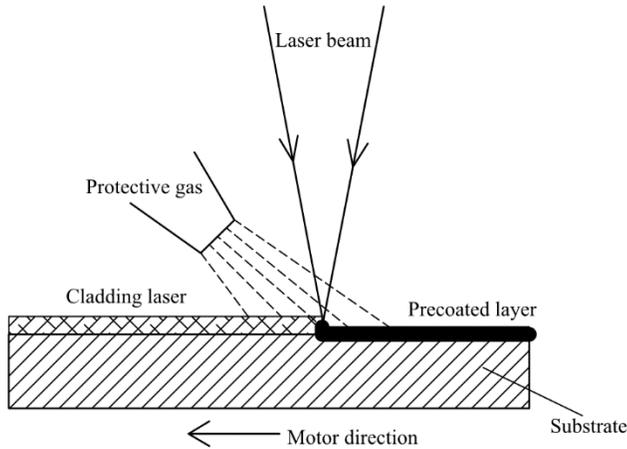
Figure 2. Schematic representations of laser cladding welding setup

employed in this research to coat the iron-based alloy powder onto the substrate which is shown in Figure 2. The shielding gas helps to prevent the oxidation within the weld set up and procedure. This fusion welding process achieves coalescence via high energy concentrated coherent light beam which is focused on the joint of weld as illustrated in the schematic setup.

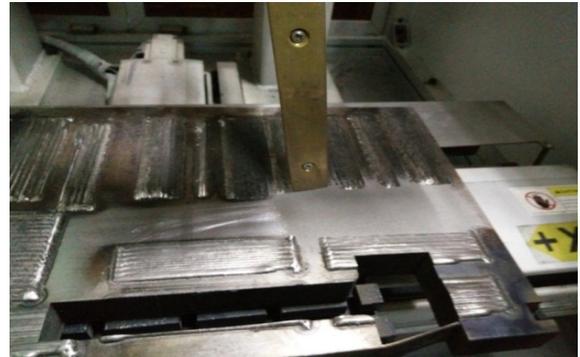
Figure 3. Laying power

First of all, adopting the method of preset powder, putting the iron-based alloy powder spread to the substrate, as shown in Figure 3. Secondly, laser positioning that has been carried out in Figure 4 was the visual aiding in positioning the alloy onto the substrate in order to carry out the welding – Laser cladding.

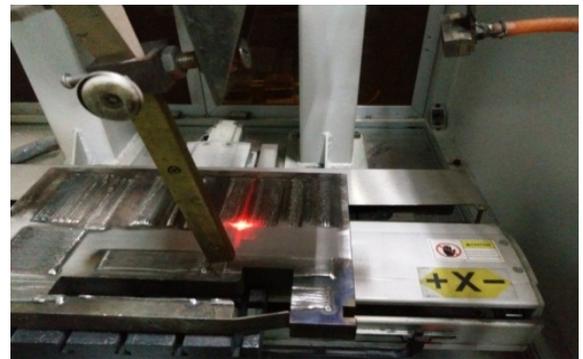
Figure 4. Laser positioning

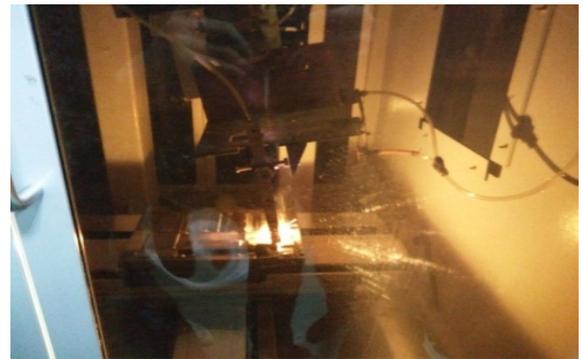
Figure 5. Laser sintering

Thirdly, sintering powder material on the surface was bonded together with substrate by using a semiconductor laser light source to be a robust structure as shown in Figure 5.

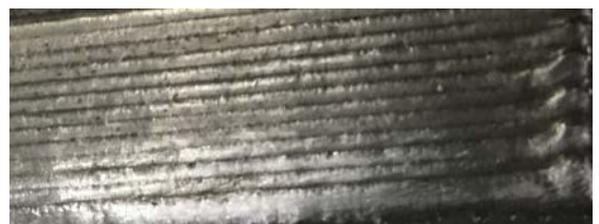
Figure 6. Cladding specimen

Finally, the clad specimen was displayed in Figure 6, which reveals the cladding of the alloy to the substrate material.

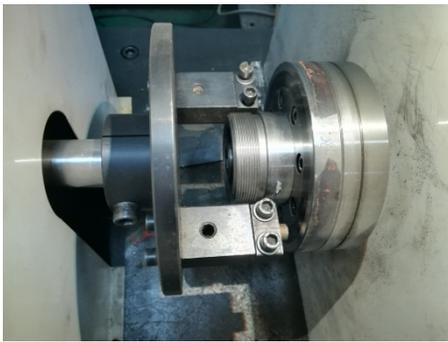
Figure 7. The friction and wear equipment

The test method was the friction and wear experiment which was carried to observe the wear appearances of samples under dry friction condition. The friction and wear equipment was shown in Figure 7. The samples were cut into a standard cylindrical specimen with a diameter of 10mm and a length of 12.5mm by a wire cutter, and the test parameters of the friction and wear machine were set in Table 4. The load was 150N, the rotation speed was 2000r / min, and the time was 5min for the dry friction and wear test .

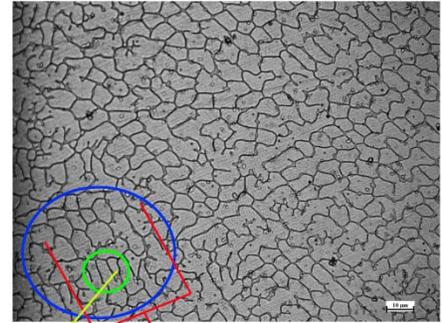
Grain in between two finger-like grains~6µm long and 3µm wide
Five finger-like grains~10-20µm long and 7-9.5µm wide

Figure 8(a). Microstructure of non-heat treatment

It is observed that the average grain size range for non-heat treatment scheme from 6µm to 20µm in length on the basis of the microscopic imaging. Besides, it will be further proved from close examination of some interesting features in the located within the microstructure.

A five fingerlike structure located at the lower left part of the microstructure further verifies the findings with dimensions tabulated in Table 5 below. The length for the first fingerlike grain measures 10.2µm whereas the width is 9.8µm, likewise the length for the second fingerlike grain is estimated at 10.5µm and width at 7µm measures. The third fingerlike grain is evaluated at a given dimension of 10µm having a width of 9.5µm, this is

followed by the fourth having a dimension of 20 μm and a width of 8 μm whereas the fifth finger is calculated at 10.5 μm and a width of 7.5 μm respectively. The area of interest is encircled in blue in Figure 8(a) accordingly, an enlarged version of this area is displayed in Figure 8(b).

There is another feature of interest located beneath the first which is a grain in between two fingerlike grains having dimensions of are 3 μm width and 6 μm length.

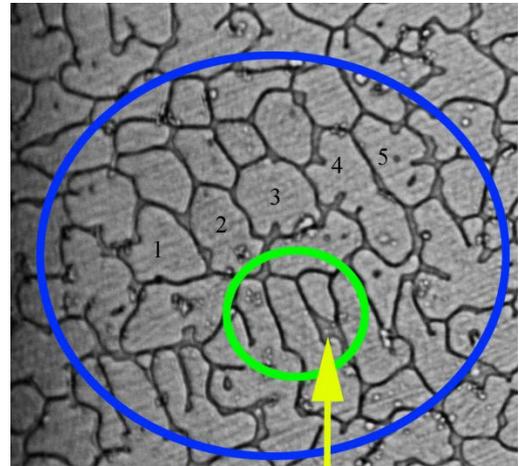
Grain in-between 2 fingers

Figure 8(b). Enlarged microstructure of non-heat treatment Within the circle

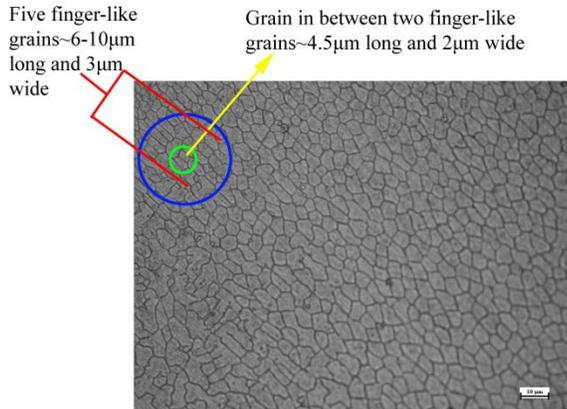
Figure 9(a). Microstructure of heat treatment

From the microstructure of the heat treatment scheme, a similar structure of interest is observed at the lower left side of the microscopic image revealing a five fingerlike array. Just like the case of the non-heat treatment scheme, the dimensions of these fingerlike structures are taken and it is found that the sizes ranged from 6 μm to 10 μm in length. However, the width is constant at 3 μm irrespective of the length. The results are tabulated in Table 3 below.

For the first fingerlike grain the length is 10 μm whereas the width is 3 μm , likewise the length for the second fingerlike grain is estimated at 7 μm and width at 3 μm measures. The third fingerlike growth is evaluated at a given dimension of 10 μm having a width of 3 μm , this is followed by the fourth having a dimension of 6 μm and a width of 3 μm whereas the fifth finger is calculated at 10 μm and a width of 3 μm respectively. The area of interest is encircled in blue in Figure 9(a) accordingly, an enlarged version of this area is displayed in Figure 9(b).

The dimensions of the other interesting feature which is the grain in between the two finger-like grains are 2 μm wide and

4.5 μ m long and can be observed as displayed in Figures 9(a) and (b).

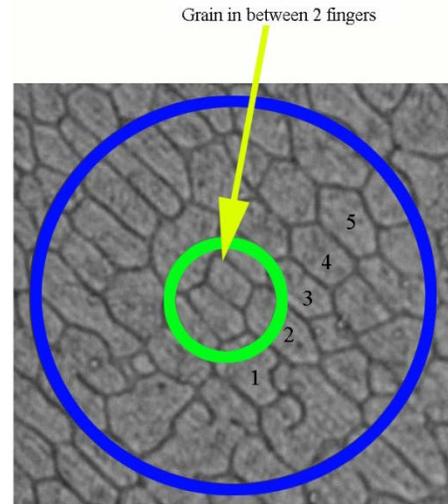
Figure 9(b). Enlarged microstructure of heat treatment within the circle

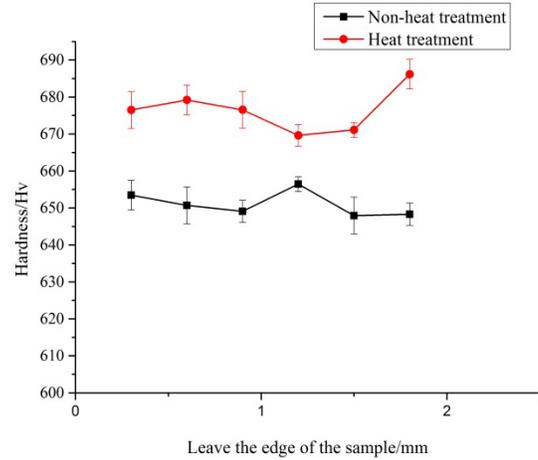
Figure 10. The hardness curves of heat treatment and non-heat treatment

The average hardness of the heat-treatment and non-heat treatment specimens was obtained by three tests as shown in Table 7 and 8. The average hardness line chart of the clad layer of the heat treatment and non-heat treatment were obtained and while the hardness of the non-heat treatment ranged between 647~656HV, that of the heat treatment was 669~686HV. This implies a rise of 1.05 times more than the hardness of the non-heat treatment and consequently offers improved wear resistance thereby reducing the wear of the material as shown in Figure 10. Combined with the above microstructure observation, the microstructure grains are more homogeneous and smaller after heat treatment. Thus, its hardness will increase.

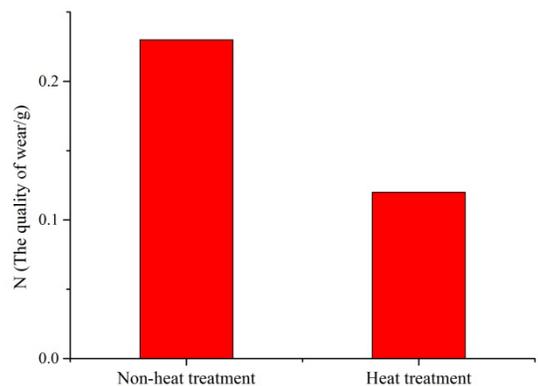
Figure 11. Quality of wear experienced in heat treatment and non-heat treatment schemes

The average results are obtained by three groups of experiments in Table 9. From Figure 11, it can be seen that the quality of wear of the non-heat treatment is 0.23 g and the heat treatment is 0.12 g. Thus, the quality of the wear of non-heat treatment is greater than that on heat treatment, which is 52%.

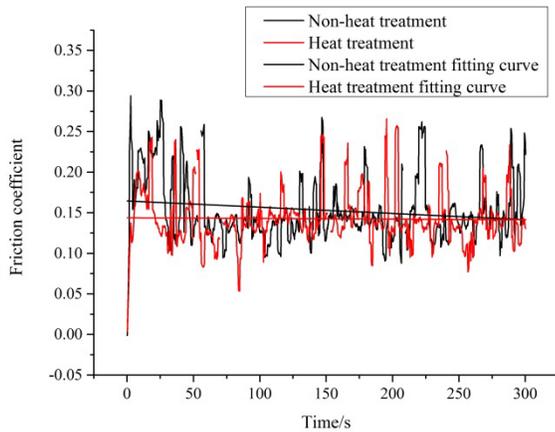
Figure 12. The relationship between time and friction coefficient

The friction existing in between the base and clad metal as well as the vertical force acting on one of the surfaces is known as friction coefficient and can be expressed in terms of the wear resistance of the material and roughness of the surface. As a result, it can be deduced that the smaller the friction coefficient, the better wear resistance of the material. In Figure 12, in order to better compare the friction coefficient of the heat treatment and non-heat treatment, here shows the friction coefficient curves of the non-heat treatment and heat treatment. It will be observed from Figure 12 that the friction coefficient is higher in the non-heat treatment compared with the heat treatment.

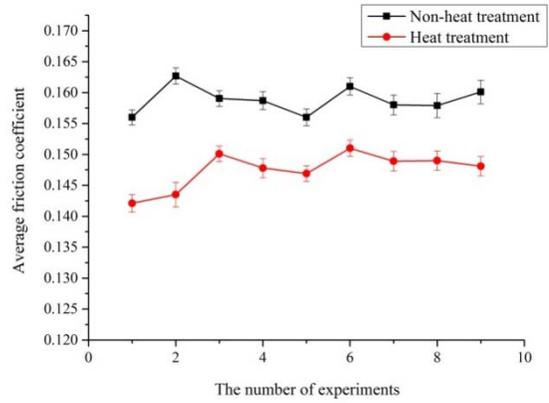
Figure 13. The average friction coefficient of each experiment

In order to better verify the results, under the same experimental conditions, heat treatment samples and non-heat treated specimens were repeated 9 sets in Figure 13. The results show that the average friction coefficient of the heat treatment between 0.142-0.151, the average friction coefficient of the non-heat treatment between 0.156-0.163.

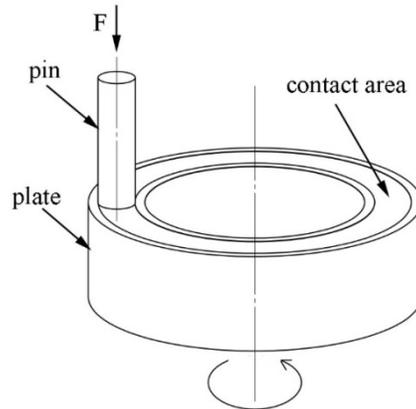
Figure 14. The wear diagram of the pin-plate friction

For precisely comparing the wear morphology of the heat-treatment and non-heat treatment samples, the same position of the samples were taken which were 2 mm * 2 mm inside the pin near the center of the plate when the pin was worn. The location is shown in Figure 14.

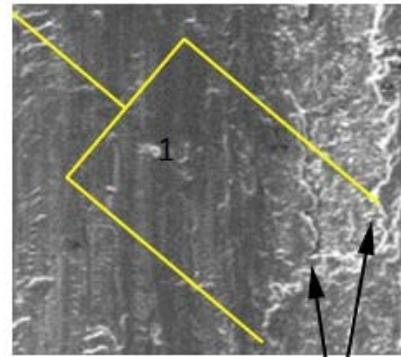
Corrugated fold and tearing 110 μ m

Figure 15(b). Enlarged image of position 1

The first being the 110 μ m corrugated fold and tearing located at top right segment of the microstructure which is further enlarged in Figure 15(b). The arrows indicate the different extremes of this fold and tear. Other folds are observed within the region and these clearly reflect the irregularities in the features of the non-heat treatment scheme.

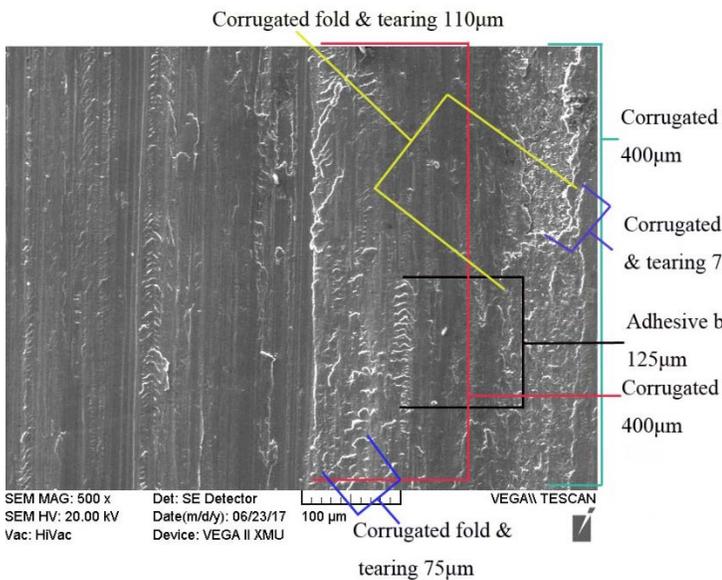
Figure 15(a). Wear situation of non-heat treated sample

Figure 15(a) reveals a microstructure of the non-heat treatment carried out on a VEGA II XMU device using a scanning electron microscopy at 20.00 kV and a SEM magnification of 500x.

The results implied the wear situation of the non-heat treatment sample from microscopic examination and image of the microstructure in Figure 15(a), that there exists folds of the order of 20μm wide and 50μm long in length, even 100μm and up to 400μm in length.

The wear situation of the non-heat treatment scheme in Figure 15(a) clearly reveals similar corrugated fold and tearing

that have occurred along the friction surface. Also present are adhesive bumps and furrows created by the adhesive. The dimensions of these features are reflected in Table 10.

The wear situation of the non-heat treatment scheme in Figure 15(a) clearly reveals similar corrugated fold and tearing that have occurred along the friction surface. Also present are adhesive bumps and furrows created by the adhesive. The dimensions of these features are reflected in Table 10.

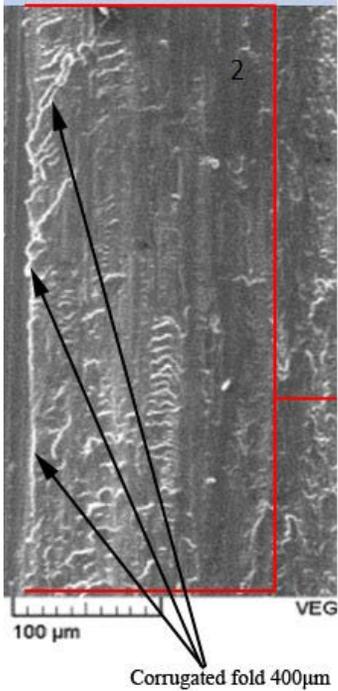
Figure 15(c). Enlarged image of position 2

The second area of interest lies in the middle of the microstructure for the wear situation of the non-heat treatment sample shown in Figure 15(a) and cuts across the whole length of the microstructure. This is the corrugated fold having a dimension of 400 μ m as seen in Table 10. The arrows in the enhanced image shown in Figure 15(c) further outline the extremes and middle of this fold. Together with the other folds present within the vicinity of this feature, the chapped and coarse nature of the microstructure for the wear situation of the non-heat treatment sample is exemplified and stands out.

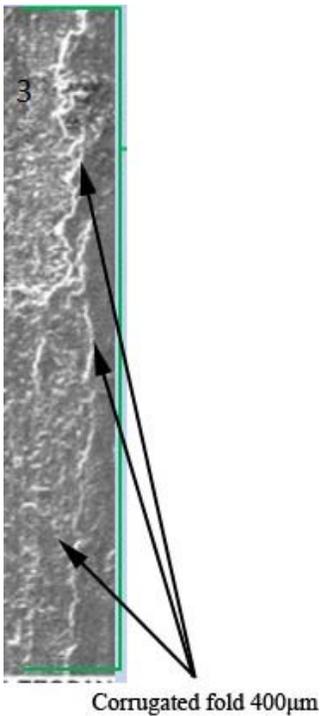
Figure 15(d). Enlarged image of position 3

The third feature is a vertical corrugated fold conspicuously found at the extreme right side of the wear condition of the non-heat treatment microstructure in Figure 15(a). This feature has been zoomed into in Figure 15(d) revealing folds along the whole

length of the microstructure; whose nature clearly depicts the rough and uneven terrain of the wear condition of the non-heat treatment microstructure in Figure 15(a). It also reveals the degree of usage and wear in the microstructure by reason of friction from the machine parts and constant use. The three arrows clearly show the extent of the corrugated fold and tear which is of the order of $400\mu\text{m}$.

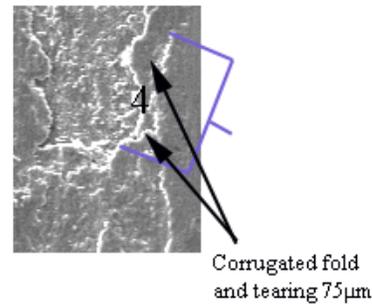
Figure 15(e). Enlarged image of position 4

A corrugated fold of the order of $75\mu\text{m}$ long is also found situated at the top right quadrant of the wear condition of the non-heat microstructure in Figure 15(a). This further enlarged in Figure 15(e) above with the arrows indicating the extreme ends of this tear and fold. Other tears and folds are also observed within the vicinity which further reveals the nature of the wear condition of the non-heat treatment microstructure in Figure 15(a) as jagged and worn out from friction of mechanical parts and usage.

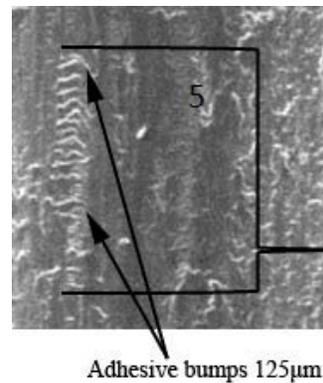
Figure 15(f). Enlarged image of position 5

There are adhesive bumps across the wear scheme of the non-heat microstructure in Figure 15(a) located at the lower right quadrant. The cross sectional length of these adhesive bumps has a magnitude of $125\mu\text{m}$ and the arrows depict the spread of these bumps as magnified in Figure 15(f). The nature of the adhesive

bumps reveals the abrasive, bumpy and textured terrain of the wear condition of the non-heat treatment microstructure in Figure 15(a).

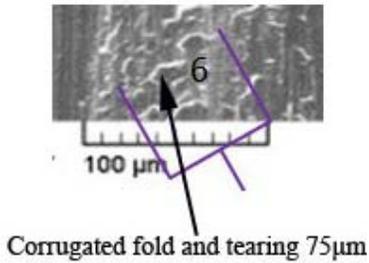
Figure 15(g). Enlarged image of position 6

The mid-section of the lower end of the wear condition of the non-heat microstructure in Figure 15(a) reveals another corrugated fold and tearing measuring up to 75μm in dimension. The arrow pointing to the feature in the magnified Figure 15(g) portrays a ridged and rugged pattern and nature of the wear condition of the non-heat microstructure in Figure 15(a). There are other corrugated folds observed within the vicinity of this fold, which further contribute towards unveiling the choppy and serrated style of the microstructure for the wear situation of the non-heat treated sample.

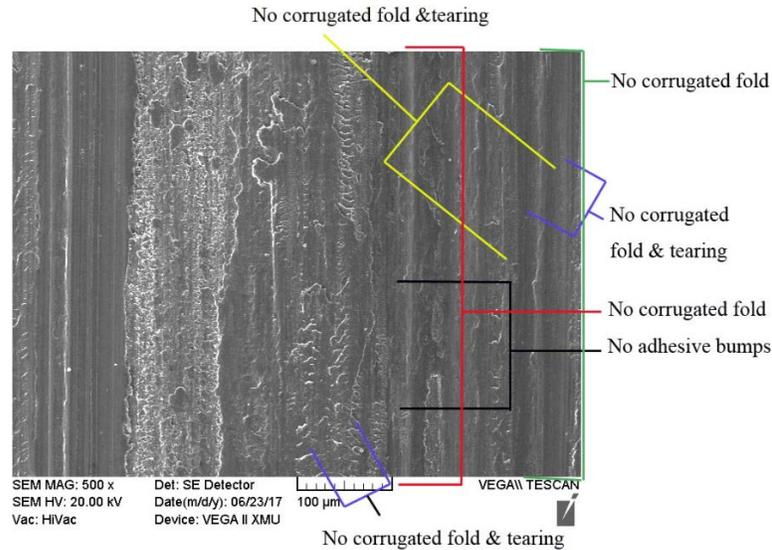
Figure 16(a). Wear situation of heat treated sample

The wear condition of the heat treatment microstructure is displayed Figure 16(a) which is a microstructure of the heat treatment obtained from a VEGA II XMU device using a scanning electron microscopy at 20.00 kV at a SEM magnification of 500x.

The surface of the heat treatment scheme reveals a relatively smooth surface compared with the wear condition of the non-heat treated microstructure in Figure 16(a). There also exists shallow folds and peeling parallel to the direction of friction. This clearly implies that the preferred scheme of the two scenarios is the wear of the heat treatment.

The surface of the heat treatment scheme reveals a relatively smooth surface compared with the wear condition of the non-heat treated microstructure in Figure 16(a). There also exists shallow folds and peeling parallel to the direction of friction.

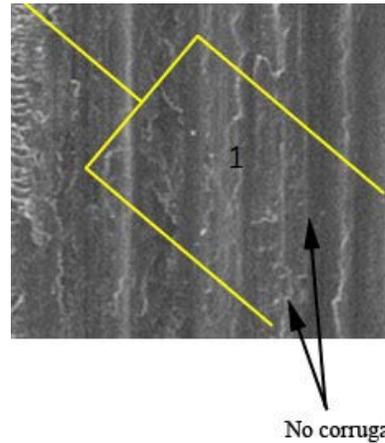
Figure 16(b). Enlarged image of position 1

The first sector to be discussed located at the top right segment of the microstructure in Figure 16(a) reveals that no corrugated fold or tearing is present. The specific corrugated fold and tearing feature found in Figure 15(b) is absent in Figure 16(b) here which clearly indicates the effect of the heat treatment on the microstructure in eliminating folds and tears hence prolonging the in-service life of the material.

The surrounding folds and rough terrain present in Figure 15(b) are also absent generating a smooth surface in Figure 16(b).

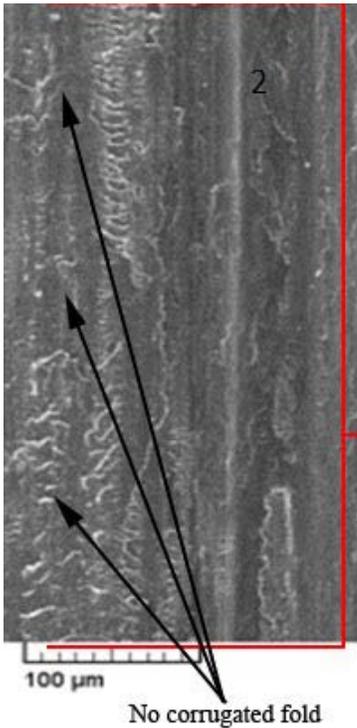
Figure 16(c). Enlarged image of position 2

The second area of interest is situated at the middle of the microstructure in Figure 16(a) across the length of the microstructure. It is observed that there is no corrugated fold present in the exact position as illustrated by the arrows in Figure 16(c). This portrays the effect of heat treatment in the wear condition of the microstructure in that it eradicates the chapped and coarse features presenting a smooth scheme which is advantageous in enhancing longevity of the material.

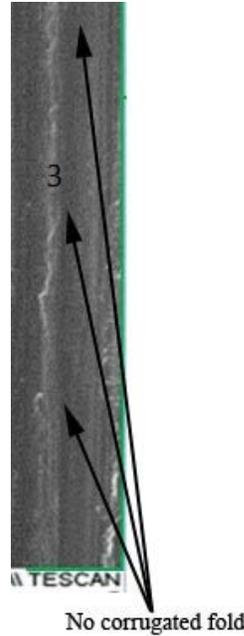
Figure 16(d). Enlarged image of position 3

At the extreme right of the microstructure in Figure 16(a) there is a smooth and clear section along the whole length, which when examined closely in Figure 16(d) confirms the fact that there is no corrugated fold present. In the place of the 400μm fold found in Figure 15(d) is the even plane feature of wear condition of the heat treatment microstructure which is beneficial to the long span of the material involved. It is worthy to note that the surrounding folds present in wear condition of the non-heat treatment scheme in Figure 15(d) is also absent in this heat treated scheme.

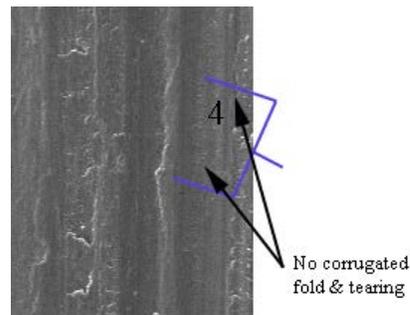
Figure 16(e). Enlarged image of position 4

Within the top right quadrant of the wear situation of heat treatment sample in Figure 16 (a) lies the no corrugated fold and tearing scenario. This is further illustrated at a closer range in Figure 16(e) which reveals the complete absence of the 75μm corrugated fold and tearing that was present in Figure 15(e) of

the wear situation of the non-heat treated sample. The clear outcome in the results clearly proves the efficacy of the heat treatment in eradicating the jagged and worn out features of wear thereby preserving the durability of the material under discussion.

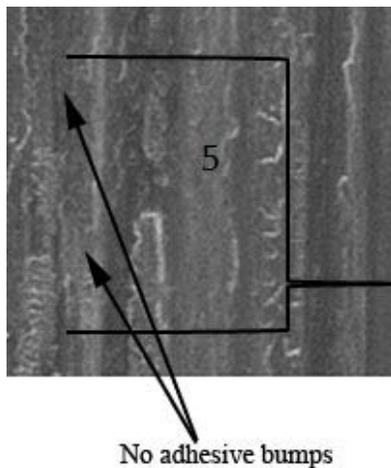
Figure 16(f). Enlarged image of position 5

The lower right segment of the wear situation of the heat treatment microstructure in Figure 16(a) houses an interesting discovery of no adhesive bumps. This demonstrated in the Figure 16(f) with the arrows pointing towards the smooth terrain. The 125 μm adhesive bumps which are displayed in Figure 15(f) are absent leaving behind a very smooth terrain in the microstructure. This is a clear indication that heat treatment scheme rids off the bumpy and textured terrain of the non-heat treatment microstructure revealing the levelled terrain in the wear condition which is conducive for the long lasting performance of the material.

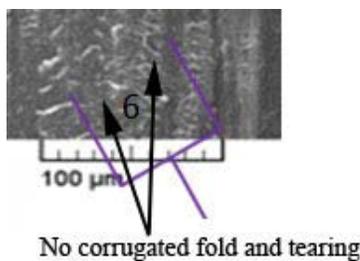
Figure 16(g). Enlarged image of position 6

The mid lower segment of the wear condition of the heat treatment microstructure is displayed Figure 16 (a) reveals the absence of the 75 μm corrugated fold and tearing conspicuously presented in Figure 15(g). The result is further analyzed in Figure

16(g) where the arrows depict the presence of the smooth terrain of the wear condition of the heat treatment microstructure. The surrounding folds and tears are also eradicated, further buttressing the fact that the wear condition of heat treatment scheme provides appropriate situation for longevity of material.
