Behaviour of continuous reinforced concrete floor slabs subjected to different compartment fires

This paper presents the experimental results of four continuous reinforced concrete slabs with three compartments under different compartment fire scenarios. The research focuses on the quantitative relationships of the compartment fire temperatures, the temperature distribution along the thickness of the slabs, the vertical and horizontal deflections, the crack patterns and failure modes of the slabs and the corners' reaction forces. The results indicate that for a continuous floor slab, the central vertical deflection of the slab in the middle compartment is considerably affected by the vertical deflections of the slab in the two edge compartments. The boundary condition, the ratio and arrangement of the top reinforcement of the continuous slab, and the fire spreading scenarios have important effects on the failure mode of the slab in different compartments. It is evident that more severe cracking happened within the slab in the middle compartment compared to the two edge compartments. For the edge compartment, the slab may fail by large deflection and the integrity failure of the sl

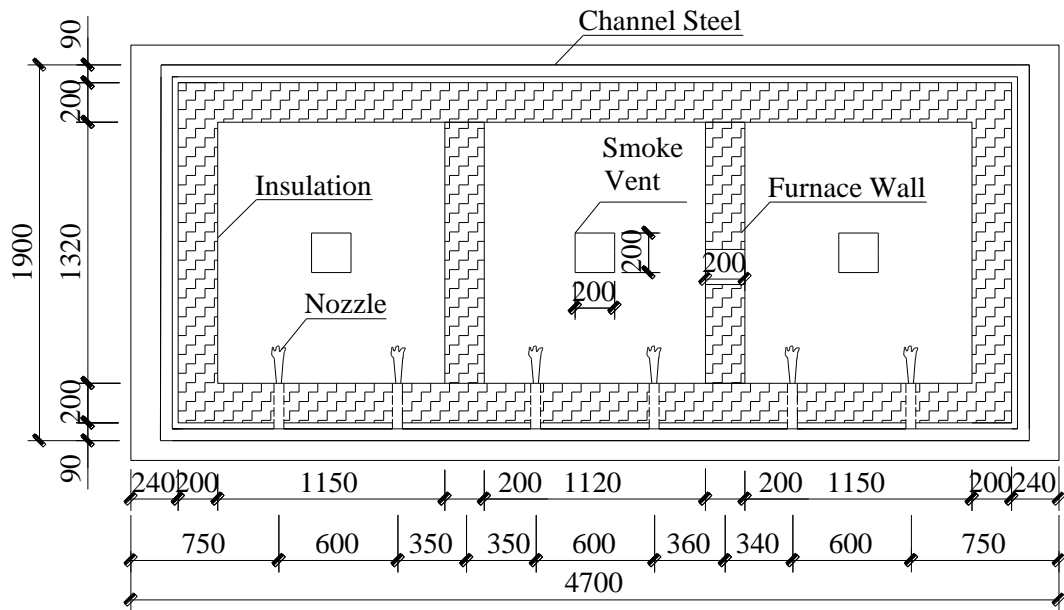
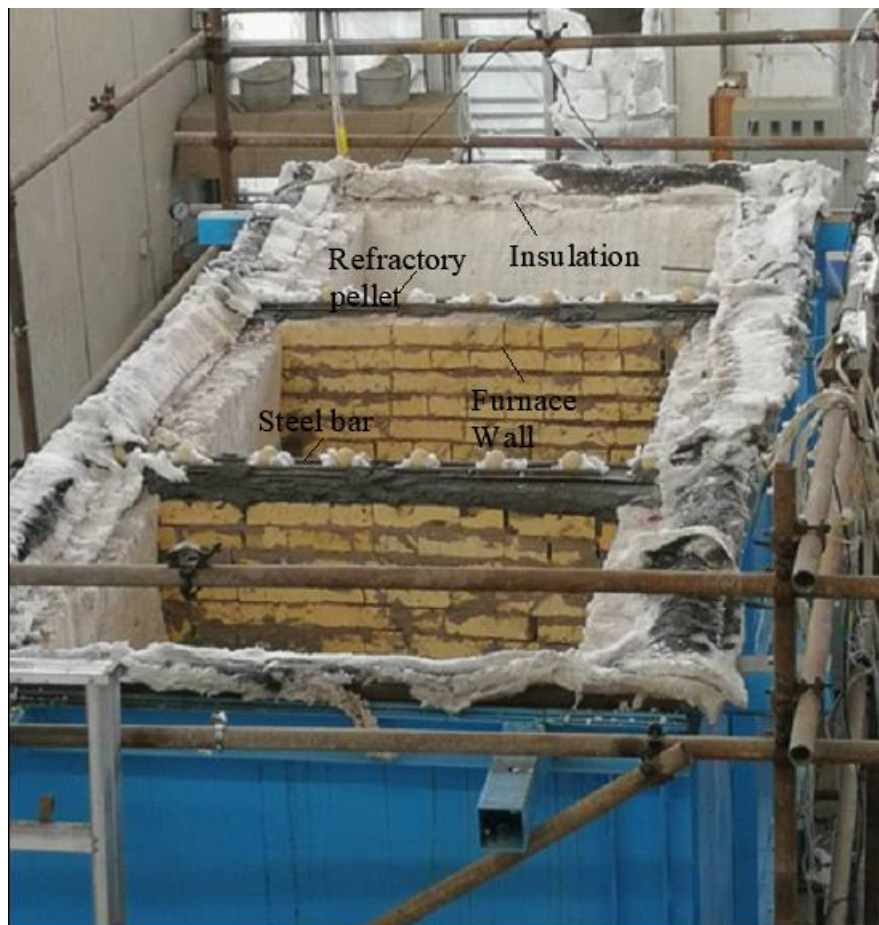
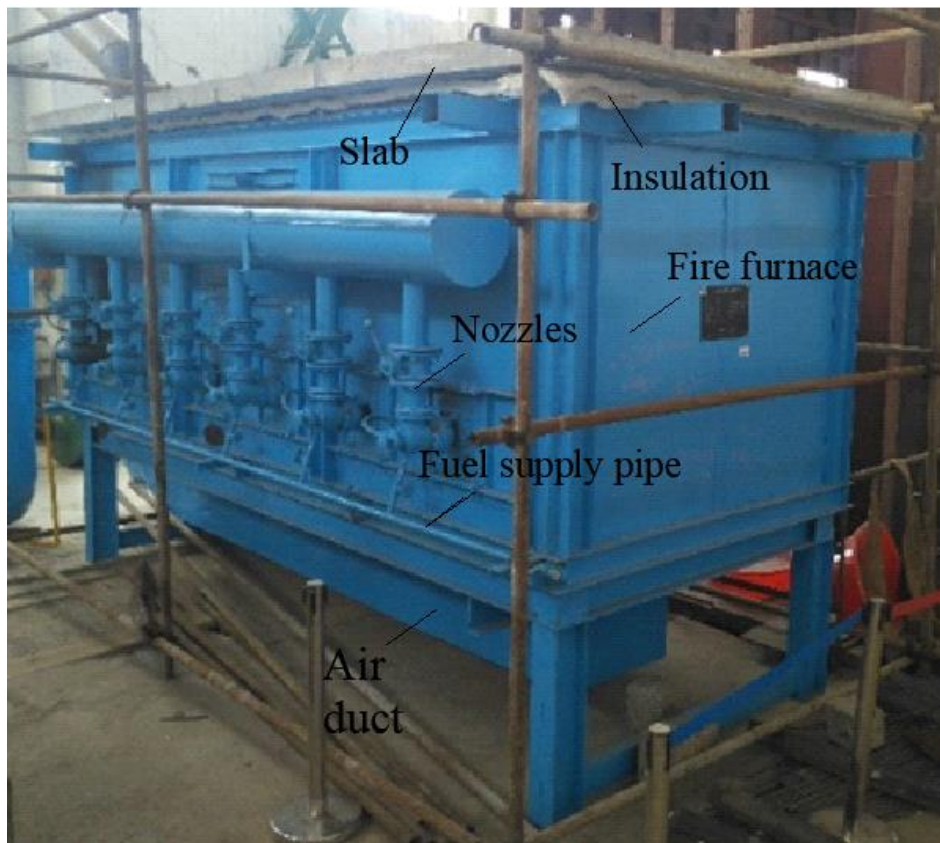
Fig. 1 Self-designed furnace (all dimensions in mm)

(a) Plan view of the self-designed furnace

(b) Photograph of the internal wall

(c) Photograph of the self-designed furnace

A furnace was specially designed and constructed to have three fire compartments, as shown in Figs. 1(a)-1(c). The external furnace side wall was constructed from the external steel frame and internal mineral wool (thickness: 200 mm). In addition, two internal walls in the furnace were composed of the refractory bricks (thickness: 200 mm). The external dimension of the furnace was 4700 mm × 1900 mm × 2570 mm, and one smoke vent (200 mm × 200 mm) was placed in each fire compartment. Six oil burners in the south furnace wall provided thermal energy, and nine Type K thermocouples (2 mm diameter, named F-1, F-2 and F-3) were placed in the north furnace wall to measure the furnace temperature. The concrete slab was placed on top of the furnace and spanned over three fire compartments and heated from the bottom. The voids between the slab and the furnace were filled with mineral wool. Four types of fire sceneries were applied on the four slabs.

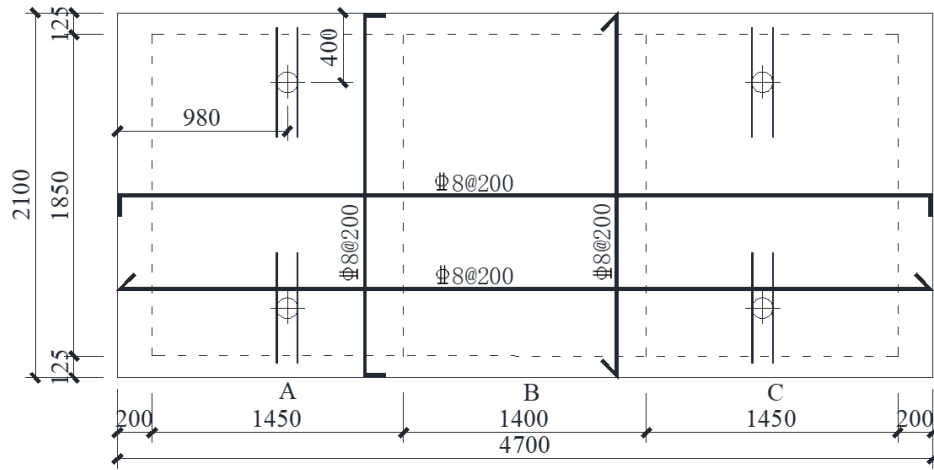
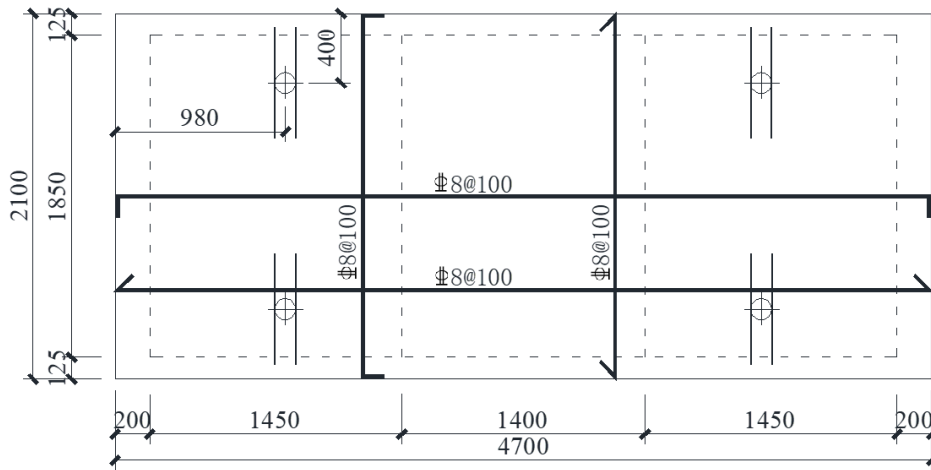
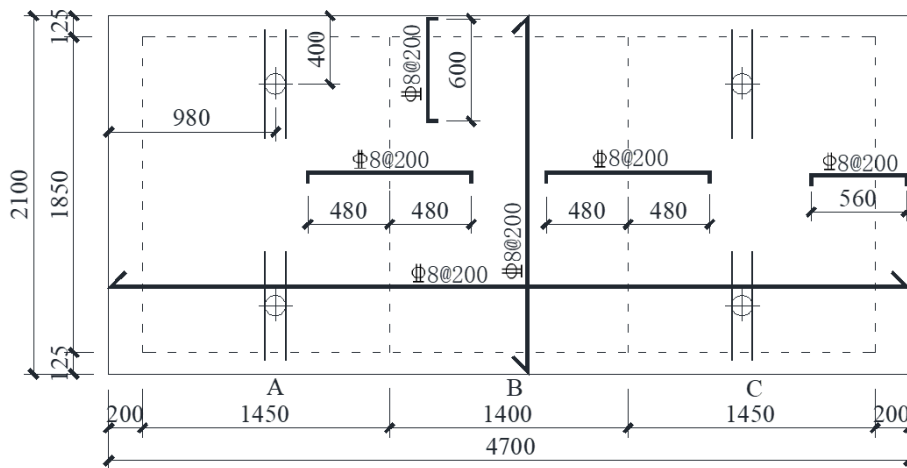
Fig. 2 The details of reinforcing steel within four slabs (all dimensions in mm)

(a) Slabs B1 and B2

(b) Slab B3

(c) Slab B4

For each slab, hot-rolled reinforcing bars of 8 mm diameter were used and the clear concrete cover was 15 mm. The average yield strength and ultimate strength of the reinforcing steel were 414 MPa and 475 MPa, respectively. The arrangement of the reinforcement in each slab was shown in Figs. 2(a)-2(c).

steel layers of Slab B4 are discontinuous over the slab in central areas of the compartments (see Fig. 2(c)). Hence, the hogging bending stiffness of the slab in the central area of Compartment B was much less compared to Slab B3. Also a large main crack was formed across Compartment B. This integrity failure of Slab B4 mainly resulted from the discontinuous arrangement of the top reinforcement layers. Therefore, for fire resistant design, it is important to utilise the continuous top reinforcing arrangement for the floor.

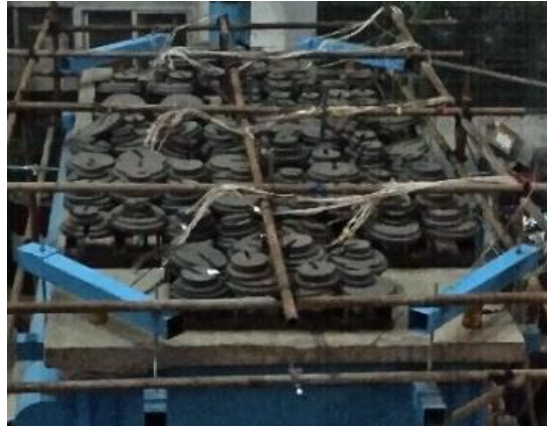
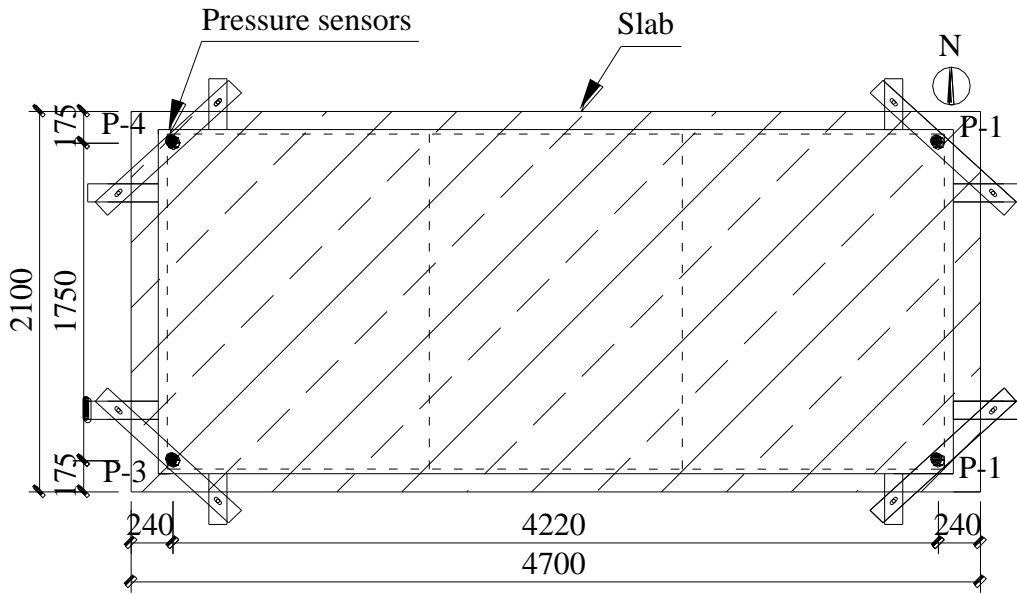
Fig. 3 Loading device, supports on the furnace wall and corners' restraint (all dimensions in mm)

(a) Loading device

(d) Corners' restraint

According to the Chinese code for the design of building structures (GB50009-2001) [23], the value of the uniform distribution load was 2.0 kN/m^2 . The loads were applied using iron brick as shown in Fig. 3(a). The uniform load remained constant during each fire test. According to the Standard of concrete testing method of China [24], each slab was continuous over the interior support (refractory pellet) and was simply-supported on steel rollers at the exterior supports, as shown in Figs. 3(b) and 3(c). In addition, each corner was held down by a steel beam, and the restraint forces at the four corners of the slab were measured by the pressure transducers (Points P-1 to P-4), as shown in Fig. 3(d). Note that, each pressure transducer was placed at the top of the slab's corner.

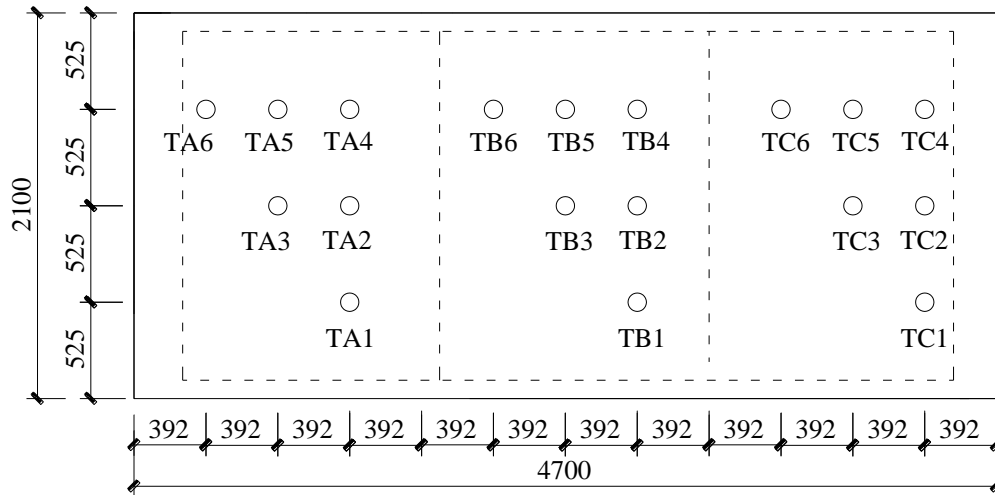
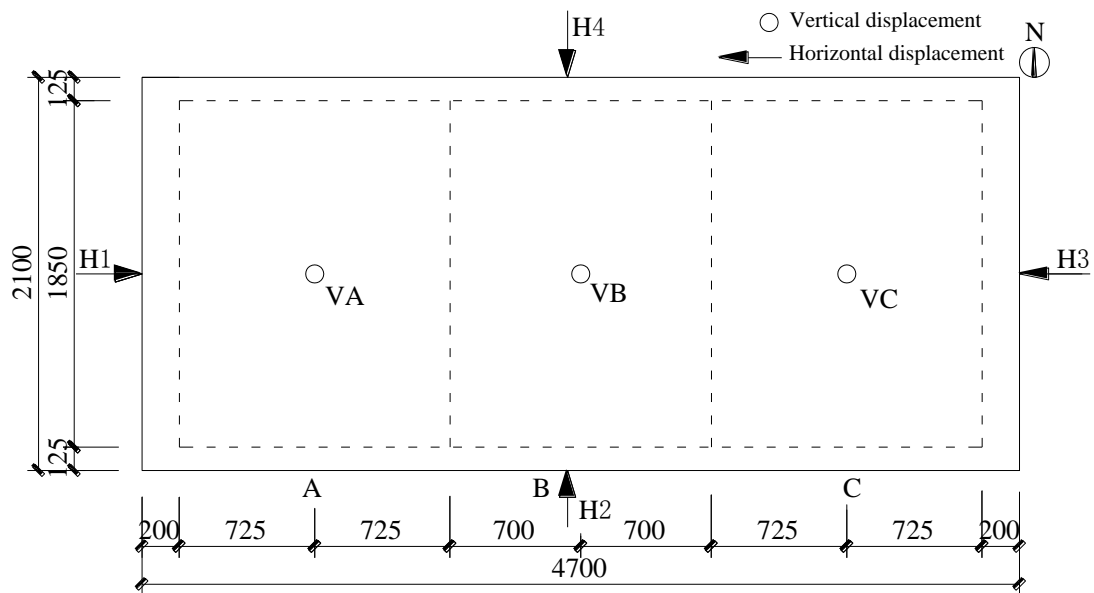
Fig. 4 Thermocouple location and displacement transducers for each tested slab (all dimensions in mm)

(a) Typical layout of thermocouples in the concrete slab

(b) Thermocouples across the full-depth of each slab

(c) Layout of the vertical and horizontal displacement transducers

Six thermocouple trees (such as Trees TA1 to TA6) were used to measure the temperatures of the slab within each fire compartment, as shown in Fig. 4(a). Each thermocouple tree consisted of 6 Type-K (0.5 mm diameter) thermocouples distributed vertically to measure the concrete temperature, and the distance between these points (Points T-1 to T-6) were 20 mm. Meanwhile, four thermocouples were placed at the mid-depth of the bottom (Points R-1 and R-2) and top (Points R-3 and R-4) steel bars, as shown in Fig. 4(b).

Fig. 4(c) shows the position of the vertical and horizontal displacement transducers (with the travel limits ranging between 10 mm to 500 mm). Three linear variable differential transformer LVDT's (Points VA, VB and VC) were placed to measure the central vertical deflection of the slab within

each fire compartment, while its horizontal deformations were measured by four LVDT's (Points H1, H2, H3 and H4).

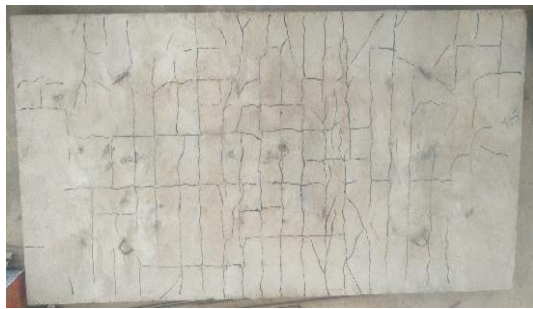
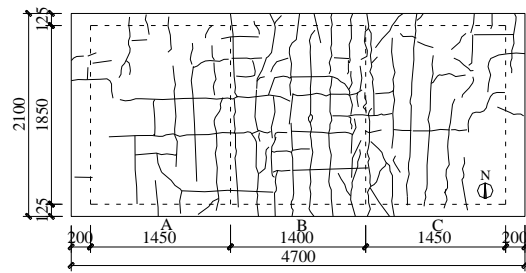
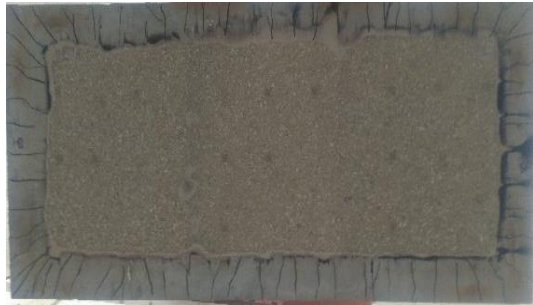
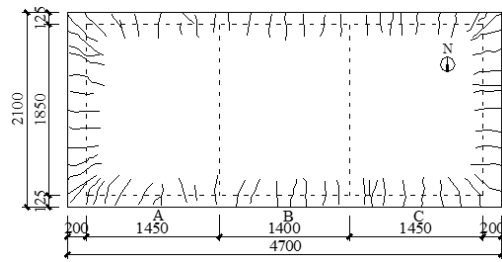
Fig. 24 Failure modes of Slab B1: (a) cracking pattern on the top surface, (b) crack development, (c) bottom surface and (d) cracking pattern on the bottom surface

(a) Cracking pattern on the top surface

(b) Crack development during the test

(c) Bottom surface

(d) Cracking pattern on the bottom surface

Figs. 24(a)-24(b) show the top view of Slab B1 after the fire. Cracks were darkened with a brush to make them visible in the photograph. Clearly, many cracks parallel to south-north (short-span) directions could be seen on the top surface of the slab within each compartment. In addition, there

were several long cracks in west-east direction in the slab within each compartment. Clearly, these two-way cracking patterns are different from those of one-way continuous slabs observed in Refs. [32-33].

Figs. 24(c)-24(d) show the bottom view of the slab after the fire. Some diagonal cracks running at 45° from the corners and some cracks normal to the edges could also be seen on the bottom surface, but no cracks appeared on the middle region of each compartment. Thus, the integrity failure did not occur in the slab. In addition, the bottom steel was not seen, although the concrete spalled on the bottom surface.

In all, there were different cracking patterns on the top surfaces of Slab B1 within three compartments. The cracking pattern of the slab in Compartments A and C were similar to each other due to the same fire and boundary conditions. But, the cracks on the top surface of the slab in Compartment B were relatively much more due to large hogging bending moment at two continuous supports. In addition, many cracks located near to two continuous supports.

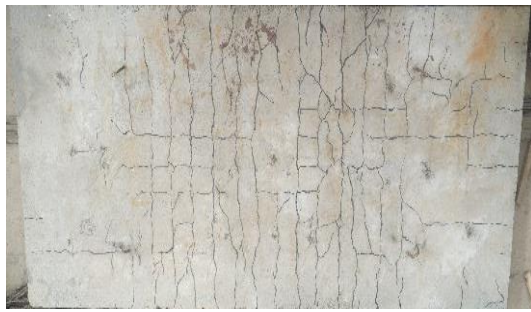
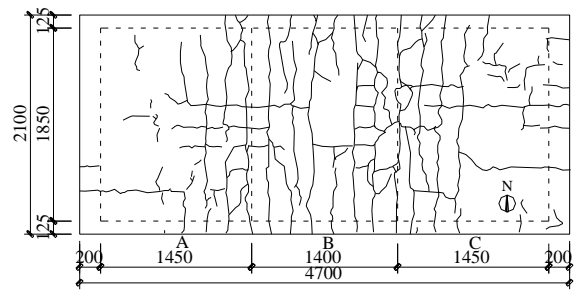
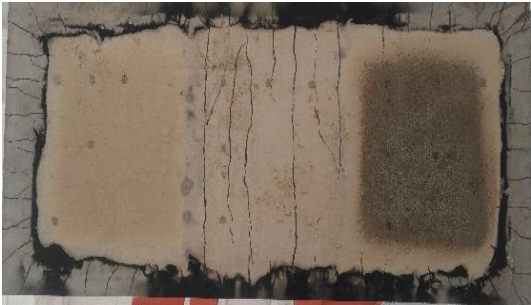
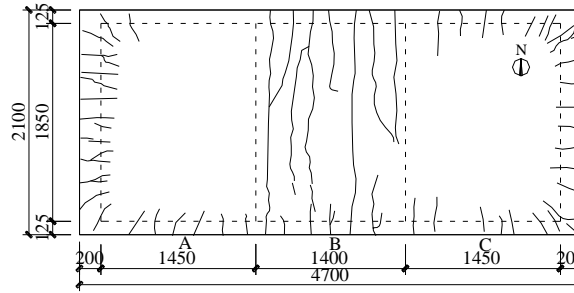
Fig. 25 Failure modes of Slab B2: (a) cracking pattern on the top surface, (b) crack development, (c) bottom surface and (d) cracking pattern on the bottom surface

(a) Cracking pattern on the top surface

(b) Crack development during the test

(c) Bottom surface

(d) Cracking pattern on the bottom surface

Figs. 25(a)-25(d) show the cracking patterns on the top and bottom surfaces of the slab after the test. The comparison between top surfaces of Slabs B1 and B2 indicates that the cracking patterns

of the slabs within corresponding compartments are similar to each other. However, there are the obvious differences on the bottom surfaces of the two slabs. Compared to Slab B1, there was no concrete spalled from the bottom surface of Slab B2. Also several north-south cracks across the whole short span appeared on the bottom surface of the slab within Compartment B. This indicated that the through thickness cracks were formed and the integrity failure occurred. Note that, based on the cracking patten of the slab within Compartment B, the slab in Compartment B was subjected to one-way bending.

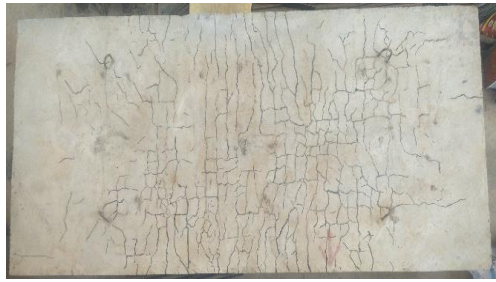
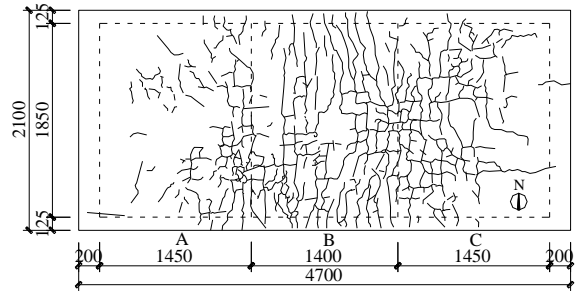
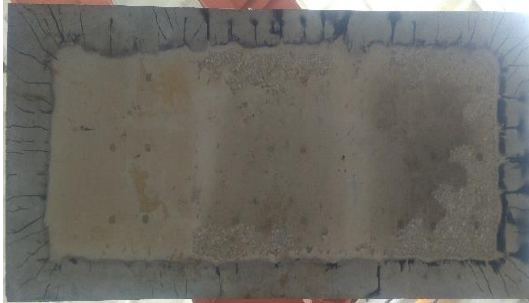
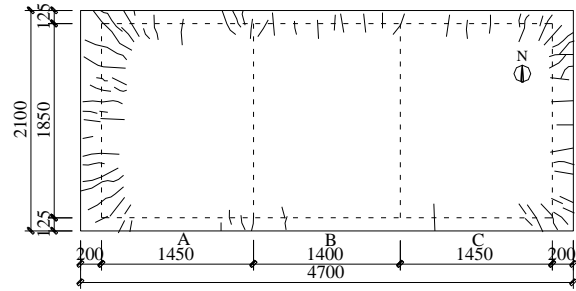
Fig. 26 Failure modes of Slab B3: (a) cracking pattern on the top surface, (b) crack development, (c) bottom surface and (d) cracking pattern on the bottom surface

(a) Cracking pattern on the top surface

(b) Crack development during the test

(c) Bottom surface

(d) Cracking pattern on the bottom surface

The cracking pattern on the top and bottom surfaces of Slab B3 after the test was shown in Figs. 26(a)-26(d). Compared to Slabs B1 and B2, the cracks' width on the top surface of Slab B3 was much smaller. This is due to the smaller steel spacing with higher reinforcement ratio. Hence, increasing the reinforcement ratio is beneficial to enhance the fire resistant of the slab, particularly to prevent the integrity failure. This conclusion is similar to the observation in Ref. [9]. For the bottom surface, the cracking pattern is similar to that of Slab B1, and the concrete on the bottom surface of the slab in Compartment C spalled.

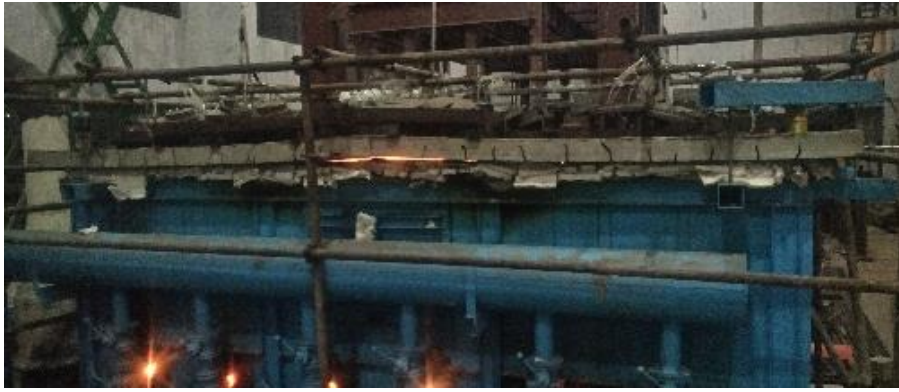
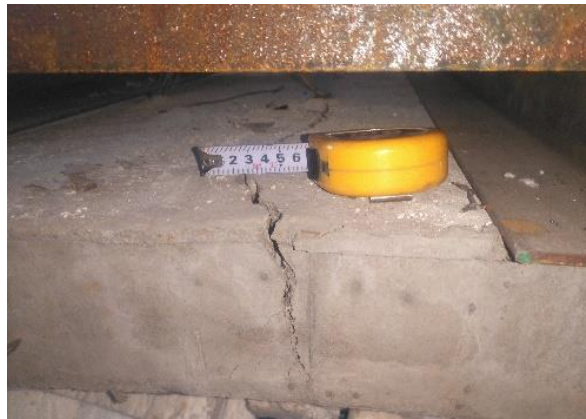
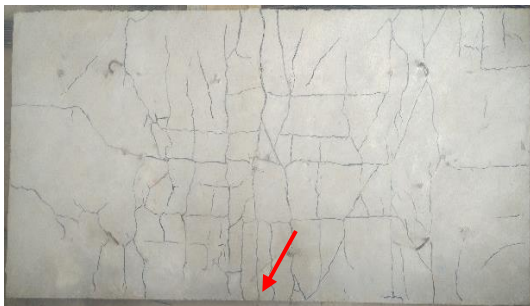
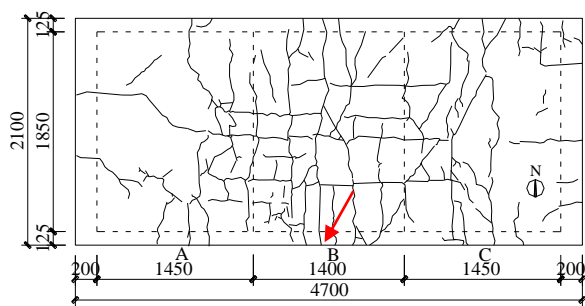
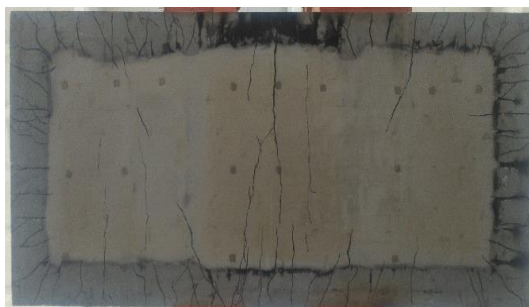
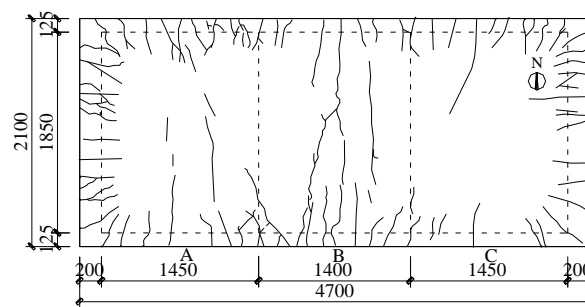
Fig. 27 Failure modes of Slab B4: (a) upward deflection behaviour of Compartment B, (b) main crack, (c) cracking pattern on the top surface, (d) crack development, (e) bottom surface and (f) cracking pattern on the bottom surface

(a) Upward deflection behaviour of Compartment B

(b) Main crack

(c) Cracking pattern on the top surface

(d) Crack development during the test

(e) Bottom surface

(f) Cracking pattern on the bottom surface

As shown in Fig. 20, before 120 min, the downward deflection appeared on the slabs in Compartments A and C, but the slab in Compartment B had the upward deflection trend (see Fig. 27(a)). As shown in Figs. 27(b)-27(d), one main crack (red arrow in Figs. 27(c) and 27 (d)) appeared near to the truncation of the top layer reinforcement within the slab of Compartment B, and its crack width was about 10 mm. At 120 min, Compartment B was exposed to fire, the width of the main crack further increased. At 146 min, Compartment C was dry, but a large amount of steam appeared on Compartment B. At 180 min, there was no steam on the top surface of the slab. Meanwhile, the width of the main crack on the top surface of the slab in Compartment B was about 20 mm. This failure mode was resulted from the hogging bending moment acting on the slab in Compartment B. In addition, no spalling was found on the bottom surface of the slab.

Figs. 27(c)-27(f) show the cracking pattern of the top and bottom surfaces of Slab B4 after the test. As expected, cracking patterns of the slabs in Compartments A and C were similar to each other, but they were different from the slab in Compartment B. In addition, due to the larger spacing and discontinuous of top layer reinforcement, many large cracks appeared on the top surface of the slab. Hence, to enhance the fire resistance of the slab, continuous top layer reinforcement should be used.
