Residual properties of three-span continuous reinforced concrete slabs subjected to different compartment fires

Wang, Y, Chen, Z, Jiang, Y, Huang, Z, Zhang, Y, Huang, Y, Li, L, Wu, J & Guo, W 2020, 'Residual properties of three-span continuous reinforced concrete slabs subjected to different compartment fires', *Engineering Structures*. <https://doi.org/10.1016/j.engstruct.2020.110352>

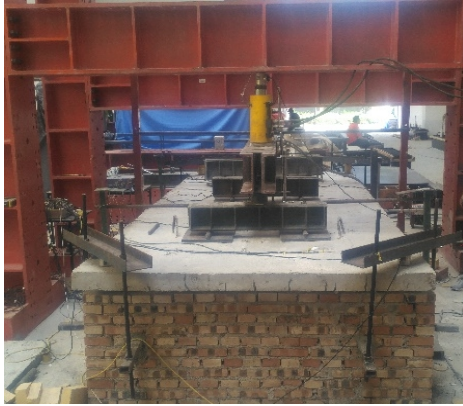
(a) Photograph of the test setup

Fig.2. Details of test setup. (a) Photograph of the test setup; (b) Photograph of the roller bearings at the supports; (c) Plan view of the test setup; (d) 1-1 Cross section of the test setup.

189 The slabs were tested using a reaction steel frame (reaction column and reaction beam), as shown in
190 Fig. 2(a). According to Chinese Code [48], the four edges of each span in one continuous slab were
191 easily supported by steel rollers on the walls, and the load was applied to the slab using two hydraulic
192 jacks (Jacks 1 and 2), as shown in Figs. 2(b)-2(d). One steel plate ($360 \text{ mm} \times 360 \text{ mm} \times 20 \text{ mm}$) was
193 placed in each loading point, and the load was measured by the pressure sensors.

774 Fig. 2. Details of test setup. (a) Photograph of the test setup; (b) Photograph of the roller bearings at
775 the supports; (c) Plan view of the test setup; (d) 1-1 Cross-section of the test setup.

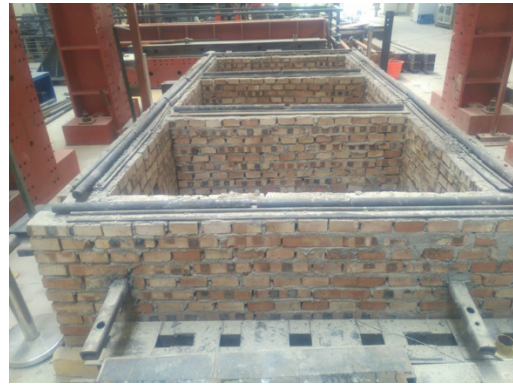
(b) Photograph of the roller bearings at the supports

(c) Plan view of the test setup

(d) 1-1 Cross section of the test setup

199 During the test, four corners were held down by the four steel beams, as shown in Fig. 2(c), and the
200 reaction force at each corner, denoted by points P-1 to P-4, was measured using the pressure
201 transducers. In this case, the present results can be easily compared to the simply supported fire-
202 damaged slabs in Refs. [1-3, 12]. In fact, to get a close-to-reality response of the structure, the beam-
203 slab specimen should further be tested in the future, particularly the effect of horizontal and rotational
204 restraint on the mobilisation of tensile membrane action.

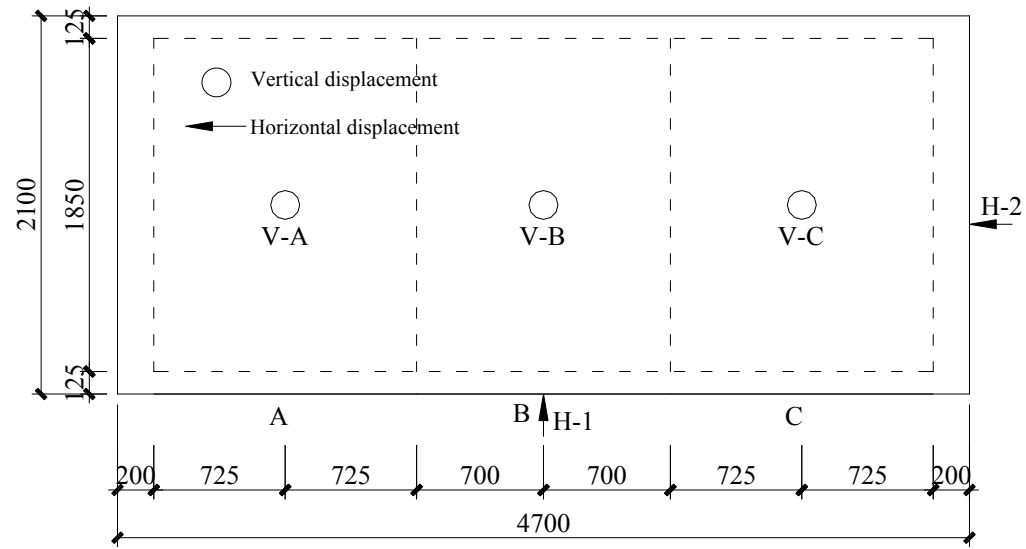
Figure 3

(a) Layout for measuring the strains of concrete and bottom reinforcement (dimensions in mm)

(b) Layout of displacement transducers (dimensions in mm)

Fig.3. Details of measurement instrumentation. (a) Layout for measuring the strains of concrete and bottom reinforcement (dimensions in mm); (b) Layout of displacement transducers (dimensions in mm).

205 For each test, the strain gauges were used to measure concrete and reinforcement strains, as shown in
206 Fig. 3(a). All concrete strain gauges were on the top surface of the slab. To reduce the damage, only
207 four reinforcement strain gauges were arranged in the lowest reinforcement layer in the direction of
208 the shorter span of the slab. In addition, Fig. 3(b) shows the positions of vertical Points V-A, V-B and
209 V-C and horizontal Points H-1 and H-2 as well as displacement transducers that have the stroke range
210 of 10–500 mm.

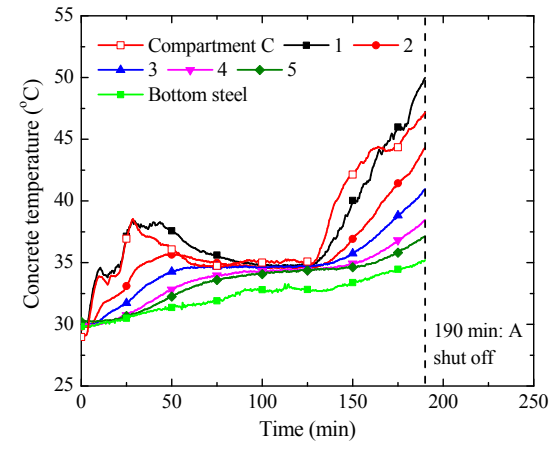
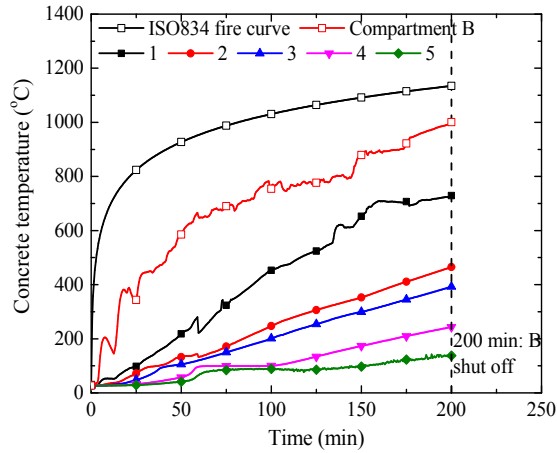
Figure 4

(a) Slab S1 (In order, heated Compartment A, unheated Compartment B and unheated Compartment C)

(b) Slab S2 (In order, unheated Compartment A, heated Compartment B and unheated Compartment C)

Fig.4. Variation in furnace temperatures, concrete and reinforcement temperatures of five slabs with time.

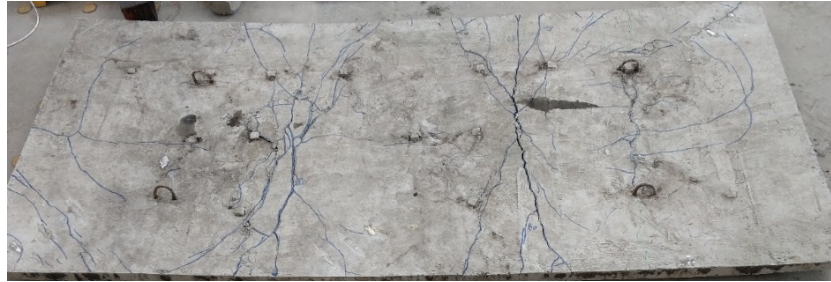
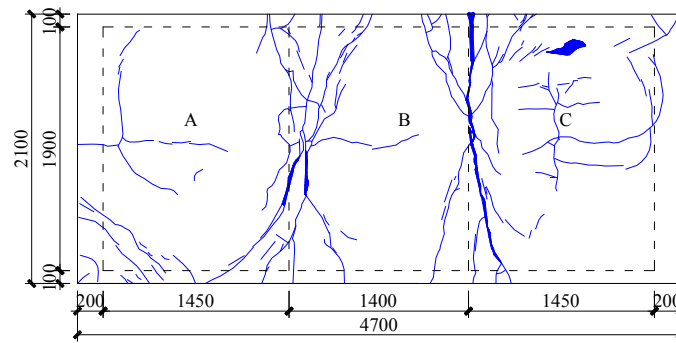
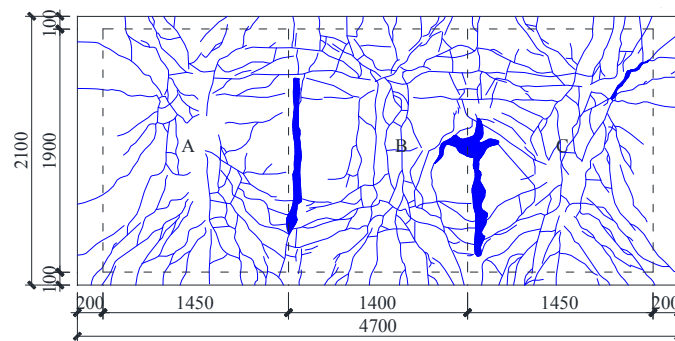
Figure 5

(a) Cracks on the top surface

(b) Cracking pattern on the top surface

(c) Cracks on the bottom surface

(d) Cracking pattern on the bottom surface

Fig.5. Failure modes of Slab S0. (a) Cracks on the top surface;(b) Cracking pattern on the top surface;(c) Cracks on the bottom surface;(d) Cracking pattern on the bottom surface.

253 For the reference Slab S0, as shown in Figs. 5(a)-5(d), the flexural failure mode appeared with a larger
254 crack intensity because the punching shear strength of the reference slab was higher than the bending

255 moment capacity. In addition, as discussed later, the maximum concrete strains on the top surface of
256 the most spans were lower than 3300×10^{-6} [37], and thus the concrete crushing on the corner of each
257 slab did not occur during the test. Finally, for the reference slab, its failure was determined by the
258 hogging flexural strength near two interior supports.

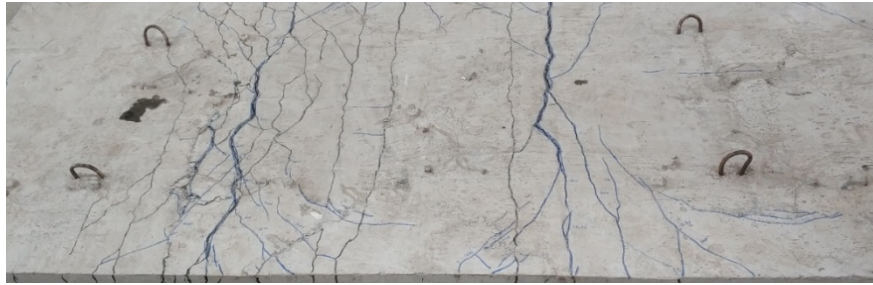
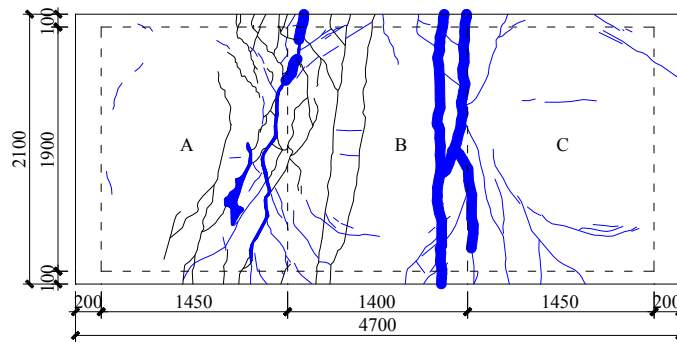
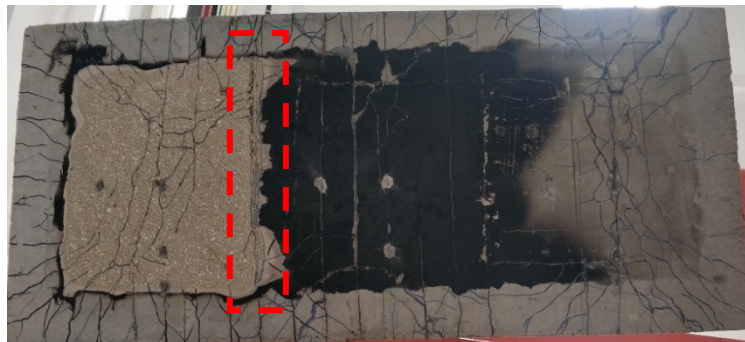
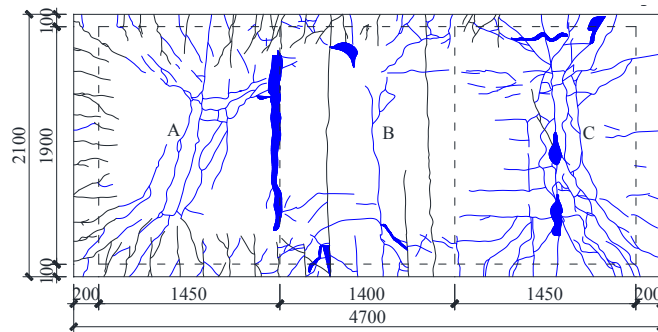
Figure 6

Fig.6. Failure modes of Slab S1-PF. (a) Cracks on the top surface; (b) Cracking pattern on the top surface; (c) Cracks on the bottom surface; (d) Cracking pattern on the bottom surface.

250 Figs. 5–10 show the cracking pattern on the top and bottom surfaces of each span in the six continuous
251 slabs. For each fire-damaged slab, the blue and dark lines indicate new and original cracks,
252 respectively.

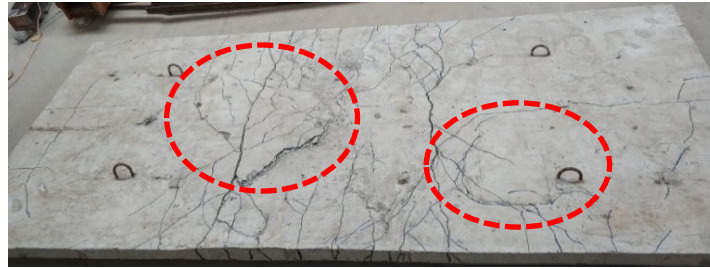
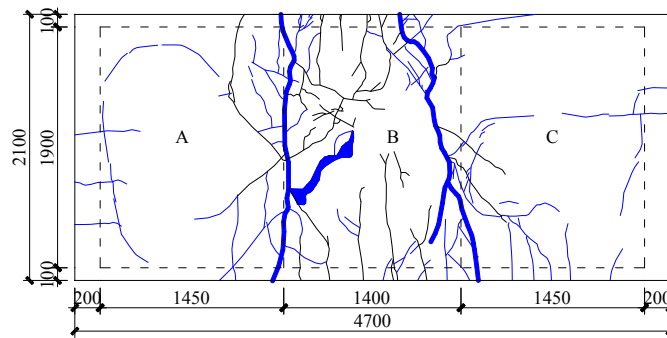
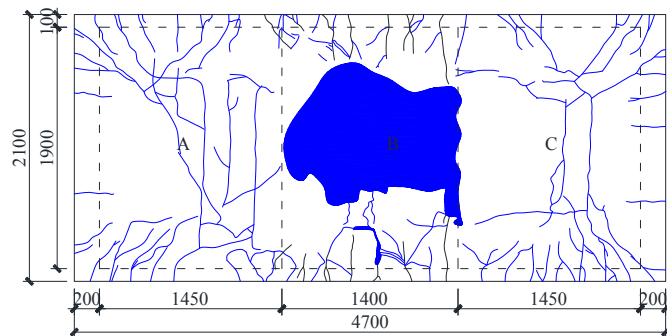
Figure 7

Fig.7. Failure modes of Slab S2-PF. (a) Cracks on the top surface; (b) Cracking pattern on the top surface; (c) Cracks on the bottom surface; (d) Cracking pattern on the bottom surface.

267 As shown in Figs. 7(a), 8(a), and 9(a), the punching cone pointed by the red circle was fully or
268 partially developed over the thickness of the slab, including Span B in Slabs S2-PF and S4-PF, and
269 Span C in Slabs S2-PF and S3-PF. The worst case was Span B in Slab S2-PF because the critical
270 concrete failure appeared near to the internal support. In contrast, the punching perimeter location of
271 other slabs was identical to the area of the steel plate (Fig. 2(c)); this was due to the high local stress.

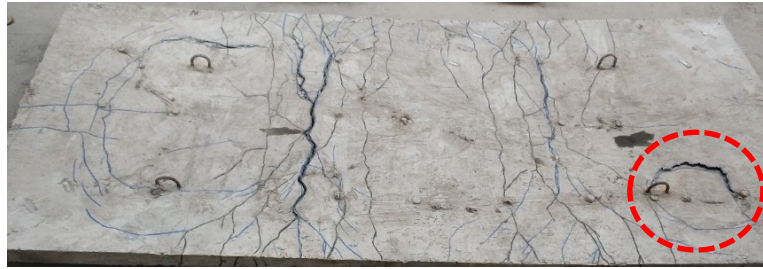
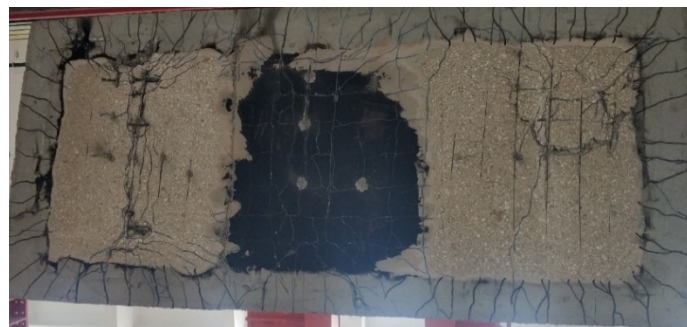
Figure 8

Fig.8. Failure modes of Slab S3-PF. (a) Cracks on the top surface; (b) Cracking pattern on the top surface; (c) Cracks on the bottom surface; (d) Cracking pattern on the bottom surface.

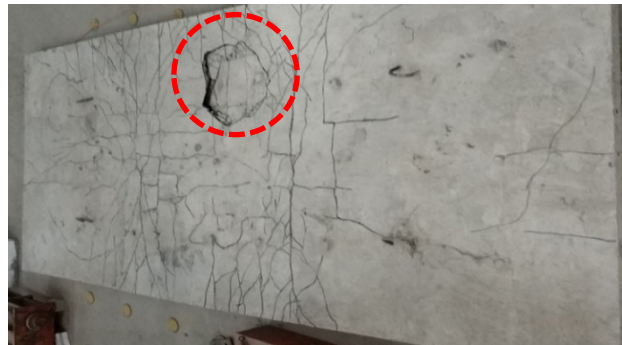
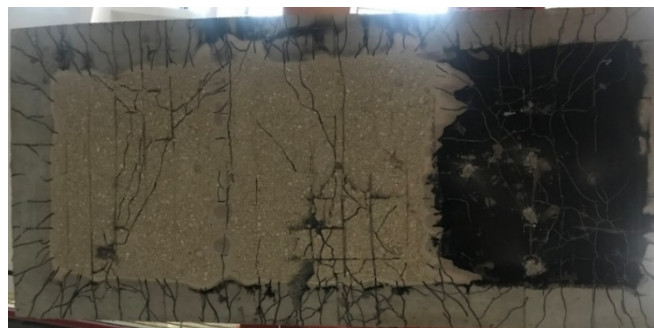
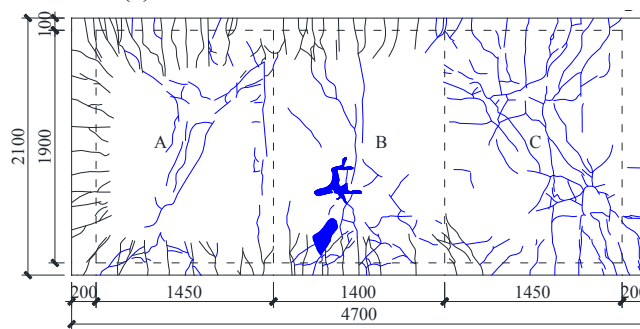
Figure 9

Fig.9. Failure modes of Slab S4-PF. (a) Cracks on the top surface; (b) Cracking pattern on the top surface; (c) Cracks on the bottom surface; (d) Cracking pattern on the bottom surface.

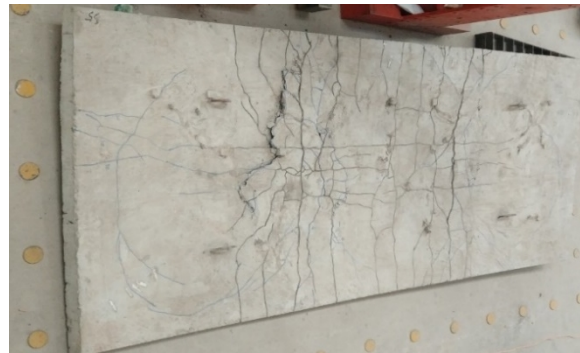
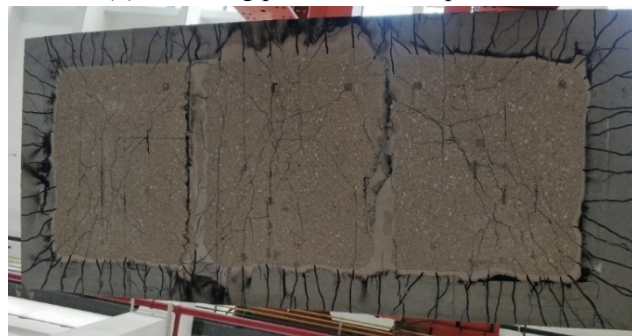
Figure 10

Fig.10. Failure modes of Slab S5-PF. (a) Cracks on the top surface; (b) Cracking pattern on the top surface; (c) Cracks on the bottom surface; (d) Cracking pattern on the bottom surface.

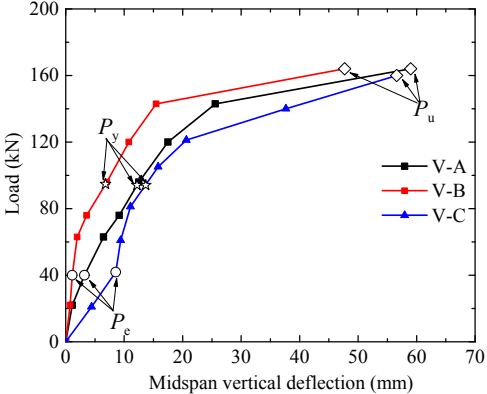
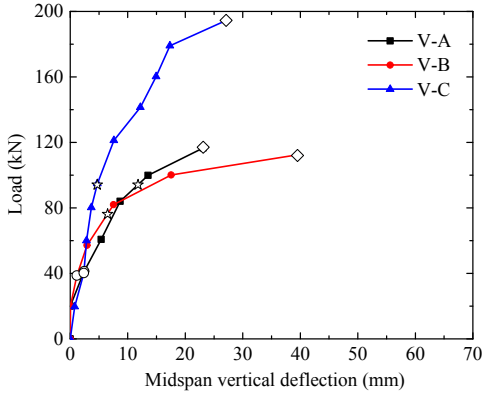
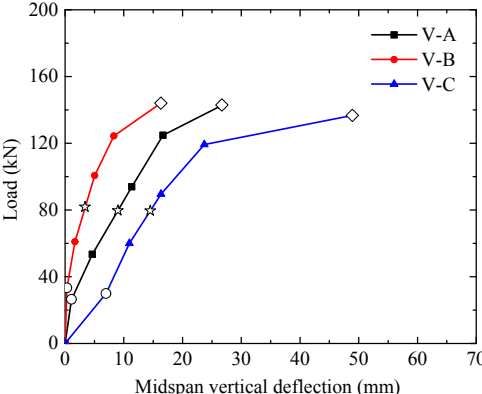
Figure 11

Fig.11. Load vs. midspan vertical deflection curves of six tested slabs; (a) Slab S0;(b) Slab S1-PF; (c) Slab S2-PF; (d) Slab S3-PF; (e) Slab S4-PF and (f) Slab S5-PF.

316 The load-midspan vertical deflection curve of Slab S0 is plotted in Fig. 11(a). For each span, the load-
317 deflection curve comprises three stages, including the un-cracked, cracked, and yielding stages. The
318 cracking load or elastic ultimate load (P_e) for each span is about 40 kN, and this is determined based
319 on the significant variation in the slope of the load-deflection curves. Thus, the initial structural
320 stiffness K_0 of each span is the ratio between P_e and its corresponding mid-span deflection (δ_e). It
321 should be noted that the P_e and δ_e values of each span can be obtained according to the significant
322 variation in the slope of the load-deflection curves, as summarized in Table 3.

334 Figs. 11(b)-11(f) show the load-deflection curves of the fire-damaged slabs S1-PF to S5-PF, and the
335 mid-span vertical deflections of Spans A, B and C are compared with each other while $P_y(\delta_y)$ and
336 $P_u(\delta_u)$ of each span are given in each figure.

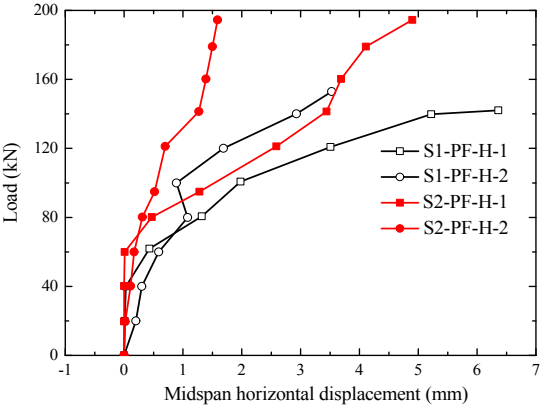
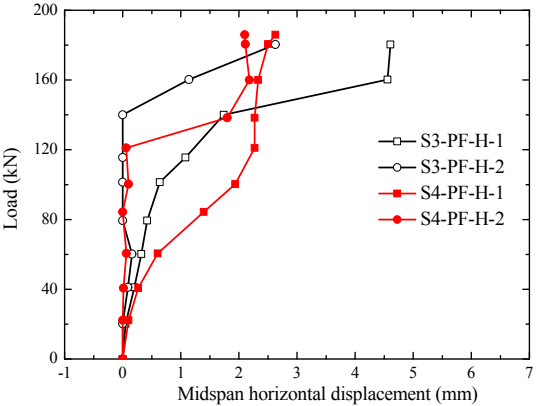
Figure 12

Fig.12. Load vs. midspan horizontal displacement curves of six tested slabs: (a) Slabs S1-PF and S2-PF; (b) Slabs S3-PF and S4-PF; (c) Slabs S5-PF and S0

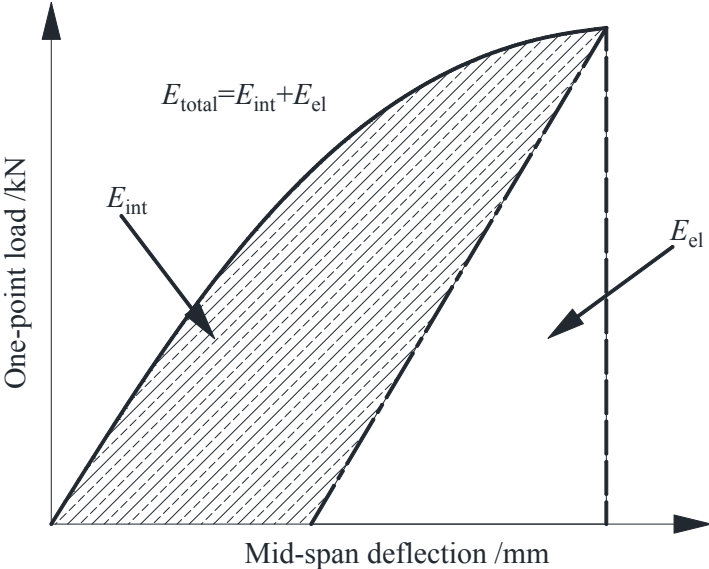
Figure 14

Fig.14. Ductility factor of absorption energy.
