THE CHARACTERISATION OF WHITE-ETCHING LAYERS FORMED  
ON ENGINEERING STEELS.

A Thesis submitted for the degree of Doctor of Philosophy

Robert Bulpett.

Experimental Techniques Centre, Brunel University

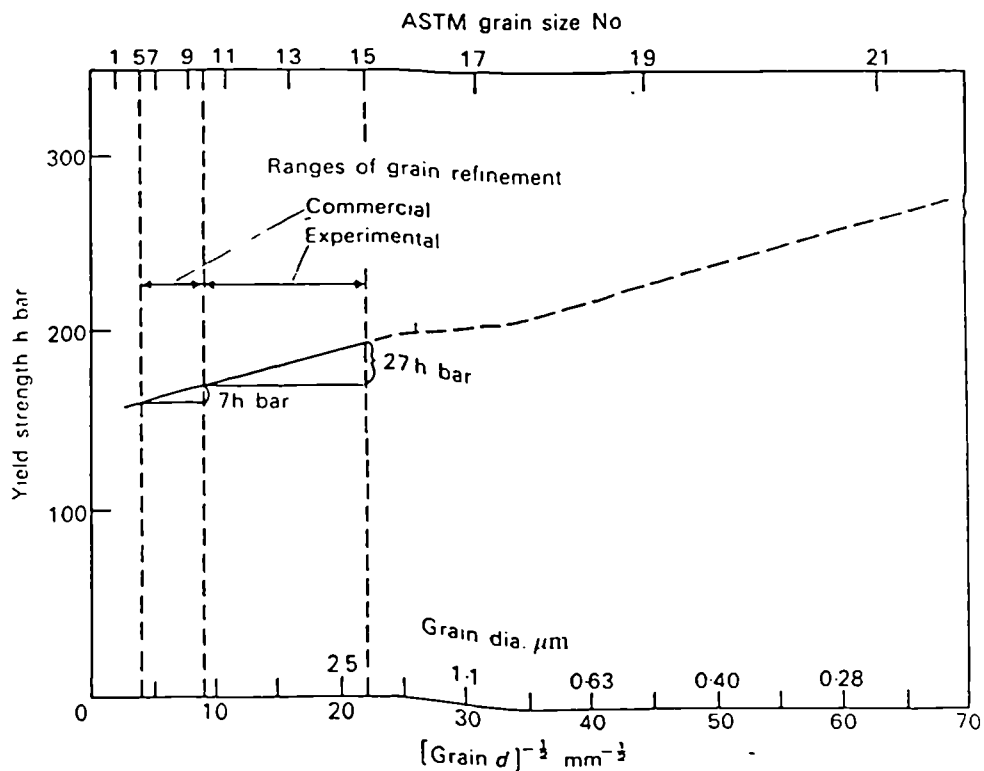
Figure 2.6. The strength of 0.5% C steel as a function of grain size. ( After Grange. 1966 )

The Hall-Petch relationship can be used to predict the effect of grain refinement on the strength of carbon steel, ( Petch 1953).

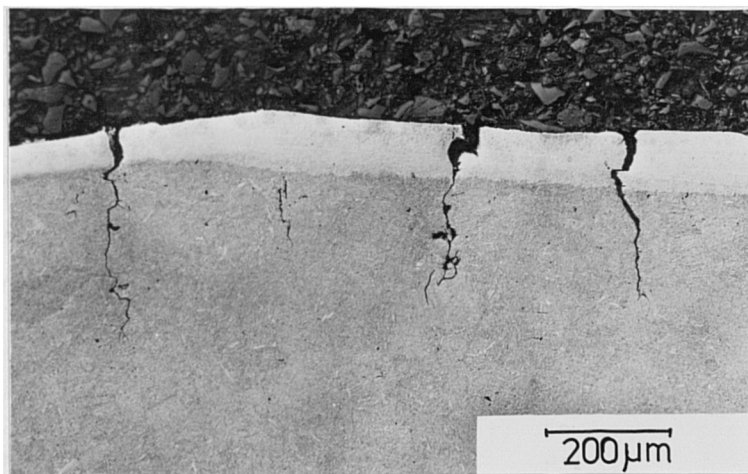
Figure 4.2.31. Chieftain gun barrel. Longitudinal cross-section at the "commencement-of-rifling", showing a region of white-layer exhibiting extensive cracking.

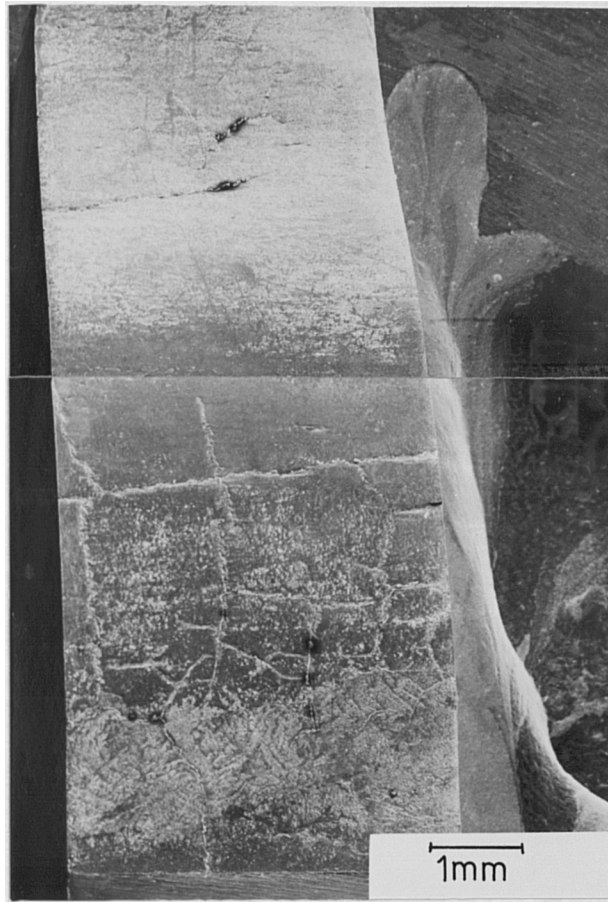
Figure 4.3.35. Chieftain gun barrel. Bore surface in the region of "commencement-of-rifling".

Examination of the microstructure following metallographic preparation, shows that to a depth of some  $100\mu\text{m}$ , the material has experienced a structural change with a modification of the martensite to produce a more homogeneous structure with an apparently greater density of carbides. See for example Figure 4.3.37, close to the surface and Figure 4.3.38, within the underlying matrix.
