**CORROSION AND ABRASION OF RINGS AND LINERS FROM
MARINE DIESEL ENGINES USING RESIDUAL FUEL**

A thesis submitted as partial
fulfilment of the
requirement for the degree of

DOCTOR OF PHILOSOPHY
OF
BRUNEL UNIVERSITY

P.E. DALE B.Tech.

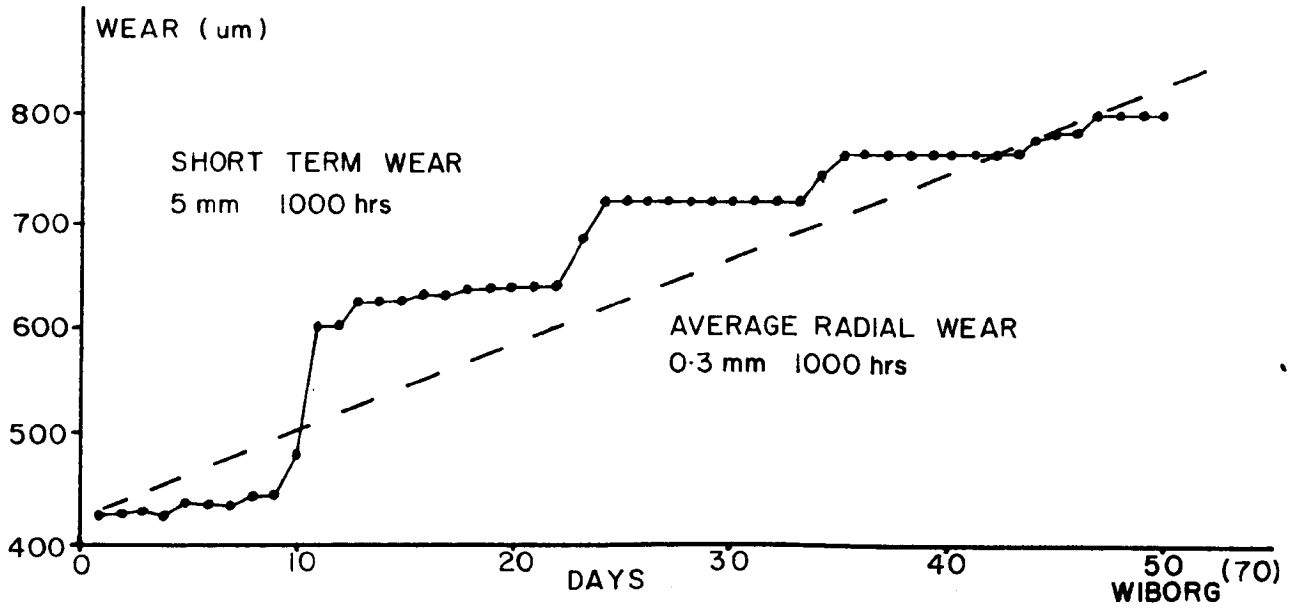
FIG. 7 Intermittent short term high wear rate periods in long term engine wear.

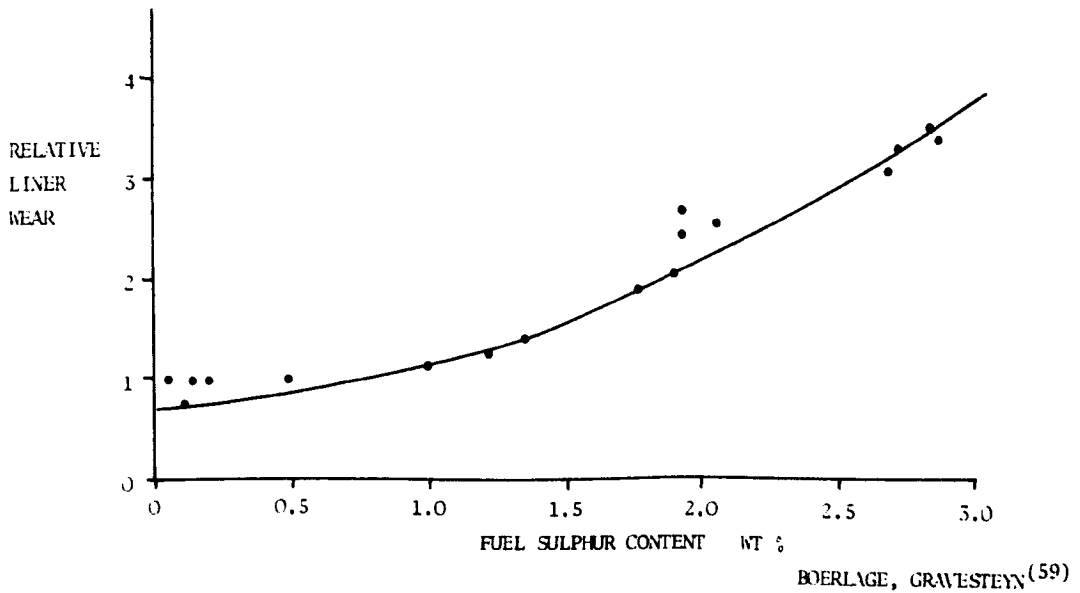
FIG. 10 Influence of fuel sulphur on liner wear.

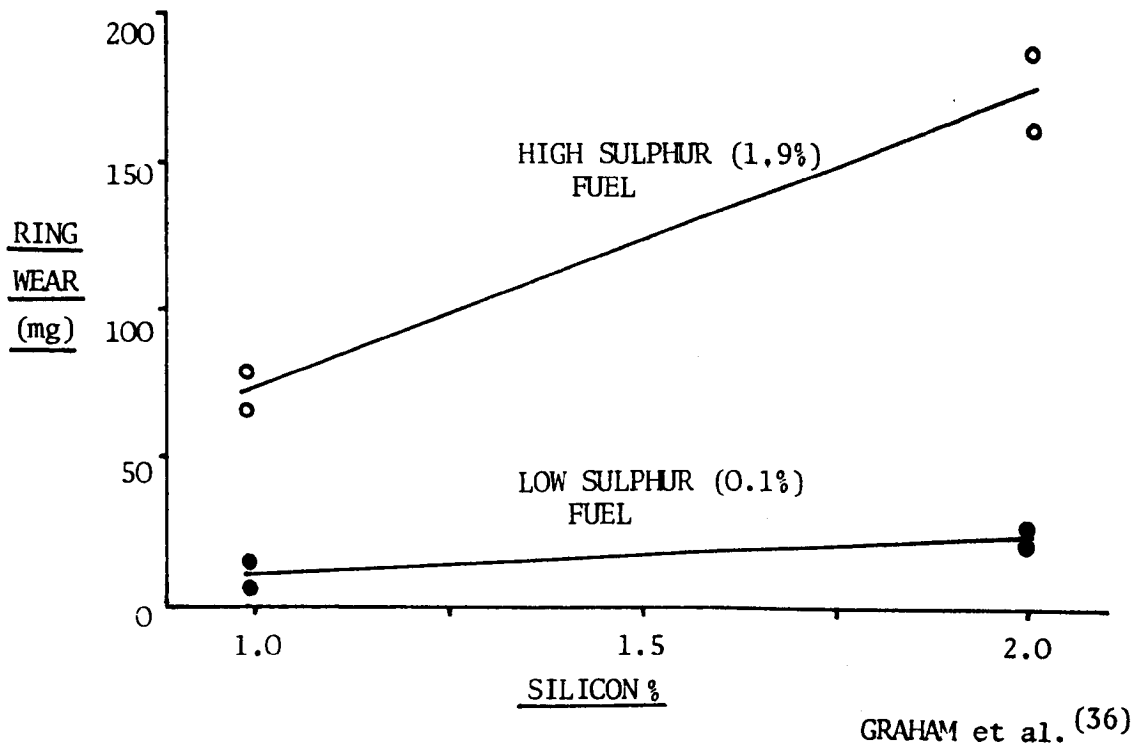
FIG. 11 Influence of fuel sulphur on ring wear.

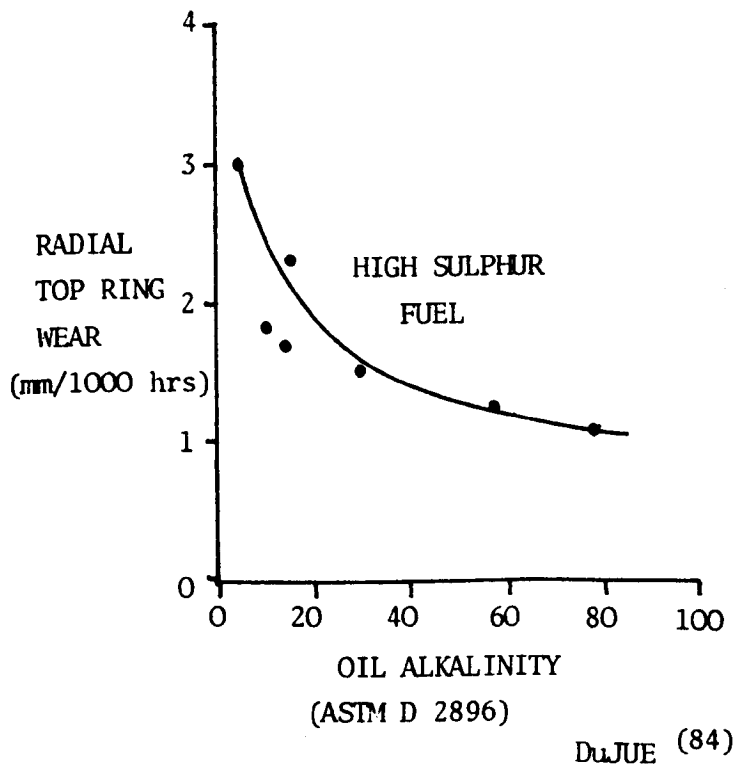
FIG. 12 Wear increase on top ring due to corrosion in the engine.

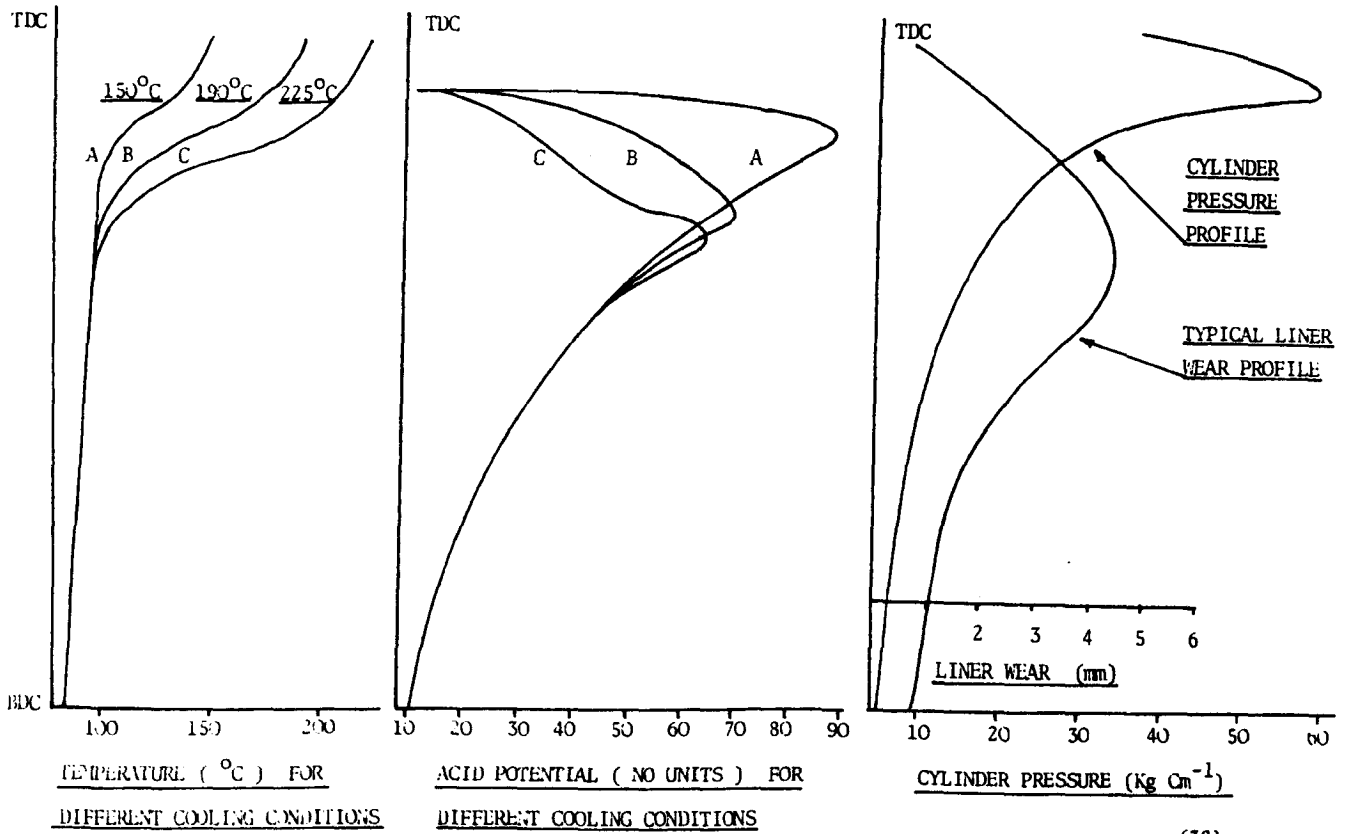
FIG. 15

Temperature, corrosion potential, gas pressure and liner wear profile for an engine running on a 3.0% sulphur residual fuel.

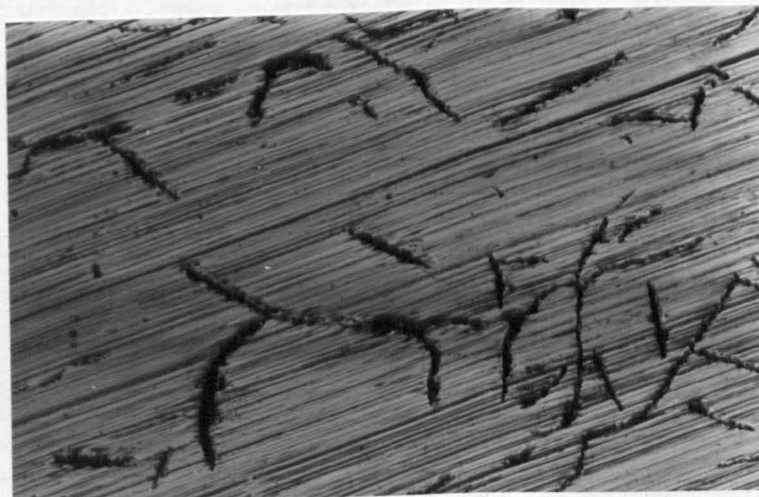
FIG. 28 Original ground surface of typical corrosion specimen.

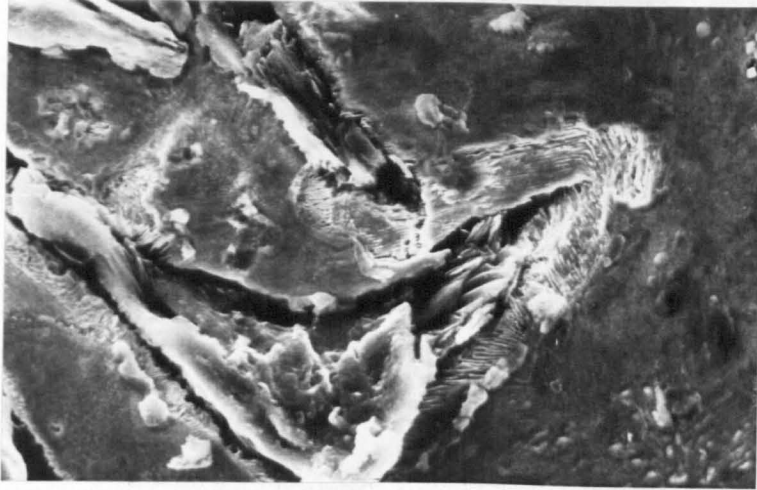
FIG. 29 Stimulation of corrosion by graphite. X1000

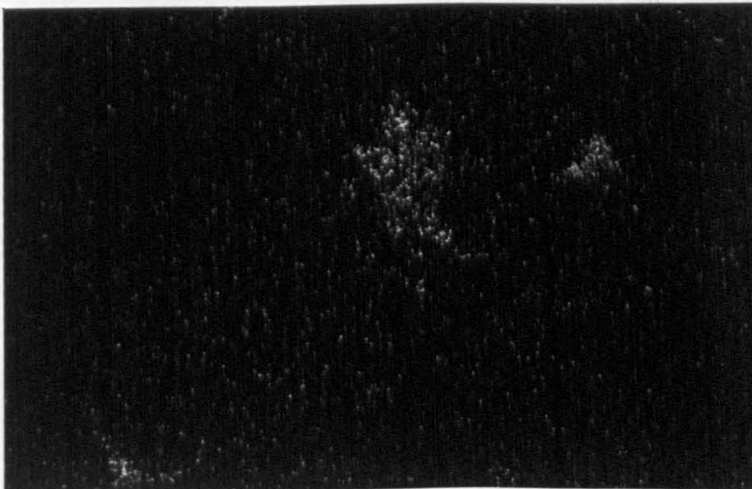
FIG. 40 E.P.M.A. for phosphorus over area shown in Fig. 39. X500

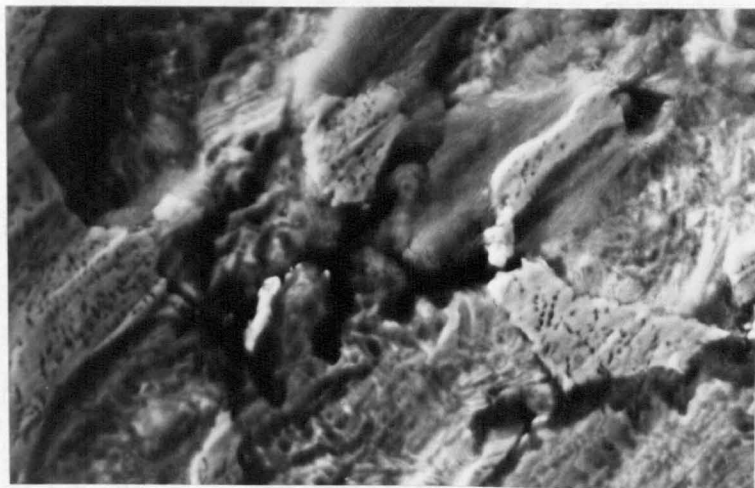
FIG. 41 Corrosion revealing internal structure X700
of phosphide eutectic.

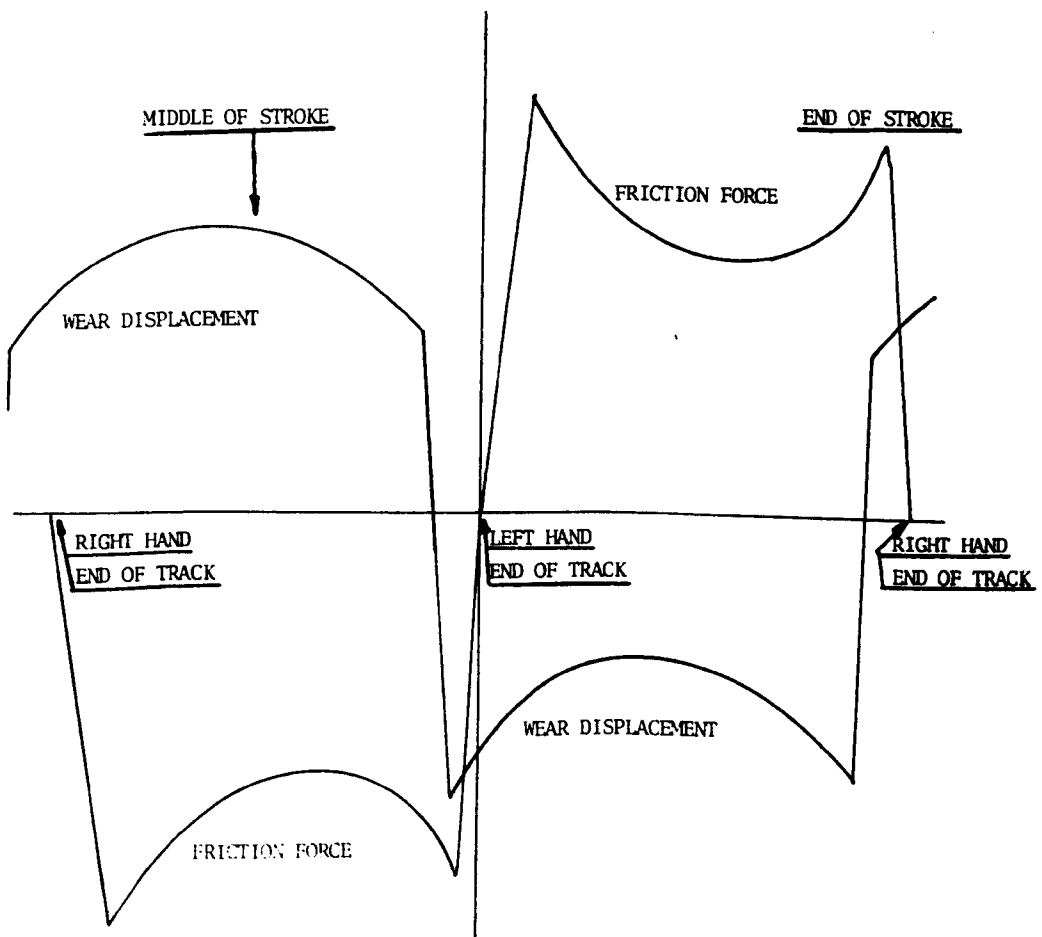
FIG. 52 Frictional force measured by transducers on either side of arm.

FIG. 111 Effect of acid addition on wear and friction transducer outputs. (see also FIG. 52)

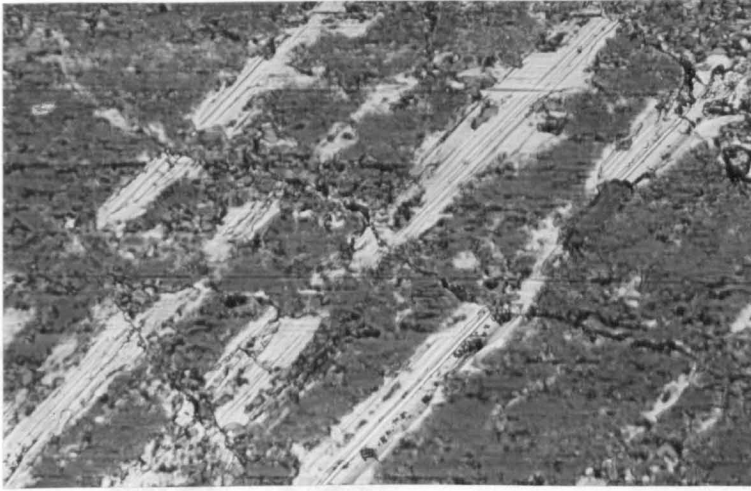
FIG. 63

Deposit on wear track in grooves of
the original grinding marks.

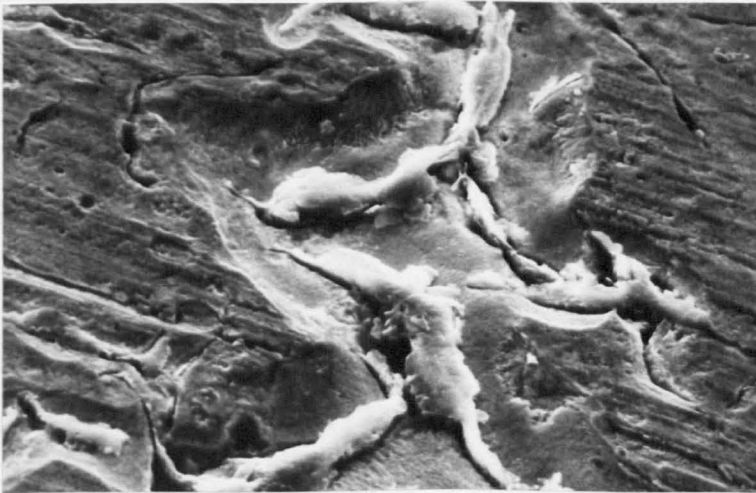
FIG. 69

Graphite stimulation of corrosion in areas subject to no abrasion.

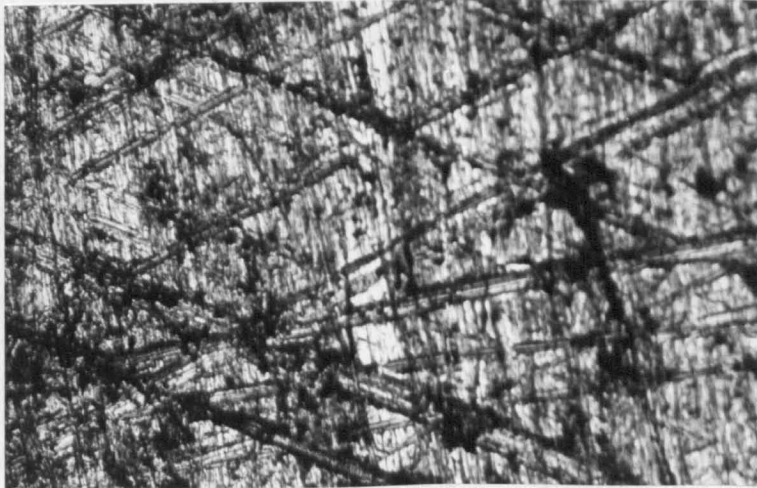
FIG. 83

Hardly any wear near the bottom of the stroke after 144 hours running on the liner run on low sulphur fuel.

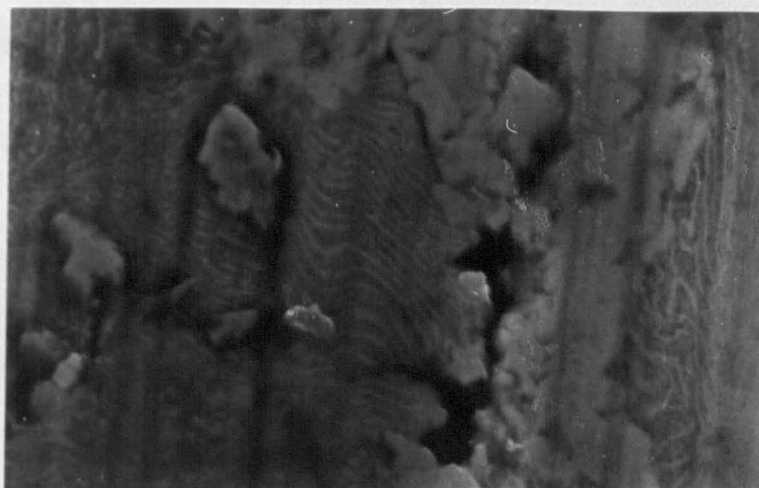
FIG. 93 Corrosion and abrasion on high sulphur test liner surface after 144 hours over top of stroke at 0° to the oil feed hole. X2000

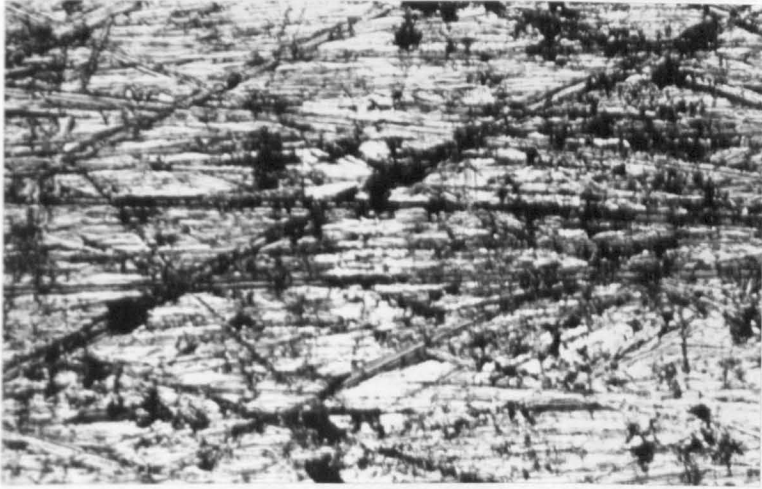
FIG. 96

Wear only in localised areas at bottom
of stroke. Conditions as in Fig. 93.

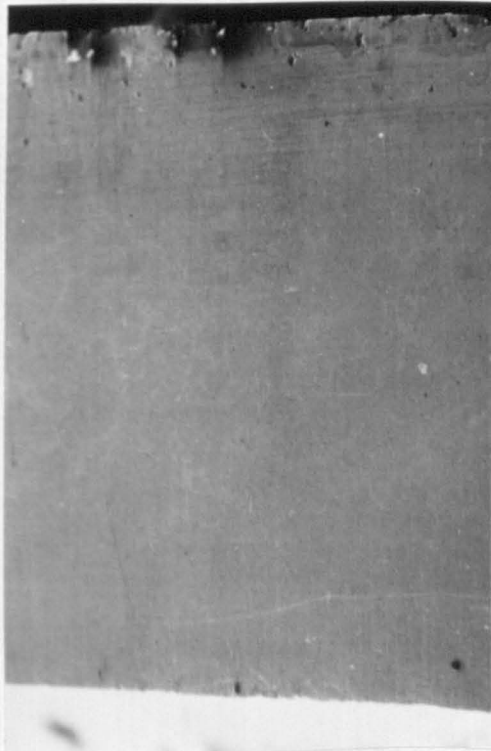
FIG. 97

Second ring rubbing face from high sulphur
test after 144 hours.

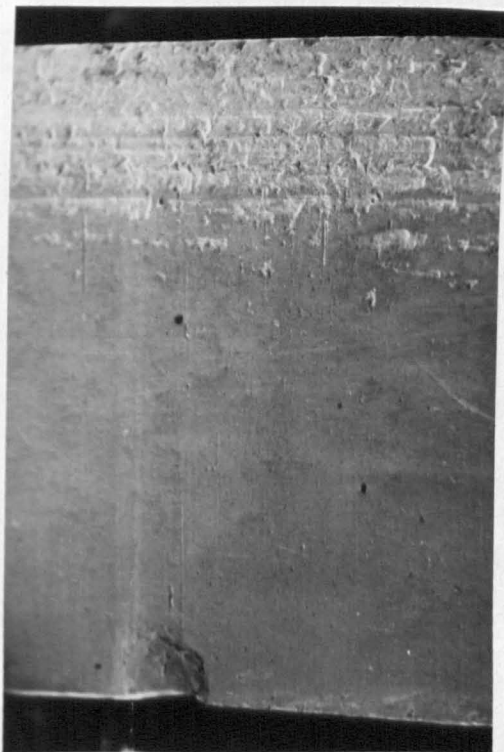
FIG. 98

Second ring rubbing face from low sulphur test after 144 hours. Area on left hand side is original surface finish which has not worn due to manufactured tapered ring section.

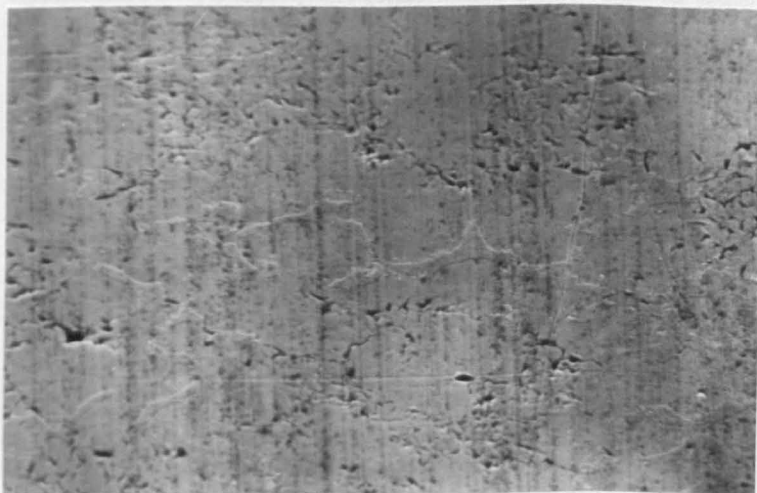
FIG. 99

Corrosive wear on ring wearing surface.
