Composite Structures

Retrofitting of interior RC beam–column joints using CFRP strengthened SHCC: Cast-in-place solution

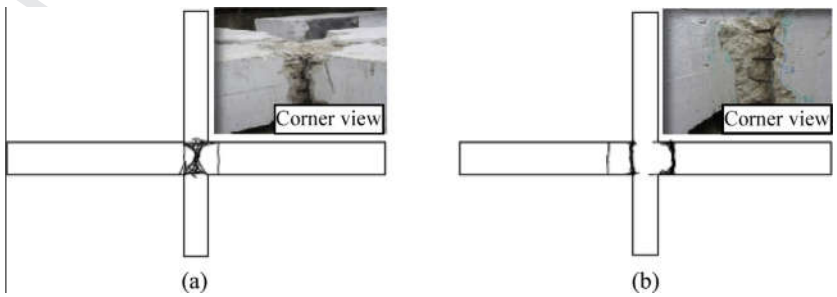
As shown in Fig. 4, in both specimens the extents of the damages included concrete crushing and spalling at the intersections of the beams and the columns, and sever sliding of longitudinal reinforcement due to significant bond deterioration. Flexural cracks on the right beam of both specimens were localized at the beam–joint interface. The main crack at the right beam of JPA3 and JPB specimens is at a position of 120 and 170 mm far from beam–joint interface, respectively. There were minor flexural cracks at the column-joint interfaces of JPB. Specimen JPA3 also has experienced severe damages concentrated in the joint region, where two wide diagonal cracks have formed and concrete cover has spalled. Additional information about experimental program and test results of the virgin specimens can be found elsewhere [20].

Fig. 4. The extent of damages before retrofitting (a) JPA3 and (b) JPB.

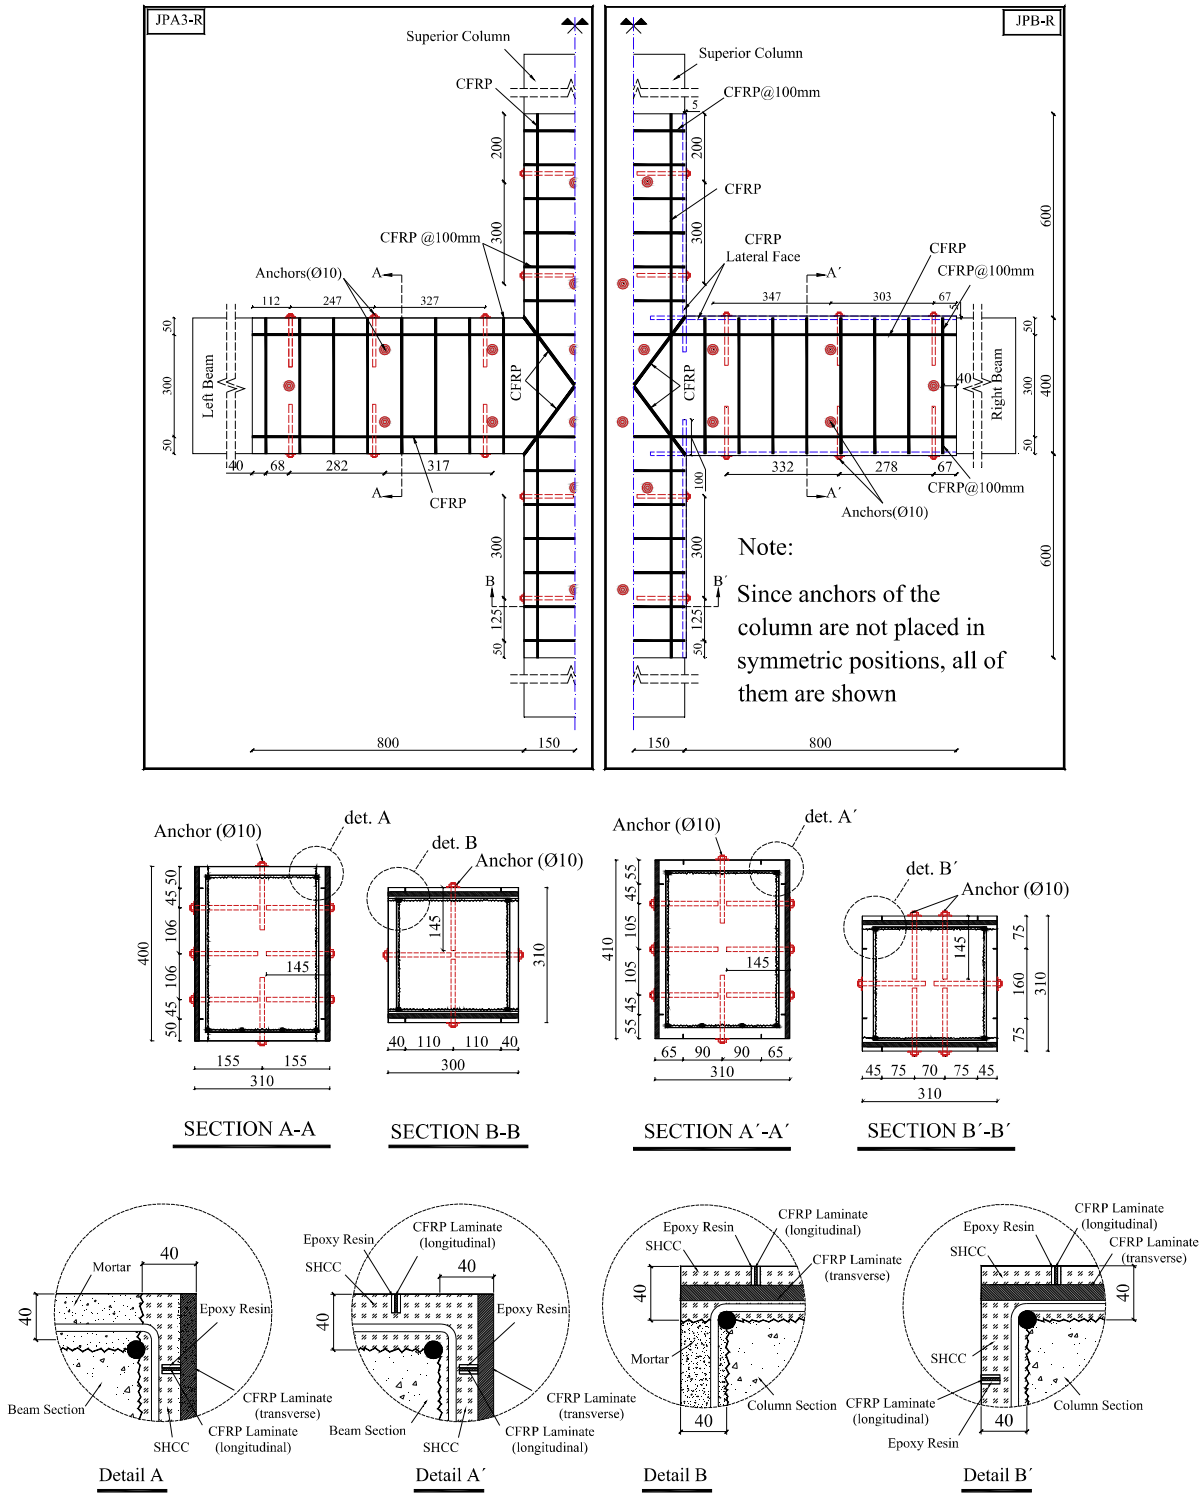
Fig. 5. Details of the schemes used for the retrofitting of the damaged specimens (dimensions in mm).

Details of the retrofitting schemes are presented in Fig. 5. The retrofitting length for both beams and columns was taken as twice of the section depth of the corresponding element. Therefore, using a jackhammer concrete cover was removed in the joint region and also in all lateral faces of the beams and columns of both specimens for a length of 800 and 600 mm, respectively. The concrete cover was initially removed up to a depth to expose the longitudinal reinforcements. Afterward, in an effort of increasing the interface area between casted-in-place materials and existing steel bars, the removal of the concrete cover continued up to attain approximately half of the diameter of the longitudinal bars. To seal the existing cracks, boreholes were drilled through the cracked sections. After cleaning the holes using compressed air, small diameter pipes were placed inside them, then the exposed crack development at the concrete substrate was sealed and epoxy resin SikaDur-52 was injected. After turning the specimen, the injection was repeated to assure that the cracked section was sealed as much as possible.

The adopted spacing for transverse CFRP laminates in both JPA3-R and JPB-R was 100 mm (Fig. 5). In an attempt to increase the shear resistance of the joint region, a pair of CFRP laminates with an X shape configuration was applied on each front and rear face of the joint region of both specimens.

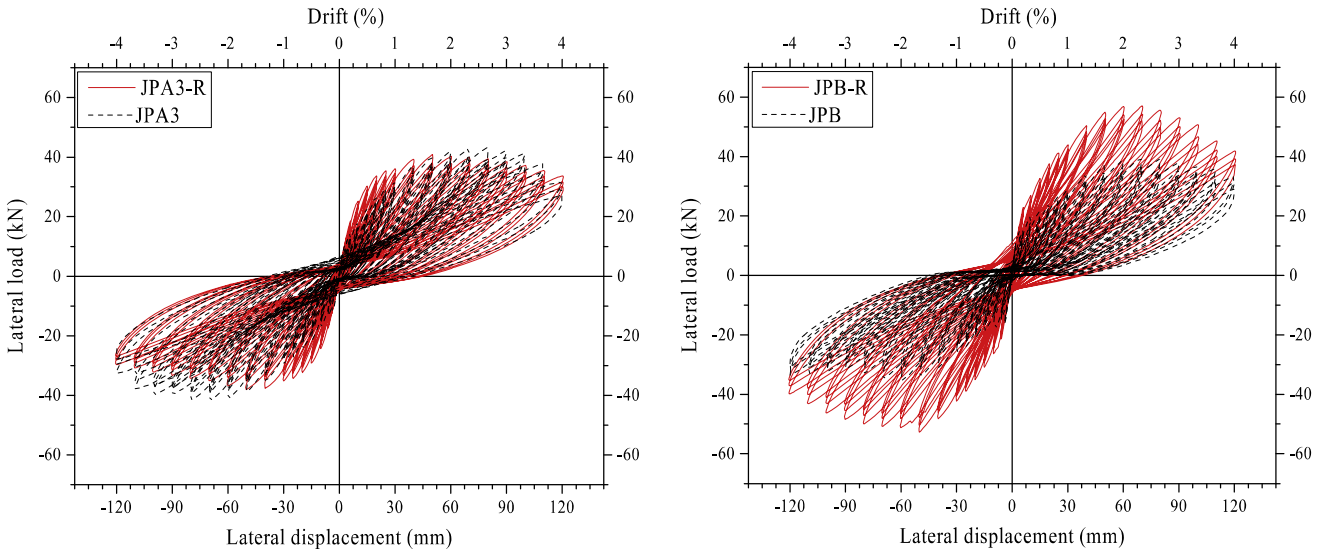
Fig. 7. Hysteretic responses of the specimens in the strengthened and virgin states.

Fig. 7 shows the hysteretic responses of both virgin and retrofitted specimens in terms of lateral load *versus* lateral displacement (and drift) registered at the top of the superior column. Both retrofitting techniques resulted in stable loops with smooth decay of load carrying capacity in the post-peak stage of the structural response. The values registered for the maximum lateral load (F_P) and its corresponding drifts (d_P) for specimens in the retrofitted and virgin states are listed in Table 1. The increase level in terms of lateral peak load after retrofitting is also indicated in this table. According to the obtained results, the retrofitting technique adopted for JPA3-R recovered up to 93% of the maximum lateral load carried out by this specimen in its virgin state, calculated as the average load in the positive and negative directions. Applying the retrofitting technique to all lateral faces of the framed

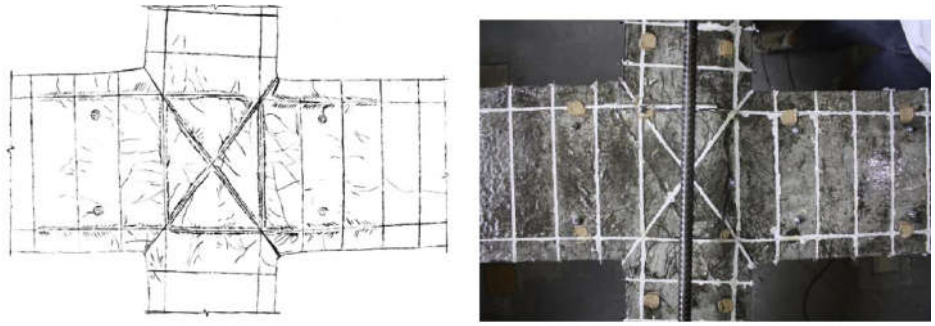
JPA3-R: The first series of cracks has initiated at the cycles corresponding to 0.33% of drift. These cracks were formed at the top face of the left and the right beams at a distance of 100 mm from the lateral faces of the column. At cycles corresponding to 0.5% of drift, cracks at the bottom faces of both left and right beams, symmetric to the cracks on top face, were observed. Some relative sliding between retrofitting layer and concrete substrate was observed when cycles of 0.83% drift were reached.

The first series of the inclined cracks at the junction of the beams and columns was observed in all four corners at the cycles corresponding to 1% of drift. Further increase in the lateral displacement at the top of the superior column resulted in the progress of these cracks into the interface of the epoxy adhesive/SHCC of the bonded X shape CFRP system at the joint region. Thus, for any larger displacement demand, damages were localized at the joint region in the form of progressive separation between the epoxy adhesive and the SHCC. Finally, at drift cycles of 1.67%, due to the load reversal effects, the debonding was almost progressed along the entire length of the elements of the X shape CFRP

Fig. 8. Damage propagation and concentration at the failure of (a) JPA3-R and (b) JPB-R.

configuration. As a consequence of this debonding, a total loss in contribution of these inclined CFRP laminates as a part of shear resisting mechanism of the joint region was occurred. Thus, shear failure of the joint region was the governing failure mode of JPA3-R.

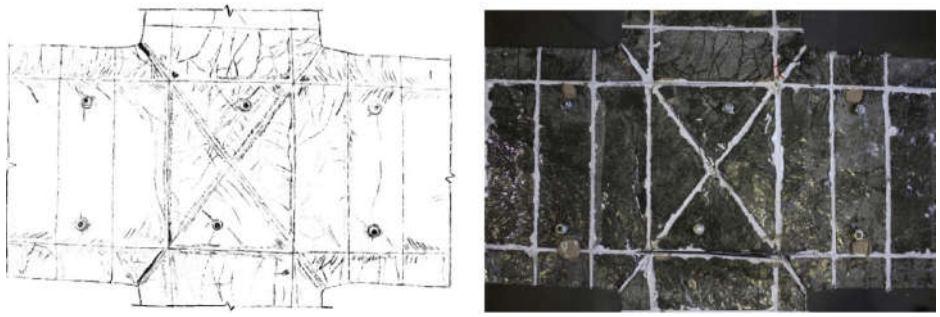
(b) JPB-R

JPB-R: The onset of the first series of cracks was at the set of cycles corresponding to 0.5% of drift. These cracks were formed at the top and bottom faces of the left and right beams in a distance of approximately 90 mm far from lateral faces of the column. The inclined cracks at the junction of the beams and columns were initially formed at cycles corresponding to a drift level of 0.83%. Similar to the case of JPA3-R, these set of cracks resulted in a progressive debonding along the interface of epoxy adhesive/SHCC of the X-shaped CFRP system at the joint region. At drift cycles of 1.67% this debonding was already progressed along the entire length of the inclined CFRP laminates. At the same cycles, the longitudinal steel bars at the top face of the right beam started to have significant sliding, so that the concrete cover perpendicular to the bended end of these bars was cracked. As it will be discussed in the next section, sliding of these rebars resulted in degradation of flexural capacity of the beams when the top face of them was in tension. The non-symmetrical response of JPB-R, in negative and positive loading directions, can be caused by this phenomenon. At the next sets of the cycles, corresponding to 2% of drift, the already cracked concrete cover over the bended region of these bars was spalled off. Afterward, any further increase in drift demand just followed by widening of the existing X-shaped cracks at the joint region. Therefore, the shear failure at the panel of the joint resulted in degradation of lateral load resistance of JPB-R in both negative and positive loading directions.

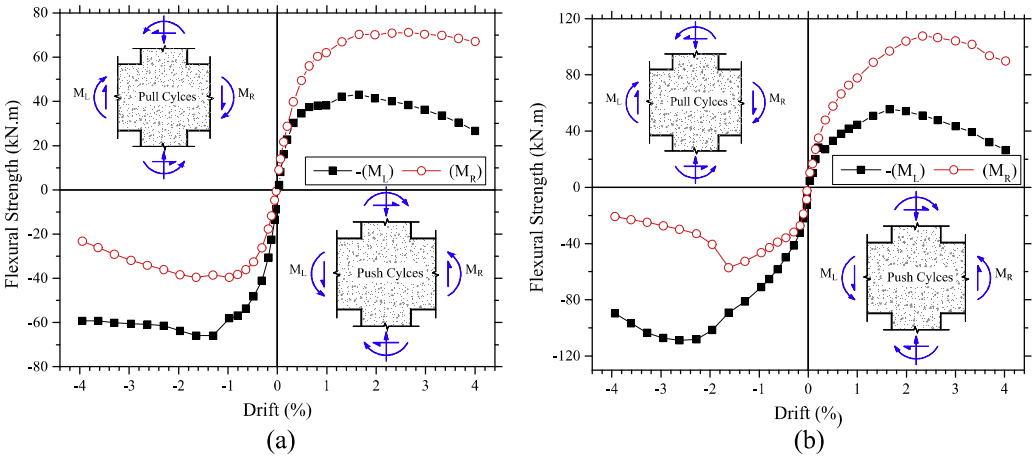
Fig. 9. Development of the resisting bending moment at the interfaces of the beams with columns (a) JPA3-R and (b) JPB-R.

According to Fig. 9a, the maximum bending moments developed in the left (M_L) and the right (M_R) beams of JPA3-R, during the negative displacement, were +65.94 and −39.6 kN · m both at a drift level of −1.64%. During the positive displacement, the left and the right beams reached their maximum bending moment, −43.04 and +71.17 kN · m, at drift levels of +1.65% and +2.65%, respectively.

As depicted in Fig. 9b, the values of maximum bending moments for JPB-R in the left and the right beams, during the negative displacement were +108.81 kN · m at a drift level of −2.62% and −57.16 kN · m at −1.62% of drift, respectively. The developed maximum bending moment for the positive displacement, in the left and the right beams were −55.64 and +107.46 kN · m at drift

levels of +1.66% and +2.33%, respectively. A sudden reduction observed in bending moment capacity of the right beam during negative loading at drift cycle of 1.67% (Fig. 9b) was caused by a significant sliding of longitudinal bars at the top face of the right beam, as discussed in the previous section.

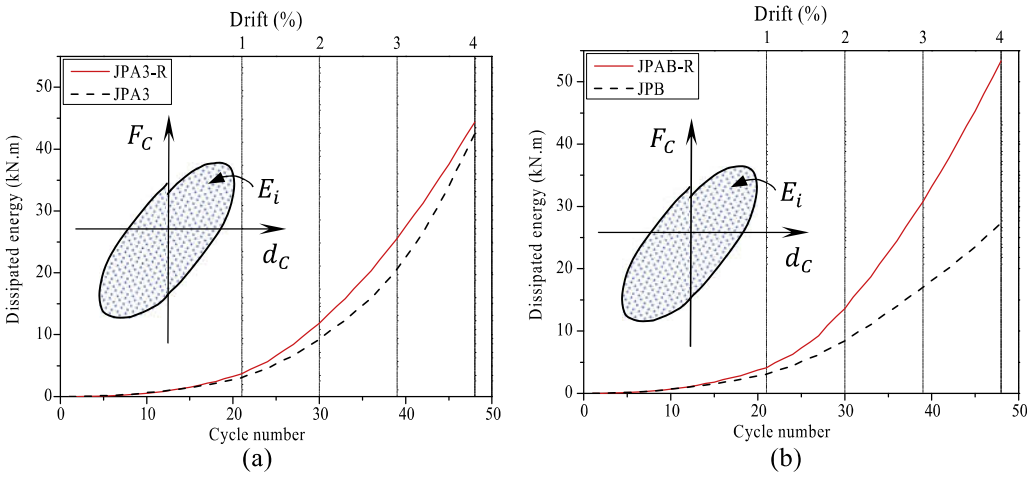
Fig. 10. Evolution of the dissipated energy during the cyclic loading (a) JPA3-R and JPA3, and (b) JPB-R and JPB.

Energy dissipation capacity of a RC element is the consequence of inelastic deformation and damage propagation. Opening and closing of cracks contribute significantly to the energy dissipation capacity, as well. Therefore, for SHCC material with the potential of formation multiple diffused micro cracks, a high level of energy dissipation under cyclic loadings is expected. The amount of dissipated energy per cycle, E_i, can be calculated from the enclosed area in each loading cycle, as presented by the hysteresis response of lateral load *versus* lateral displacement. Summation of the dissipated energy with respect to the increment in lateral drift results in cumulative dissipated energy up to each given level of interstory drift. The evolution of the dissipated energy for retrofitted and corresponding specimen in virgin state is presented in Fig. 10. During all loading steps, both retrofitting solutions have provided a cumulative dissipated energy higher than the one registered in their corresponding virgin state. In this respect, the retrofitting solution applied in JPB specimen was more effective. In fact, at 4% of drift the cumulative dissipated energy of JPA3-R was 44.4 kN·m, which was only 5% larger than the corresponding value in JPA3, while the JPB-R reached 53.4 kN·m indicating an increase of 95% comparing to value calculated for JPB.

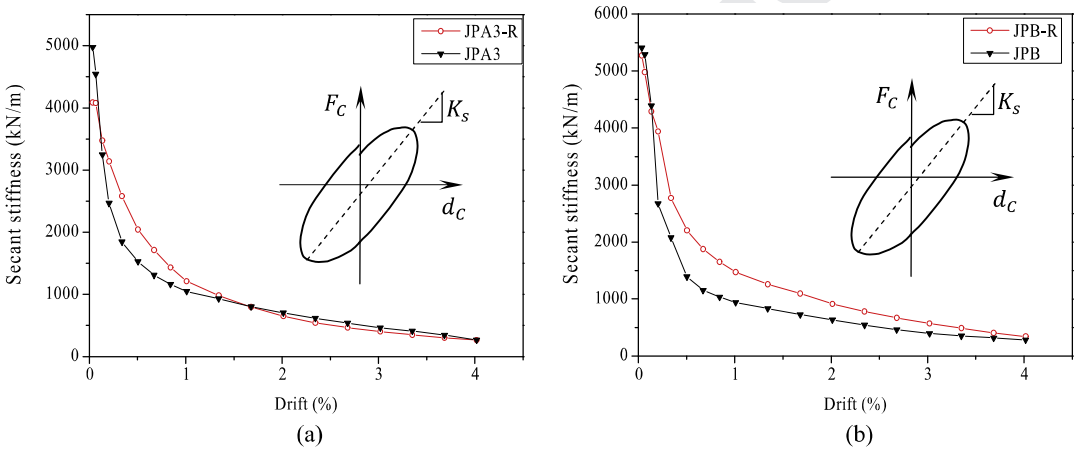
Fig. 11. Secant stiffness evolution in (a) JPA3-R and JPA3, and (b) JPB-R and JPB.

to this figure, the retrofitting technique adopted for JPA3-R has just restored 82% of the initial secant stiffness of this specimen in its virgin state, while the technique applied on the JPB-R has almost restored the initial secant stiffness registered in JPB (its virgin state). This can be explained by a less effective bond between the casted mortar and the old concrete of JPA3-R.

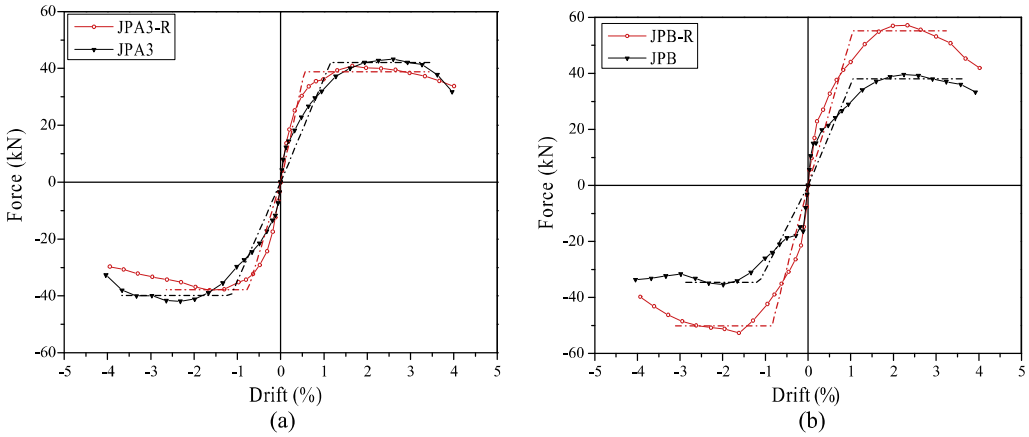
Fig. 13. Envelope of the load *versus* drift for both the repaired and virgin specimens along with the equivalent elastic–perfectly plastic curves (a) JPA3-R and JPA3, and (b) JPB-R and JPB.

assuming equivalent elastic–perfectly plastic response. To estimate this bi-linear curve, two conditions should be fulfilled: (i) the area under this curve should be equal to the one of the envelope of load *versus* lateral displacement, and (ii) the deviation between these two curves, measured based on the absolute sum of the areas enclosed between these curves, should be the minimum (see Fig. 12). The displacement ductility index is then calculated as the ratio between the ultimate and the yield displacements. In this context it was assumed for the ultimate displacement the one corresponding to 10% loss of the peak load ($0.9F_p$). The envelope of the load *versus* drift, and also the equivalent elastic–perfectly plastic curves estimated for both the retrofitted and virgin specimens are presented in Fig. 13. Table 3 also indicates the yield and the ultimate displacements obtained for the calculation of the displacement ductility index for the positive and negative loading, where μ_Δ^V and μ_Δ^R are the ductility for the specimen in the virgin and retrofitted state, respectively. The reported ductility index is calculated as the average ductility using the corresponding values of displacement ductility in both positive and negative displacements. It is verified that, for both retrofitted specimens the average of the yield displacements, in negative and positive directions, has decreased when compared to the average value registered for their corresponding specimens in the virgin state. The reduction of the yield displacement is a consequence of lower stiffness degradation assured by the retrofitting system, mainly during the cycles up to 1.15% of drift. According to the results included in Table 3, and comparing to the displacement ductility registered in the specimens in its virgin state, the retrofitting strategy has assured an increase of 56% and 12% in displacement ductility of JPA3-R and JPB-R, respectively. The higher increase in displacement ductility of JPA3-R can be attributed to the larger sliding between the retrofitting scheme and the concrete substrate, and also due to the existence of larger damages before retrofitting of this specimen.
