# The water weakening effect on the progressive slope failure under excavation and rainfall conditions

Xiang Yu<sup>1,2</sup> · Tao Zhao<sup>2</sup> · Bin Gong<sup>2</sup> · Chun'an Tang<sup>1</sup>

## Abstract

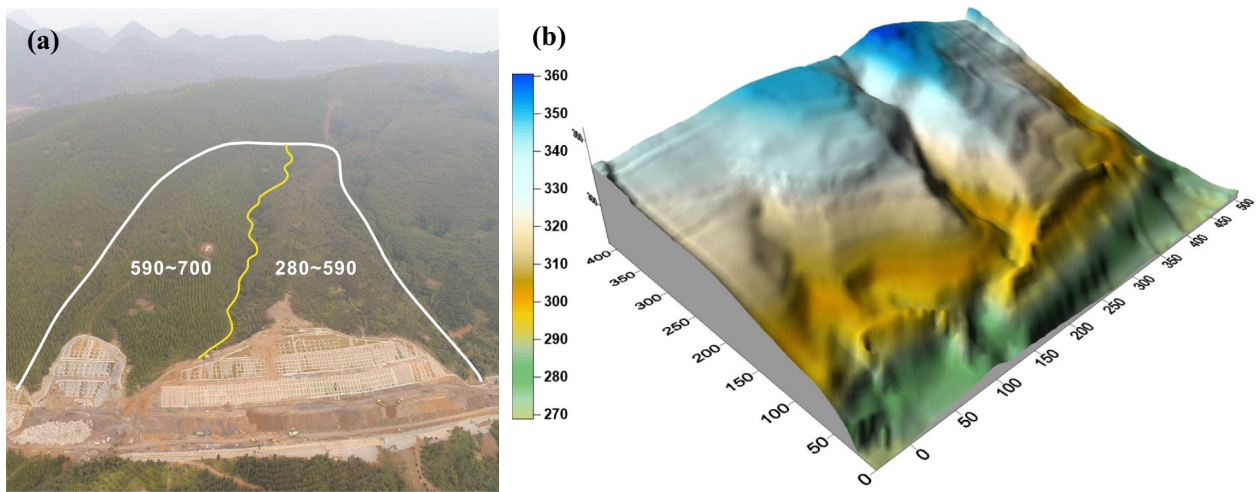
The studied highway slope is situated in Guangdong Province, China. The slope is covered with dense vegetation, which can be divided into K158+280~590 and K158+590~700 sections by a gully, as depicted in Fig. 1(a). The terrain slopes downwards from north to south, with a relative height difference of 90 m, as shown in Fig. 1(b). The natural slope angle ranges from 16° to 20°, and the inclination is 180°. The area presents a syncline structure, the north and south rock strata dip between 15–53° and 19–61° respectively, which are both dip rock strata and not conducive to slope stability.

Fig.1 Slope topography and geomorphic characteristics: (a) UAV image, (b) 3D terrain map

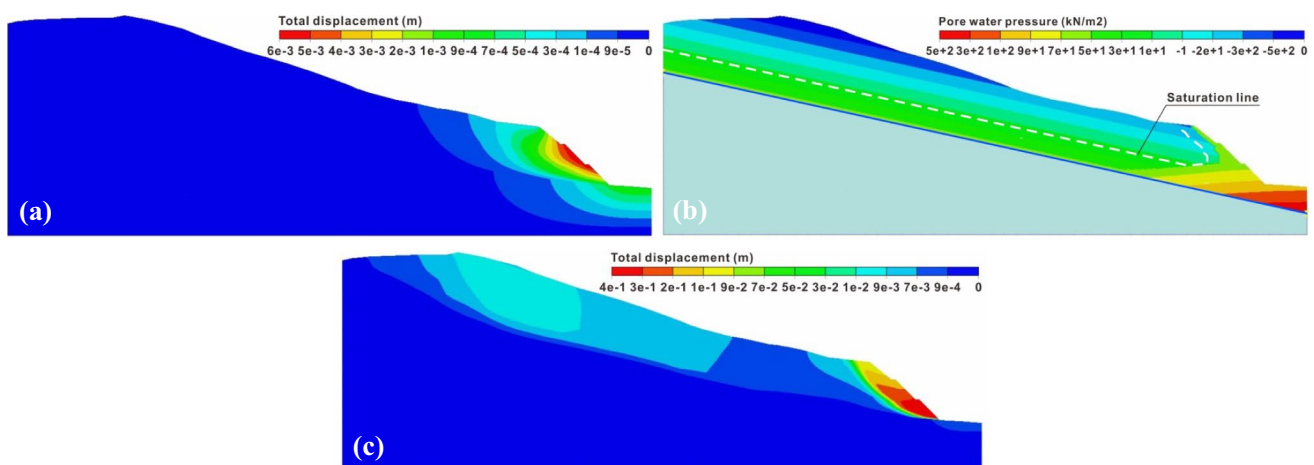
Figure 7 illustrates that the slope is stable at the initial stage, with a factor of safety of 1.229. Following the initial excavation, the factor of safety decreased to 1.085, indicating the onset of the creeping stage. Deformation concentrated in the surface from the middle first-level to the lower fourth-level slope, as shown in Fig. 7(a). Additionally, a shallow sliding surface occurred from the top of the excavated slope to the slope toe, as depicted in Fig. 5(a). In the rainfall stage, the slope skipped the extrusion stage and directly entered the sliding stage, with the factor of safety reduced to 1.015. Rainfall infiltrated along the excavated slope, creating a transient saturation zone in the front and raising the groundwater level of the lower shale. Meanwhile, the rest remained unsaturated with suction pressure values increasing from bottom to top, as demonstrated in Fig. 7(b). This resulted in the loss of effective stress of the front soil mass and reduction of shale shear strength parameters, leading to traction landslide of the excavated slope and deformation of the middle and rear soil mass, as depicted in Fig. 7(c).

Fig.7 Deformation and seepage characteristics of slope in initial excavation and rainfall stage: (a) total displacement after initial excavation, (b) pore water pressure at 93-day of the rainfall, and (c) total displacement after rainfall

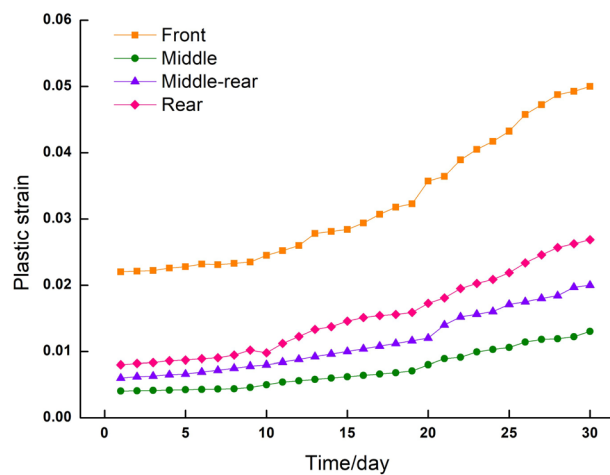
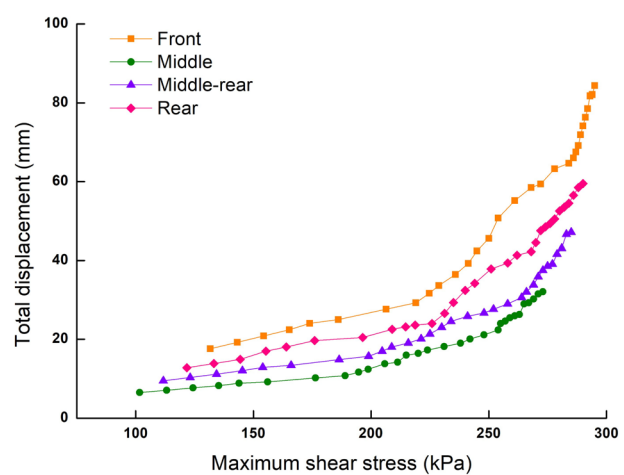
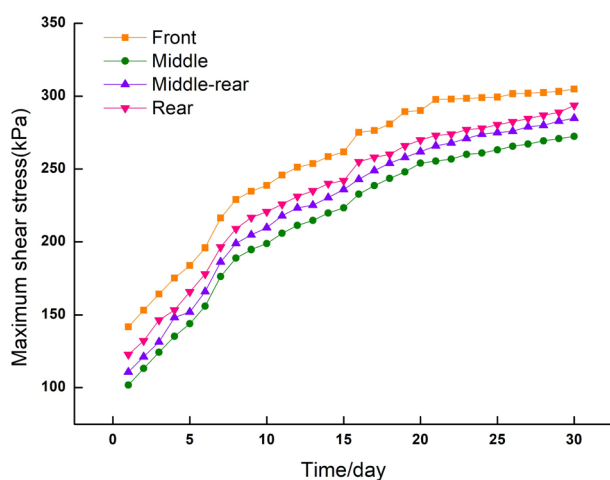
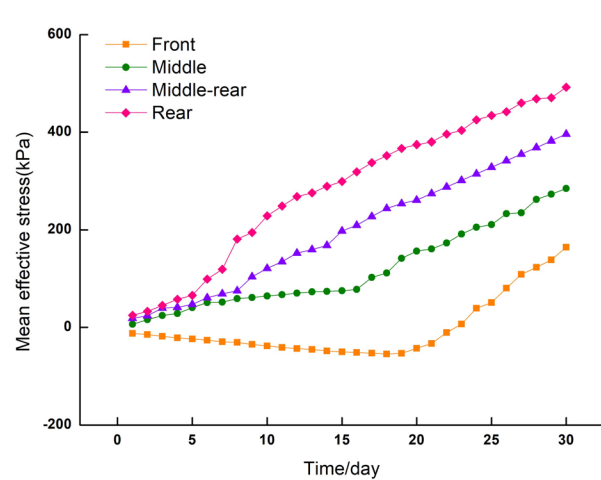
Figure 9(a) and (b) illustrate the three-stage deformation of hydrated shale. Unlike the instantaneous creep–creep stability/attenuation–accelerated creep process observed in shear tests and uniaxial compression tests (Fang et al. 2022b; Cai et al. 2019; Zhu et al. 2019a, b), the strain–time curve gradually increases. During the initial stage (1–10 days), the deformation rate remains nearly constant at zero or a low level, with no significant increase in plastic strain. In the intermediate stage (10–20 days), the deformation rate slowly increases. During the later stage (20–30 days), the deformation rate increases sharply until slope failed. The maximum shear stress exhibits a nonlinear relationship with

**Fig.9** Mechanical characteristics of shale under hydration. (a) Plastic strain vs. time (b) Maximum shear stress vs. displacement (c) Maximum shear stress-time (d) Mean effective stress vs. time

When considering Fig. 9(c) and (d), it is evident that during the initial stage, shale exhibits anelasticity where the plastic strain lags behind the stress change. As a result of shear strength reduction, the shear stress significantly increased, with the average increment being 98 kPa at the 10th day of hydration across measuring points. Concurrently, effective stress changes at the front, rear, and middle-rear measuring points, where the front recorded tensile stress increasing from -12.5 kPa to -38.1 kPa, the data obtained at the rear and middle rear indicated compressive stress, with values increasing from 18.47 kPa and 24.69 kPa to 120.81 kPa and 228.97 kPa, respectively. However, the plastic strain remained relatively constant. Despite slight shale mechanical parameter reduction altering the slope stress state, the residual shear strength enabled the hydrated layer to remain stable, and the high elastic modulus restricted deformation. During the intermediate stage, moderate increases in plastic strain are observed. The growth rate of shear stress at each measuring point slows down, and the effective tensile/compressive stress exhibits an obviously growth, suggesting the tensile shear and compressive shear deformation are occurred at the front and middle to rear part, respectively. In the later stage, the shear stress-time curve remains almost constant, while the plastic strain continues to increase. Figure 9(b) shows that when the maximum shear stress exceeds 270 kPa, the displacement sharply rises, indicating that the hydrated shale has reached its yield limit and is rapidly damaged. The damaged soil masses at middle to rear push forward, leading to increased compressive stress and causing the front failure mode to transition from tensile shear failure to compressive shear failure.
