Failure Analysis of a Steel Motorcycle Kickstand

Zainul Huda · Koh Wen Shi · Robert Bulpett

Submitted: 1 July 2008 / in revised form: 28 April 2009 / Published online: 12 May 2009
© ASM International 2009

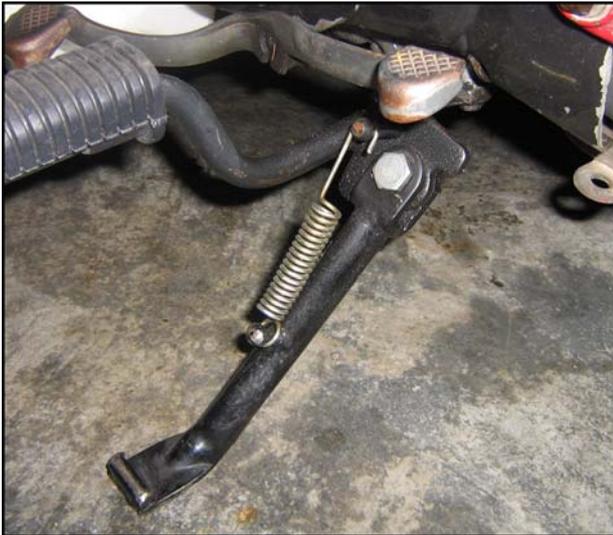
A motorcycle kickstand is an accessory component for a motorcycle; it is a swiveling metal bar for holding a two-wheeled vehicle, such as a motorcycle, upright when not being ridden. The kickstand is attached to the motorcycle using a bolt and nut, so that its position can be adjusted. In operation it can rotate almost 100° up and hides under the side cover keeping it safely out of the way of the rider. Figure 1 shows a general view of a kickstand attached to a motorcycle.

Fig. 1 General view of a kickstand attached to a motorcycle
