Composite Structures

Assessment of the efficiency of prefabricated hybrid composite plates (HCPs) for retrofitting of damaged interior RC beam–column joints

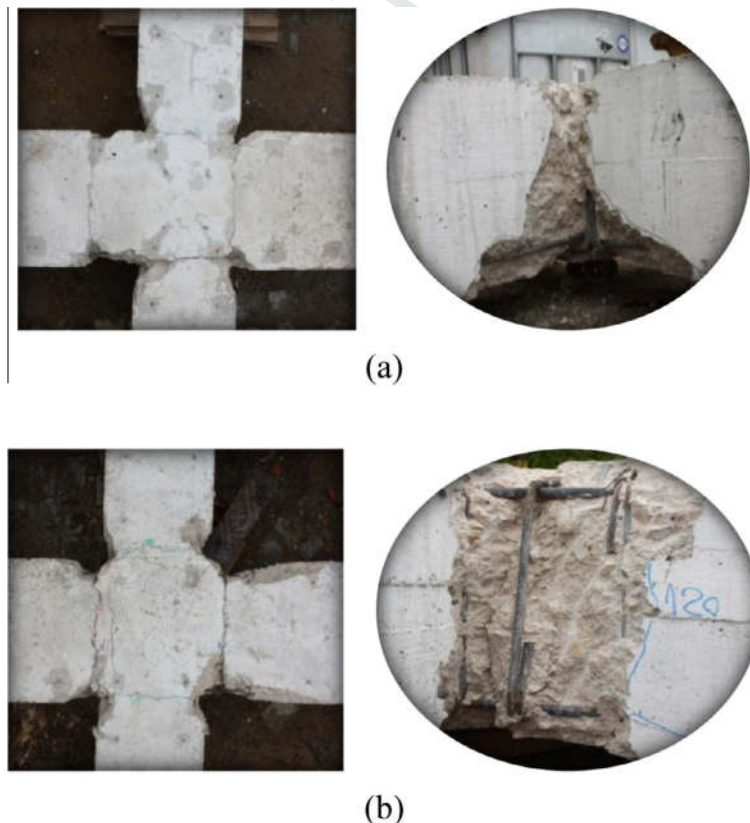
Fig. 4. The extent of damages before retrofitting (a) JPA0 and (b) JPC.

As consequence of deficient bond between smooth longitudinal bars and the surrounding concrete, the damages at the end of the test were mainly localized in the vicinity of the joint region into the beams and columns. As shown in Fig. 4, the extent of the damages includes concrete crushing and spalling off at the intersections of the beams and the columns, severe sliding of longitudinal reinforcement due to significant bond deterioration and, eventually, flexural cracks localized at the **beam–joint** interfaces or column–joint interfaces. In JPA0 one of the flexural cracks was, however, localized at a certain distance from the joint region

(Fig. 4a). Additional information about experimental program and test results of the virgin specimens can be found elsewhere [21].

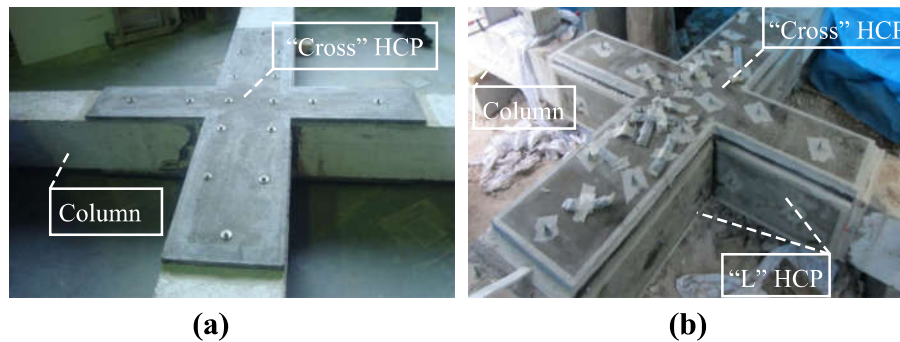
Fig. 6. View of the repaired specimens (a) JPA0-R and (b) JPC-R.

All the retrofitting process was performed with the specimens in horizontal position. For both specimens the remaining crushed and spalled off concrete at the corners of the joints was removed and then replaced with Sika Grout-213. To seal the cracks, boreholes were drilled through the cracked sections. After cleaning the holes using compressed air, small diameter pipes were placed inside them, then the superior face of the cracks was sealed and then epoxy resin SikaDur-52 was injected through these pipes. After turning the specimens, the sealing process was repeated to assure that the cracked section was sealed as much as possible. The concrete substrate was also slightly roughened using hand-held concrete scabbler to partially expose the aggregates. This surface roughening aims to improve the HCP-concrete interface bond properties. Prior to the installation of the HCPs, chemical anchors were mounted inside the holes perforated on the beams, columns and joint regions, at the positions represented in Fig. 5. Before mounting the anchors, the holes were partially filled with Hilti Hit-HY 200-A as a fast curing injectable bonding agent. The embedded length of the anchors inside the concrete was 115 mm. Fig. 6 shows a view of the specimens after the HCPs have been applied.
