Effect of Processing-Induced Oxides on the Fatigue Life Variability of 6082 Al-Mg-Si Alloy Extruded Components

Aluminium alloy 6082 is widely used in the automotive and aerospace industries due to its high strength-to-weight ratio. However, its structural integrity can sometimes be affected by an early fatigue failure. This study investigates the fatigue performance of extruded 6082-T6 samples through a series of fatigue tests conducted at varying stress levels. The material showed significant variability under identical fatigue conditions, suggesting the presence of microstructural defects. Scanning electron microscopy with energy-dispersive spectroscopy (SEM/EDS) and scanning transmission electron microscopy (S/TEM) were used to identify the nature and location of the defects and evaluate the underlying mechanisms influencing the fatigue performance. Computer tomography (CT) also confirmed the presence of oxide inclusions on the fracture surface and near the edges of the samples. These oxide inclusions are distributed throughout the material heterogeneously and in the form of broken oxide films, suggesting that they might have originated during the material's early processing st

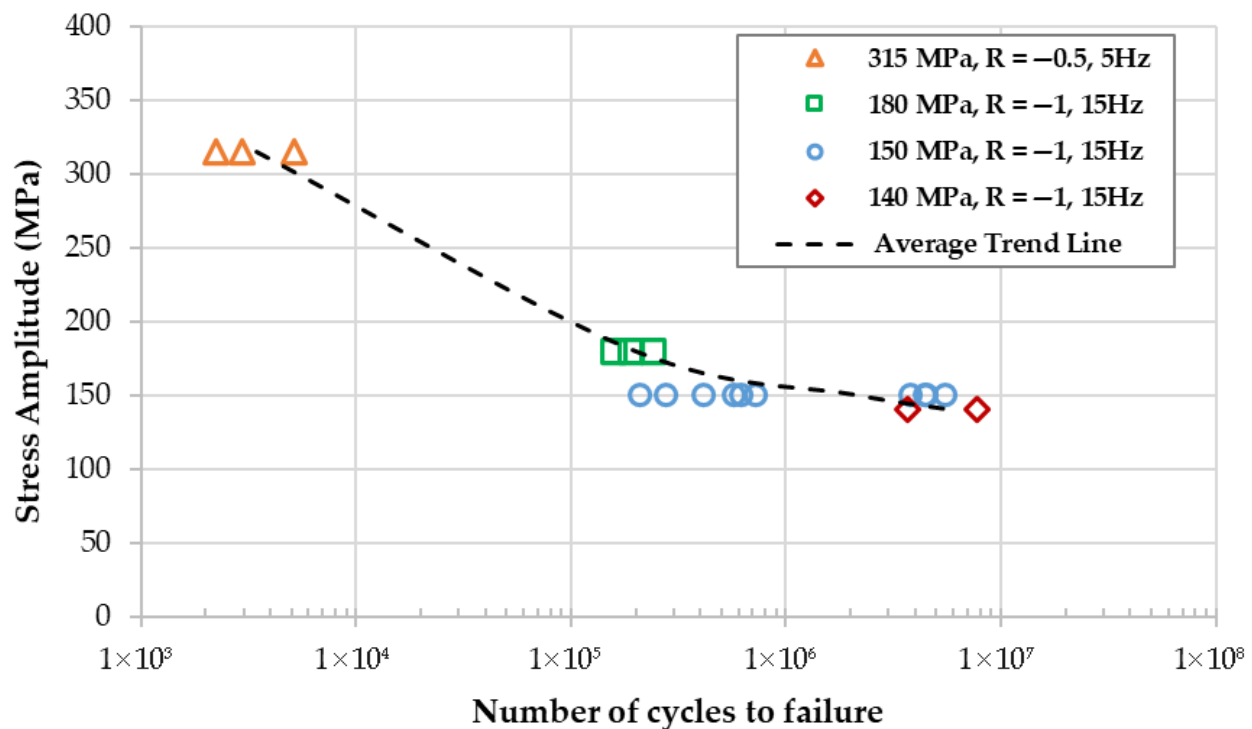
Figure 6. Fatigue life of the alloy at various fatigue conditions.

Multiple fatigue tests were performed under varying fatigue conditions, including different stress levels, loading frequencies, and stress ratios, to investigate the fatigue behaviour of the alloys. Figure 6 shows the stress amplitude against the fatigue life of the samples, and Table 3 presents the average fatigue life of the samples under different fatigue conditions. The detailed fatigue data are given in the Supplementary Materials.

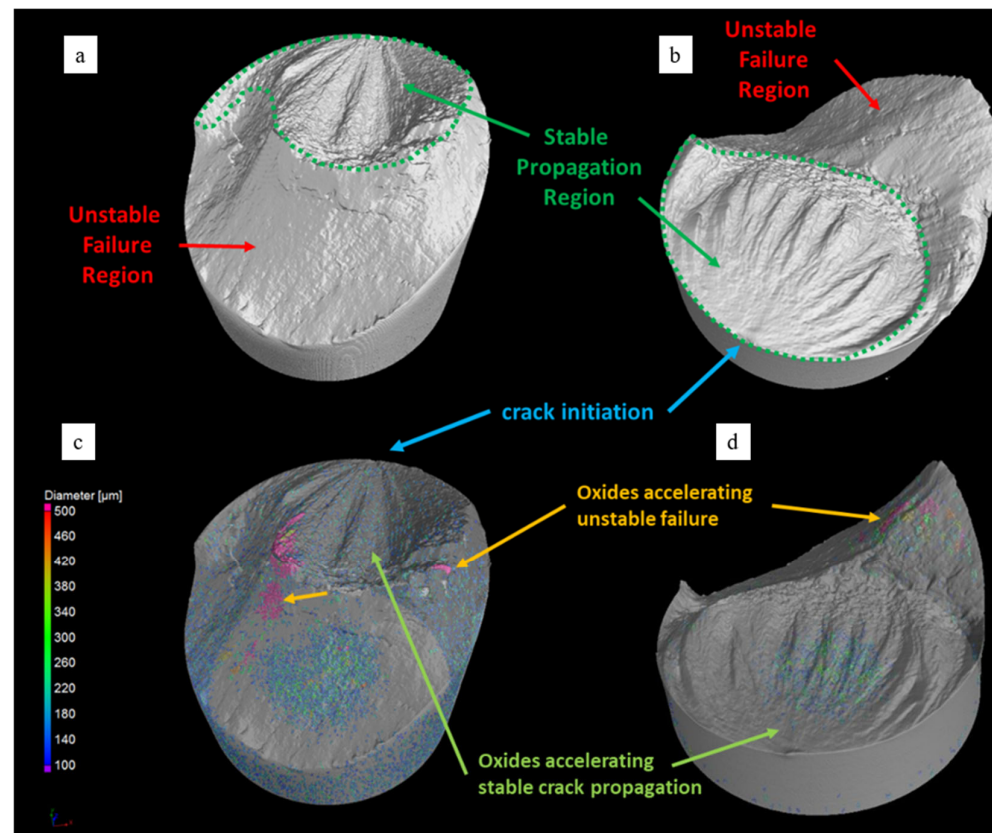
Figure 12. 3D views via X-ray CT of two fractured samples tested under 150MPa: (a) and (c) sample with low fatigue life (0.4 million cycles); (b) and (d) sample with high fatigue life (4.4 million cycles).

Figure 12a,b present the 3D views from Computed Tomography around the fracture zones for the two samples tested at 150 MPa, but which failed at different numbers of cycles. The crack initiation, stable propagation region, and final unstable failure region

are highlighted in the image. Figure 12c,d show a representation of the 3D view of the internal oxides identified in the samples in the volumes shown (up to 2 mm below the fracture surface). A colour scale is included to represent the Feret diameter (max length) of each defect.

The sample with lower fatigue life (Figure 12a–c) exhibits an oxide volume fraction of 0.35% with a particle density of 10/mm³, while the sample with higher fatigue life (Figure 12b–d) presents an oxide fraction of 0.22% and particle density of only 6/mm³.
