Abstract: Corrosion costs the Oil & Gas Industry billions of pounds annually, primarily due to environmental factors such as high salinity, temperature fluctuations, and humidity in marine environments. Mobile Offshore Drilling Units (MODUs), especially jack-up rigs, are particularly susceptible to these dangers. This paper examines the impact of cold stacking on aging jack-up rigs and highlights how the absence of an adequate corrosion control system can accelerate structural deterioration. Our findings show that repair costs following cold stacking can far exceed the costs associated with maintaining rigs in a warm-stacked state. Preload tanks are critical areas prone to degradation due to microbiologically influenced corrosion (MIC) and inadequate preservation practices. Furthermore, although high-strength steels are frequently utilized in the construction of jack-up rigs due to their durability, we illustrate that, in the absence of meticulously devised preventative measures, these steels are susceptible to considerable corrosion, resulting in substantial repair expenses and diminished operational lifespans. This study highlights the significance of proactive corrosion control

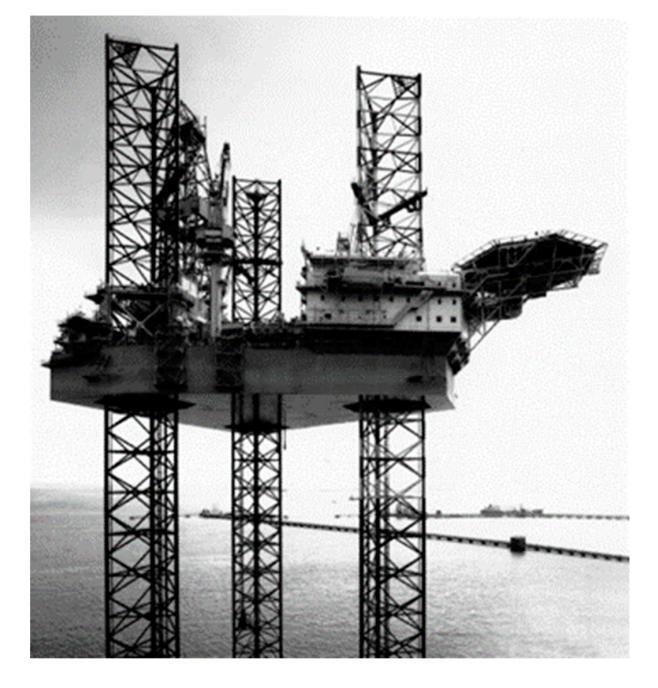
Figure 1. Components of a jack-up drilling rig.

A jack-up is a Mobile Offshore Drilling Unit (MODU) and consists of three main components, which are the Hull, Legs, and Spud cans, as well as many other pieces of equipment, as shown in Figure 1.

The Hull is a watertight structure on which the Cantilever and Jacking System, living quarters, helideck, and equipment are housed. The leg and spud cans are steel structures that support the hull when it is elevated. The spud cans of the jack-up are footings that penetrate the seabed to provide adequate bearing and lateral stability. The jacking system is a mechanism that can lift or lower the hull of a jack-up, the most common of which is a Rack and Pinion system.

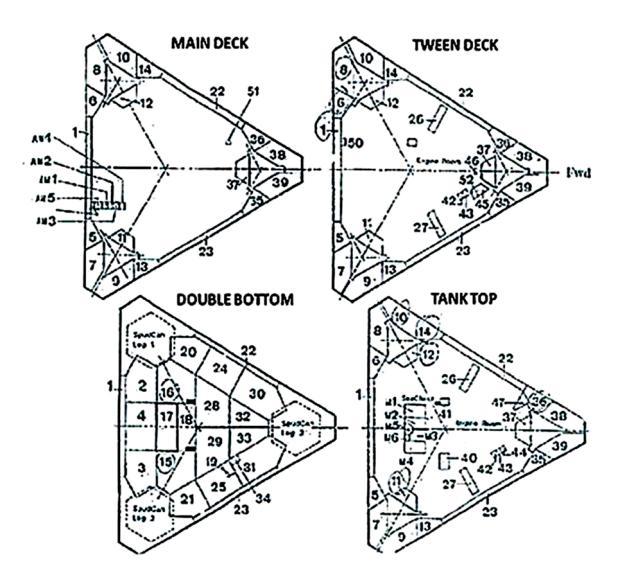
Figure 2. The arrangement of pre-load tanks in our researched jack-ups.

The jack-up must settle on the seabed soil; therefore, there are a few preload tanks within the hull. Different designs have different tank arrangements, and Figure 2 shows the general arrangement of the pre-load tanks on the jack-up rigs investigated within our research. During the pre-load, seawater is pumped into these tanks until a full settlement on the seabed is achieved, and then the preload water is dumped overboard.

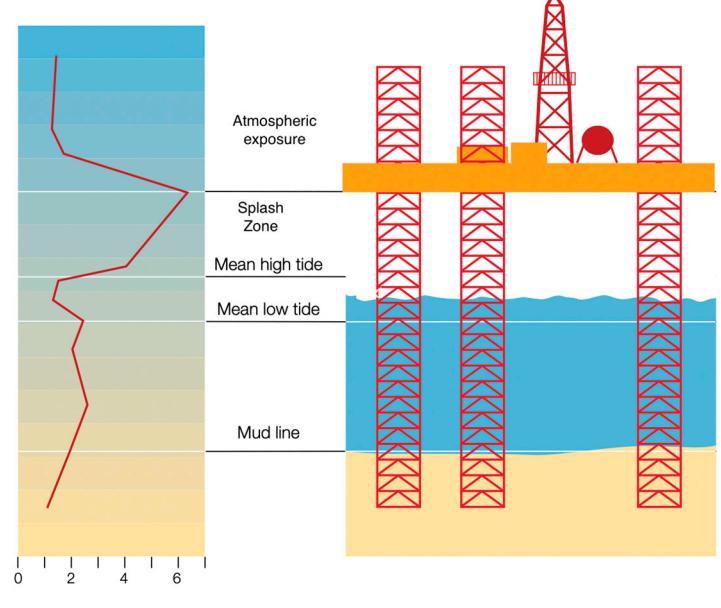
**Figure 3.** Observed corrosion rates in different zones, based on original inspection data from this study [32].

Figure 3 shows that corrosion rates vary greatly throughout different zones of the structure; the splash zone shows the highest rates because of its exposure to cycle wetting and drying conditions.

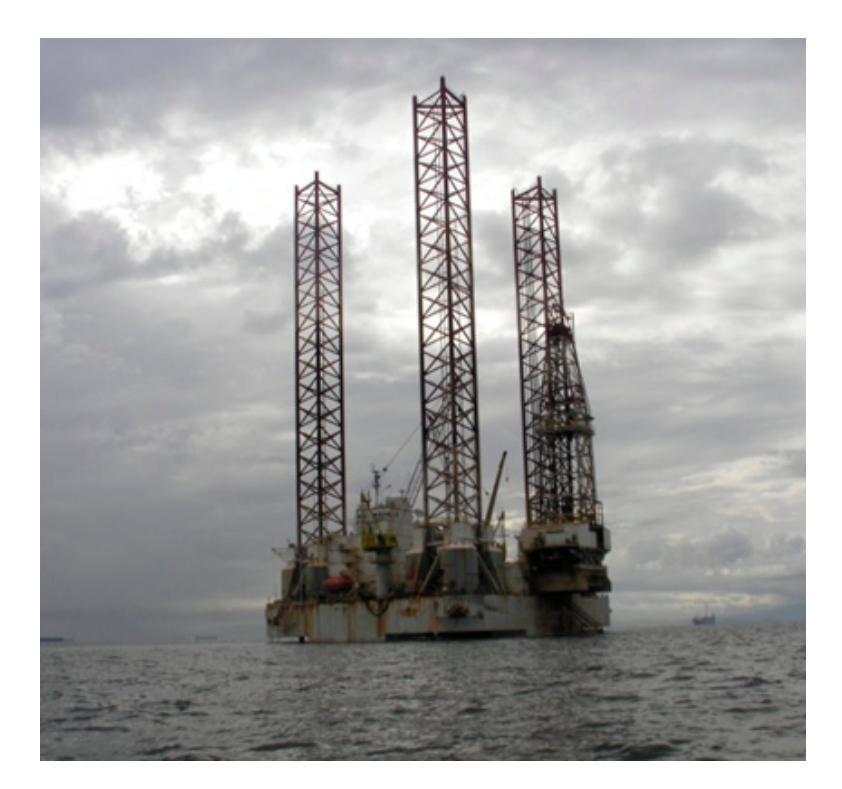
Figure 4. The case study jack-up before sailing to the shipyard for repair.

The case studied was constructed in 1985 with a maximum water depth of 328 ft, shown in Figure 4. The rig was cold stacked for a year and the initial survey showed that remedial work due to corrosion was required to reactivate the rig. Just one year after the rehabilitation, significant corrosion damage was noted, which called for more repairs. This review reveals possible contributing reasons, including inadequate surface preparation before the protective coatings are applied, poor coating choice for high-salinity and splash zone conditions, or application problems including unequal coating thickness. The rapid corrosion observed just one year after the overhaul can be attributed to several key factors, as follows:

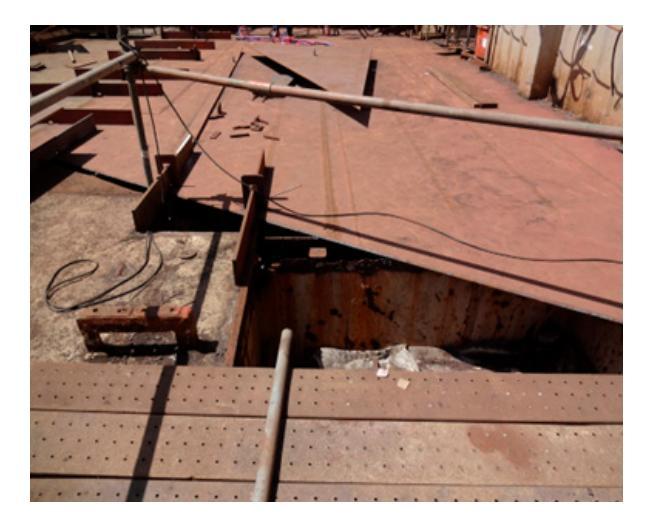
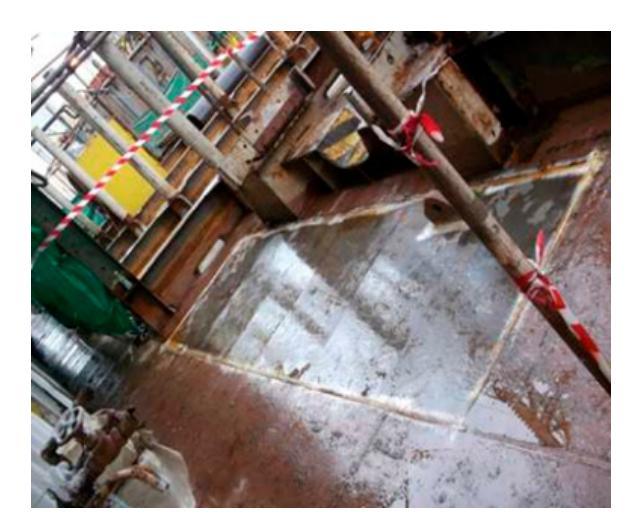
Figure 5. Steel renewal in place.

Figure 5 illustrates the actual steel replacement on one location of the Hull, respectively.

The repairs to the main deck comprised a completed steel renewal and repair at nine locations; three applications of coating of the entire main deck; repair to deckhouse structures as per the DNV load line survey, which included some renewal of the steelwork; the renewal of 12 pieces of the tank manhole and six pieces of the blank flange; pipe rack strengthening by partial renewal and repair; and the renewal of all Bollard caps. The repair uncovered substantial corrosion in various regions of the structure, notably in the splash zone and ballast tanks. Key observations encompass the following:

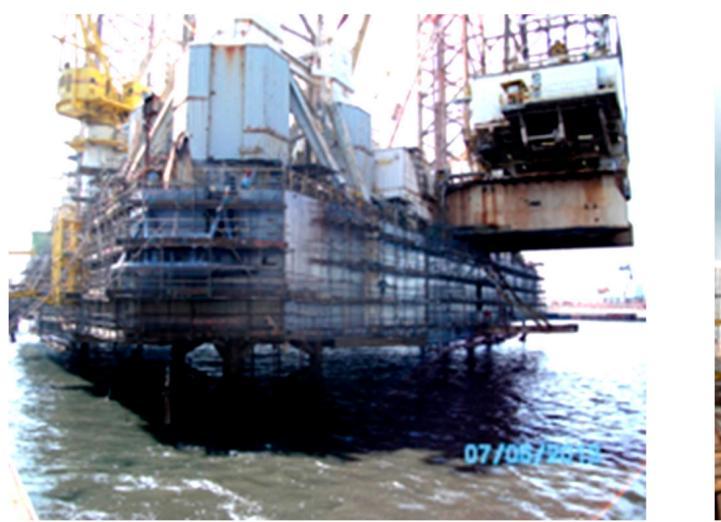
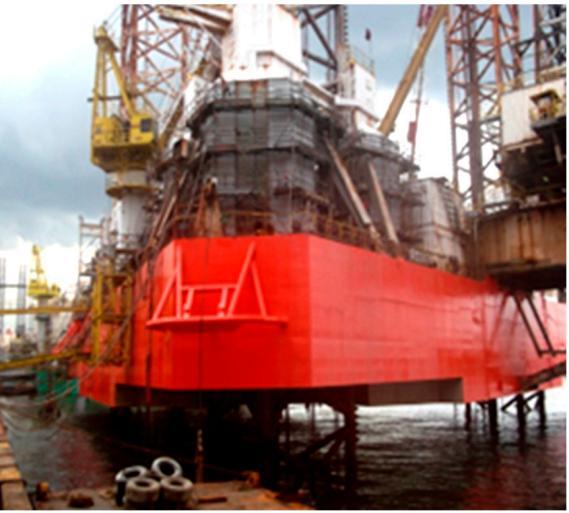
Figure 6. Hull perimeter before and after the protective coating.

Hydro-blasting of all tanks and repairs as needed. Also, three-coat painting of the entire hull perimeter (Figure 6).

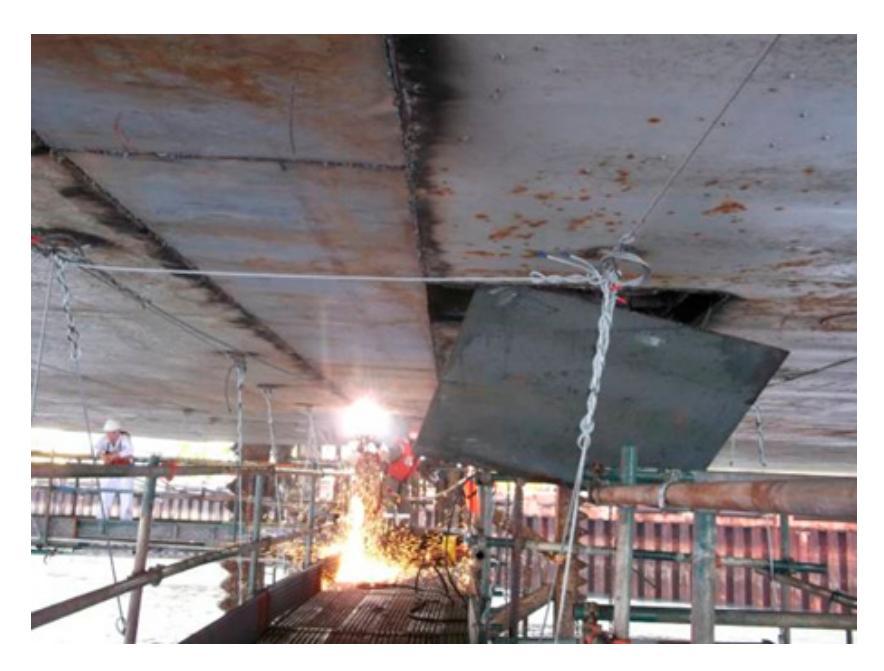
Figure 7. Steel replacement at the Hull's bottom.

- Jack House Wind wall: Removal of old corroded cladding, repair to corroded support beams and C-Channel foundation, and installation of a new wind wall, including new doors.
- Piping: Koomey unit HP tubing, seawater line at storeroom walkway, corroded hammer unions at the drill floor, main engine and compressor cooling lines piping renewed, flushed, and tested, and the drill water and airline from the cantilever to drill floor renewed.
- Hull Bottom Repair: Holes were detected during hull integrity inspection. The steel plate was replaced (Figure 7).

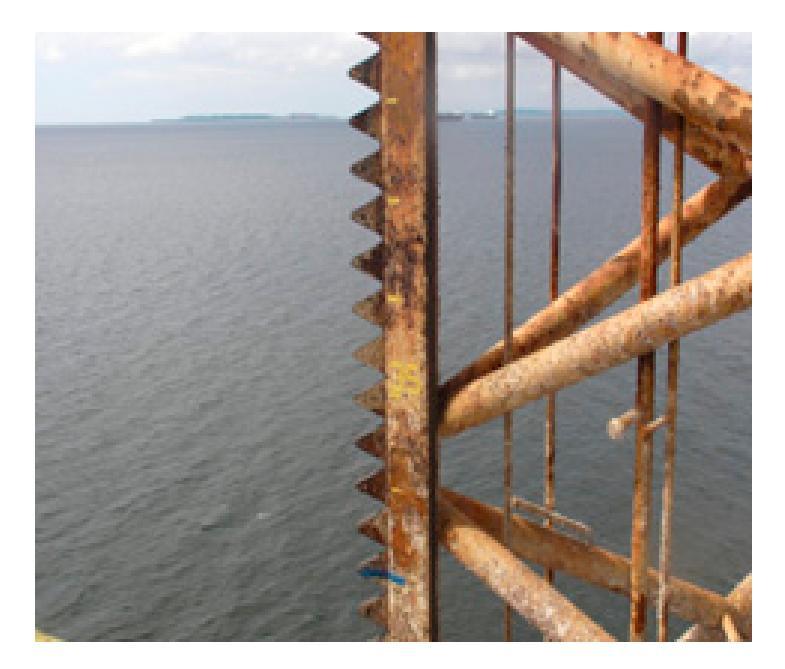
Figure 8. Corrosion on the legs.

- Helideck Structure: Buttering of corroded and pitted areas, with localized repair and painting.
- Legs and spud cans: Figure 8 shows part of the corroded leg.

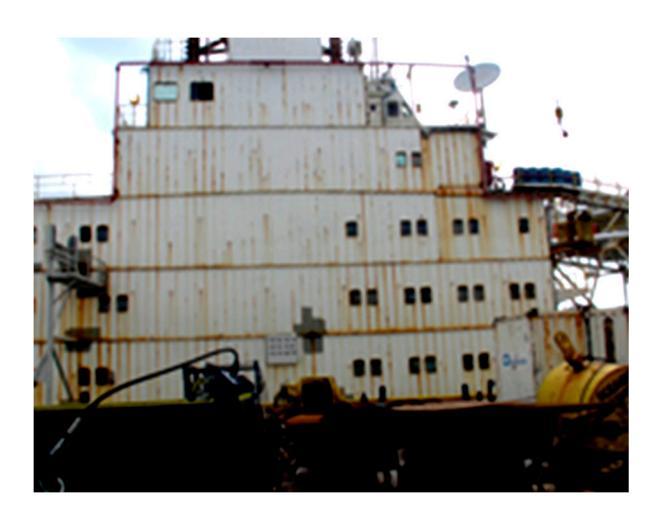
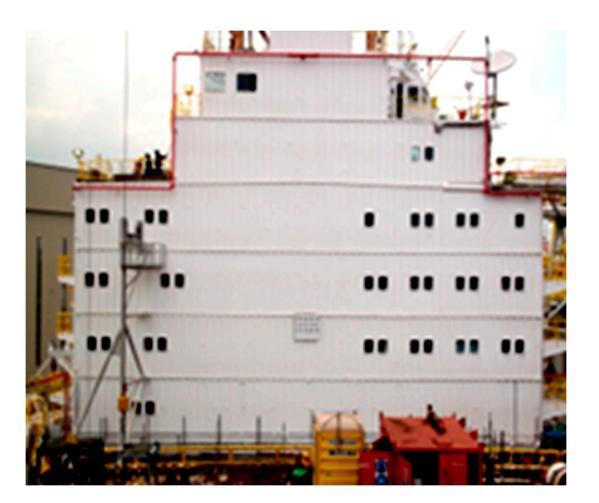
Figure 9. The living quarters.

The repairs conducted on the living quarters can be seen before and after the repairs and the application of the new coating in Figure 9.
